# **Note on the Ground Cracks in Kadalundi Panchayath, Kozhikode**

(Reference: Govt. Letter No. 22718/K1/2013/DMD dated 23/04/2013)

**Hazard, Vulnerability and Risk Assessment Cell**  
Department of Revenue and Disaster Management, Govt. of Kerala  
2<sup>nd</sup> Floor, Institute of Land and Disaster Management  
PTP Nagar, Thiruvananthapuram 695038  
Tel/Fax: 0471-2364424  
Email: hvracell.gok@gmail.com

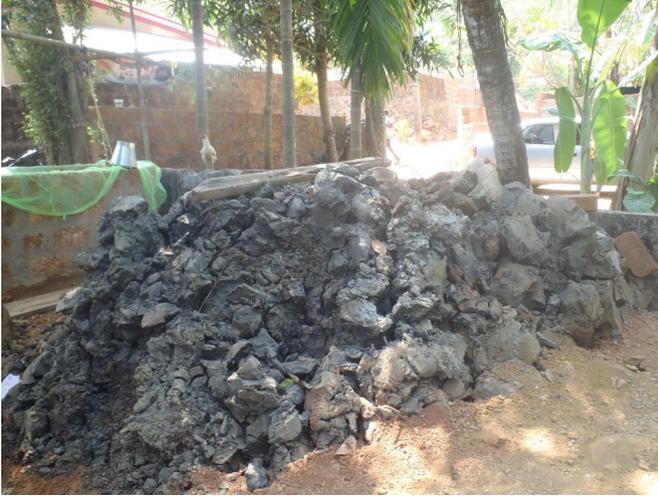
In conclusion, it can be stated that excess draining of water from the clay substrate has caused shrinkage with slight ground subsidence and emergence of cracks especially in the peripheral region of the low lying area. This can aggravate under uncontrolled pumping of water from the region during a drought period. Two dwelling units appear to be affected and may require additional maintenance. As such they are not unsafe, but may be verified by a competent structural engineer.

Black clay from a recently dug open well which swells and contracts with the presence and absence of water

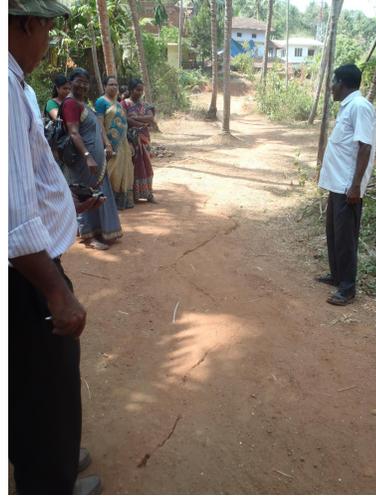
Ground cracks were observed in an area of about 0.25km<sup>2</sup> mostly around eleven dwelling units. The cracks are discontinuous and oriented mostly in northeast direction. A few of them were oriented in ENE-WSW direction. The horizontal separation is limited to one or two cm. The extension of the cracks into the building resulted in minor cracks to the floor and walls of houses. The windows and door frames have been visibly separated from the walls but with very minor displacement only. One of the houses belonging to, Shri. Anil Kumar C.K. showed a tilt of the wall in the NW and SE corner by about 5 cm. Sub horizontal cracks were also noticed in the wall. Another house owned by Smt. Sumathi has also developed visible cracks on the NW corner of the building with the walls and floor exhibiting slight displacement. Most of the houses did show some evidences of hairline cracks developed recently. The local people have testified that the event was noticed from 20.04.2013 and continued till 22.04.2013. As such the damages excepting the two houses mentioned are minor. The two houses mentioned may need some reinforcement to the walls. However they need not be evacuated as the dwelling units are still intact.

Ground cracks

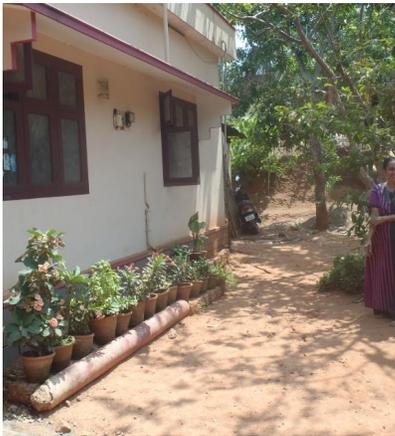
Ground cracks

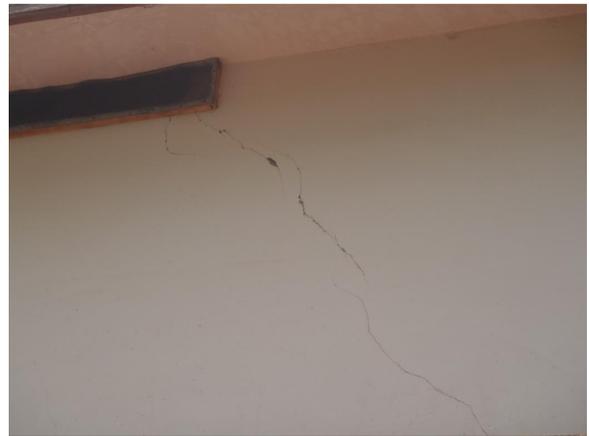
Damage to walls of houses

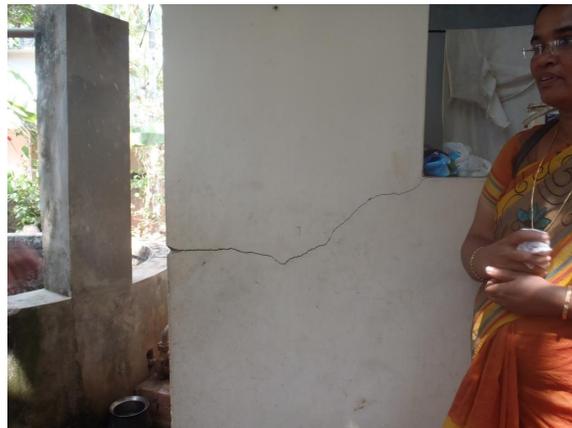
Damage to walls of houses
