# Investigation of soil piping incident at Kottaykkal, Perumannaklari Panchayat , Kanjikuzhinarayil, Malappuram

Field investigation report

May 2018

**ESSO-National Centre for Earth Science Studies**

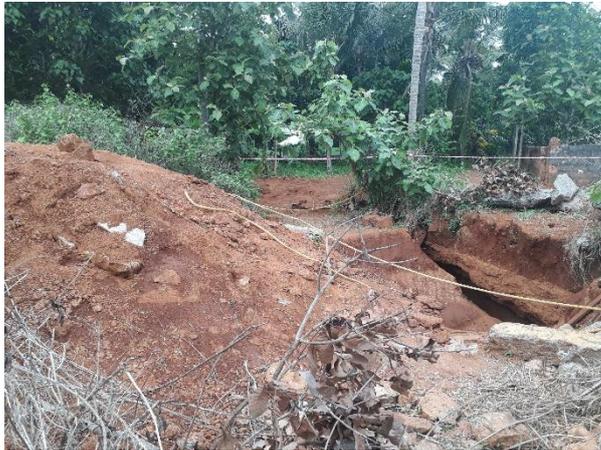
Deep ground fissures/ cracks with varied displacement were observed in two plots (Figs 2, 3 and 4 in a residential area on a laterite mesa in the Perumannaklari panchayat. Elongated in a roughly E-W direction these fissures form an oval shape bordering the ground subsidence locality. The subsided portion is sloping in the direction of South –South East direction.

Figure 2 Fissure in Zainudin's land

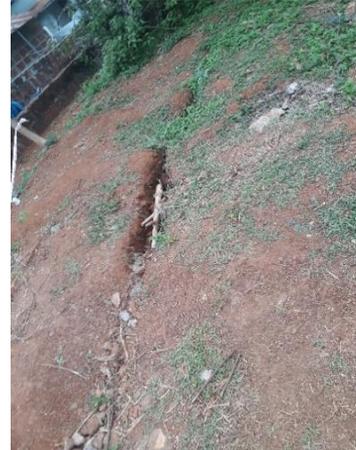
Fig 3 Fissure extending to eastern limit

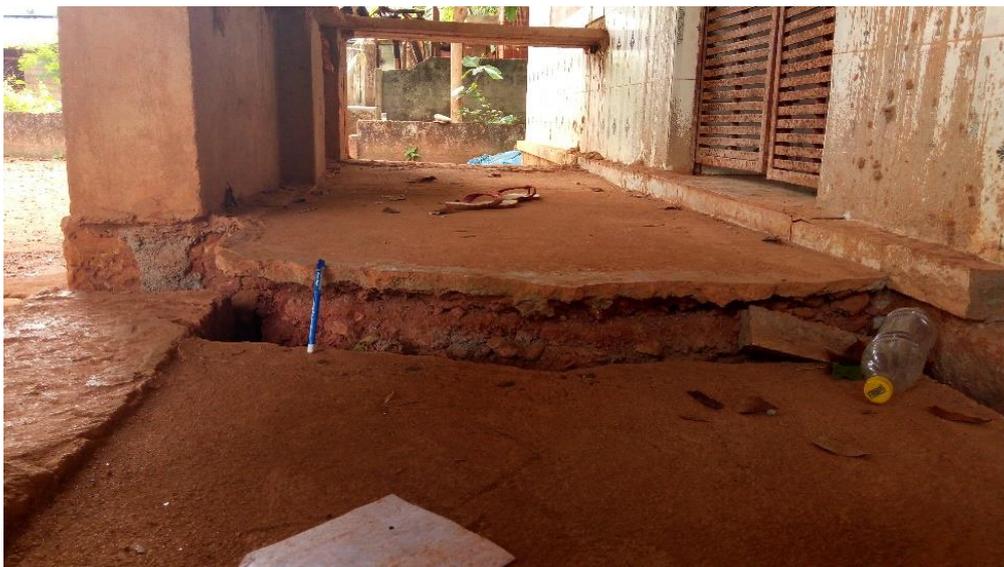
Figure 4 Ground fissures displacing the basement of the Abdul Rahim's house

The land had subsided about 30 cm vertically. The horizontal separation is found varying from few mm to 25 cm at places. The ground movements have caused considerable damage to the two houses situated in these areas. The ground cracks were wide open at certain places and posing danger. The matter was noticed by the media and public when a goat was accidentally slipped into the crevasse formed by the crack and got killed. The district administration then prevented the locals from entering the affected site. The wide fissures were posing danger to life and property of the locals. Based on the request of the district administration, KSDMA has requested NCESS for an investigation.

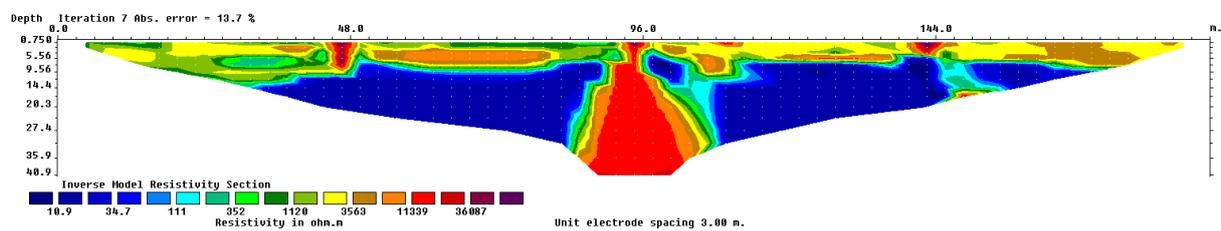
Figure 5 ERT (Schlumberger) taken in the EW profile (survey line 1)

Profile 1 was laid with an electrode spacing of 3.0m and the mid-point of the survey line was near to the subsidence. Schlumberger (Fig.5) Wenner, (Fig.6) and dipole-dipole configurations have been done over the area. Among the three, Schlumberger can be most useful for mapping the tunnel cross-sections. From the section the low resistivity layer is about 6 meters in the resistivity section could be an indication of the groundwater zone. *In the middle of the section a high resistivity zone separate the water saturated area is an indication of the suspected soil pipe.* The configuration fails to map the tunnel bottom even though from physical observations it is known that the actual vertical extent of the tunnel is lesser than the interpreted depth of the array.

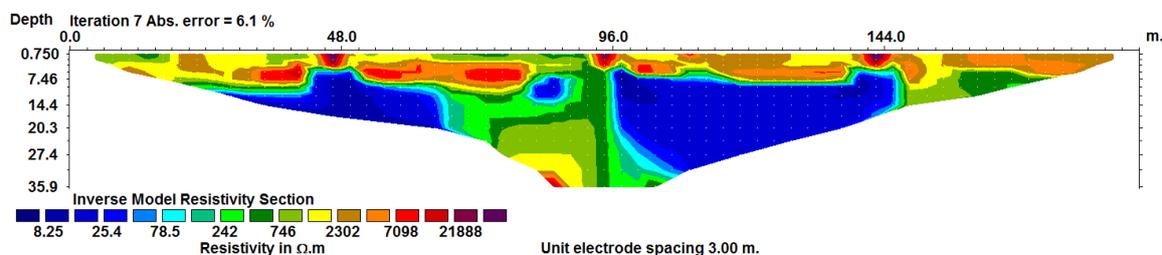
Figure 6 ERT (Wenner array) taken in EW direction - Survey line 1

The qualitative interpretation of the resistivity section indicates that the technique could delineate the conductive zones where the soil pipes are formed. The profile 1 has taken

close to the subsidence and possible orientation of pipe at the location is known. However, the geometry of the soil pipe is not found decipherable from the resistivity section probably due to higher electrode separation in comparison to the diameter of the soil pipe. In profile 2 electrical resistivity survey was carried out parallel to this profile on the northern side of the affected site. Since the suspected pipe in this area is small in size it escaped detection in the survey. In this location the size of the pipe was possibly small to escape the detection from ERT

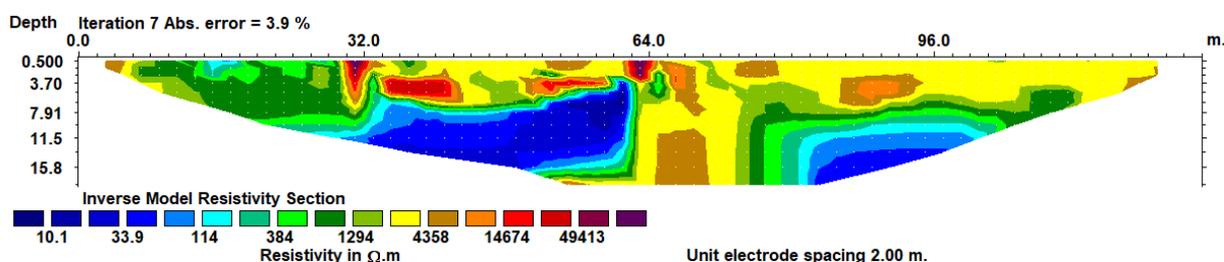
Survey line 2 was laid at 50m north of the major subsidence at an electrode spacing of 2m and the total lateral extension of 128m. The resultant data (Fig. 7) gives a maximum depth about 16m. The resistivity tomography could not recognize any pipe in this locality as the suspected pipe is much smaller in size in this locality.

Figure 7 Electrical resistivity tomograph of Schlumberger array

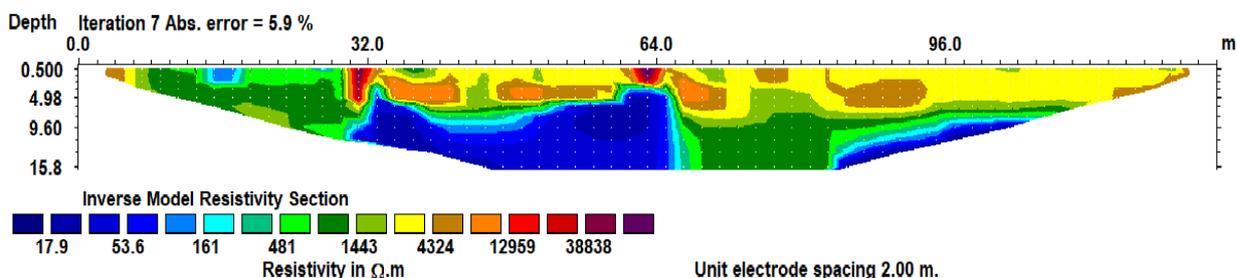
Figure 8 Electrical resistivity tomograph of Wenner Array

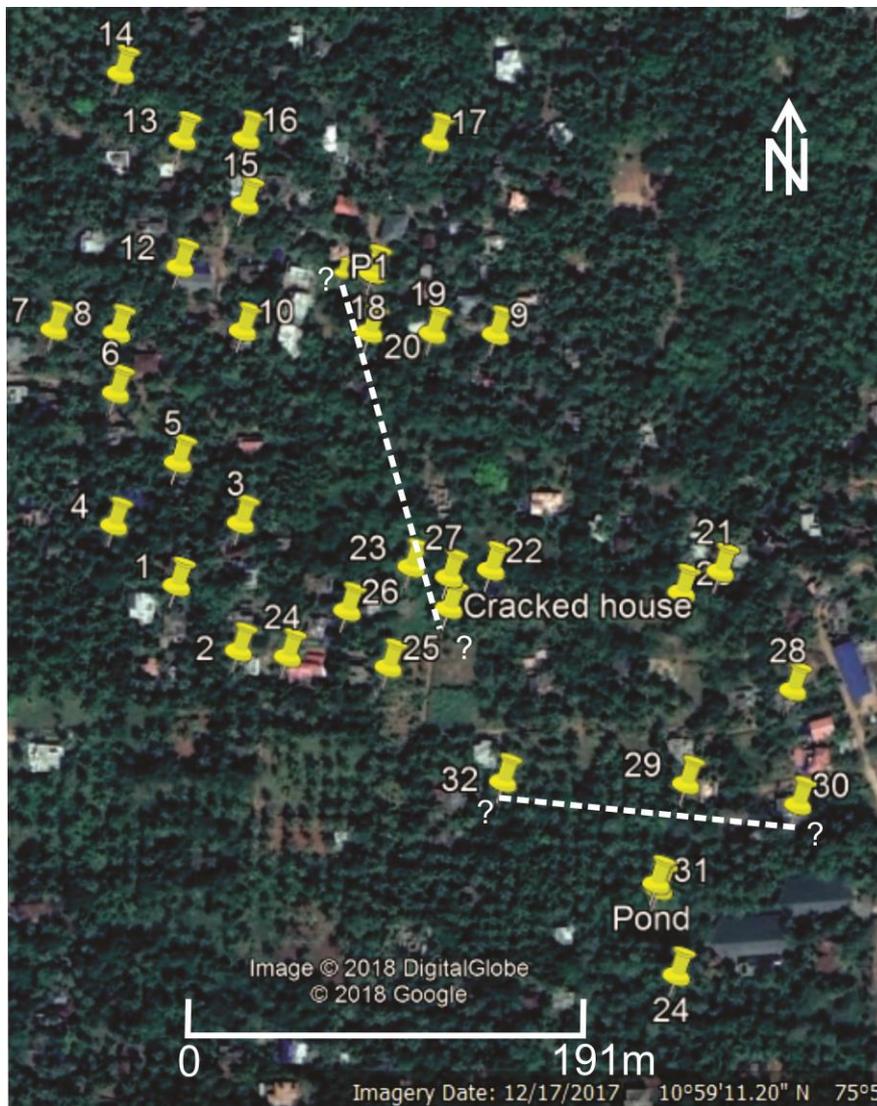
Figure 9 Google Earth image showing various studied wells and location of affected house. The dotted line represents the NNW-SSE and E-W trending soil pipes.

In Perumnaklari also the field studies have indicated the presence of soil pipes in this area. The geophysical survey conducted very close to the affected locality has indicated the presence of a void which extending to a depth of 26 meters. The hydrogeological studies also indicated (table 1) the presence of tunnels and caves in few wells. So it is suspected that pipes trending in NW - SE and E-W are present in the area (fig 9). A more detailed study is required map the network of soil pipes in this locality.

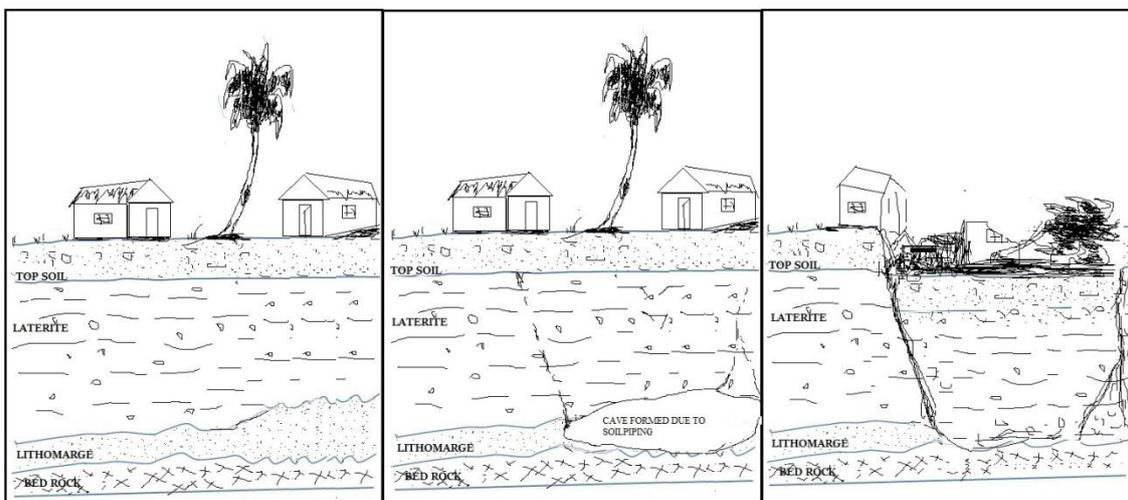
Ground investigation has revealed that it is due to an underground soil erosion called "soil piping" or Tunnel erosion. The "Soil piping" ( tunnel erosion ) is the subsurface erosion of soil by percolating waters to produce pipe-like conduits below ground especially in non-lithified earth materials. Soil piping or "tunnel erosion" is the formation of subsurface tunnels due to subsurface soil erosion. Piping is an insidious and enigmatic process involving the hydraulic removal of subsurface soil causing the formation of an underground passage (Ingles, 1968). During rain percolating waters carries finer silt and clay particles and forms passage ways. The resulting "pipes" are commonly a few millimeters to a few centimeters in size, but can grow to a meter or more in diameter. They may lie very close to the ground surface or extend several meters below ground. Once initiated they become cumulative with time, the conduits expand due to subsurface erosion leading to roof collapse and subsidence features on surface.

Figure 10 Sketch showing the subsidence related to soil piping in Perumannaklari (not to scale)

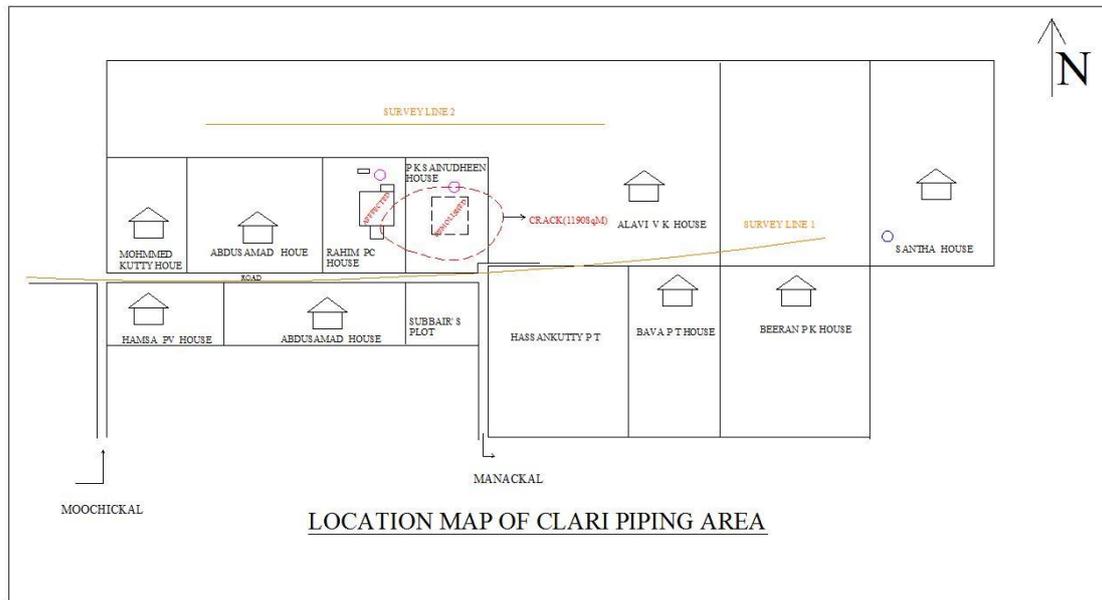
Figure 11 Map showing the extent of the soil piping affected area in PerumannaKlari (Clari)

The affected two plots now pose extreme danger to the local community. It is reported that one goat while grazing in this area accidentally fell into the crevasse formed by the ground fissures. So it is recommended that this area should be barricaded and prevents the locals from entering into it. Local panchayat may take appropriate measure to educate the people and put informative boards in this area. The ground subsidence has extended towards east and a small portion of V.K Alavi's property is also affected.

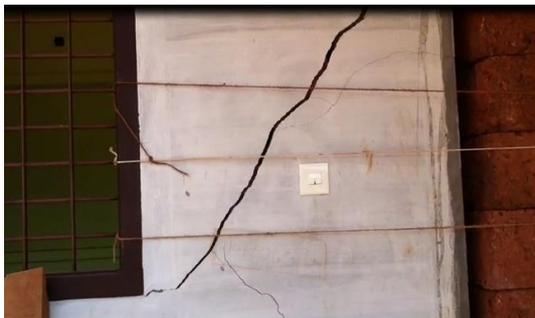
Figure 12: Zainudins house Cracks on the wall

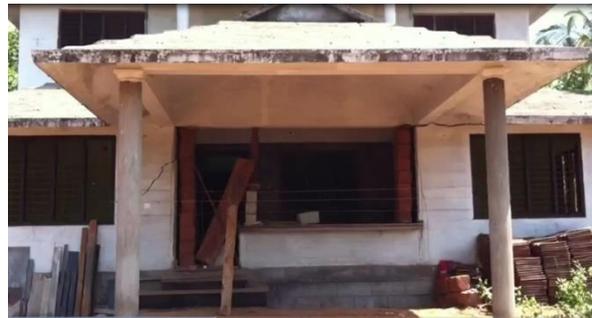
The land disturbances have taken place in two adjacent residential plots. One belong to the Zainudin Paruthikunnen and the other belonging to Sri Abdul Rahim , Pottachola. **Zainudin Paruthikunnen house and plot:**In the 2013 investigation by CESS it was mentioned that *“The terraced relatively new house belonging to Shri. Zainudeen, Paruthikunnen, is totally damaged with almost all the walls and floor cracked beyond repair. Sub horizontal cracks are noticed on all the walls and basement. Plaster is peeled off exposing the bricks in many places. There is no definite pattern in the cracks. The floor tiles have been dislodged with formation of cavities below on account of ground subsidence. The basement appears to have subsided by few cms. Ground cracks are more prominent on the northern and eastern part of the building. The open well with water on the northern side of the house has developed a crack all around the circular opening at about 5 m depth with an inclination to the south. There is a visible displacement seen*

along the cracked surface. The crack is seen in the laterite profile below the hard vermicular layer.”

Figure 13: Zainudin’s house in 2013 (file photo)

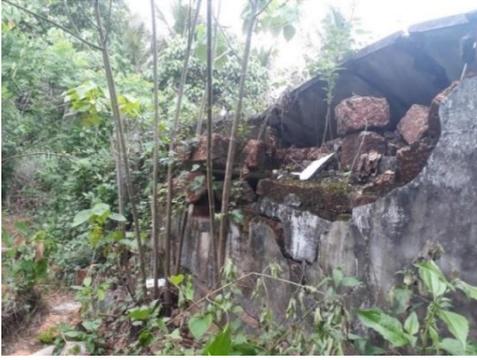
At the time of this visit the house of Sri Zainudin was completely in a broken down condition (Photo 14). Ground cracks have become huge. The land had subsided about 30 cm causing huge ground fissures of about 17 meters. The subsidence has taken place in an oval shape with elongation in the EW direction (photo 16). The fissures have propagated to the basement of the

old house there by completely destabilising it. Now only basement and remnants (photo 14 and 15) of the building are seen.

Figure 14 Zainudins house (2018)

Due to the ground subsidence the house and the plot cannot be put into any use and should be abandoned. The widened ground cracks are posing danger and it is barricade to prevent people from entering into the compound. Here the loss is total. Repair of this house or resettlement here is ruled out due to progressive subsidence of the ground.

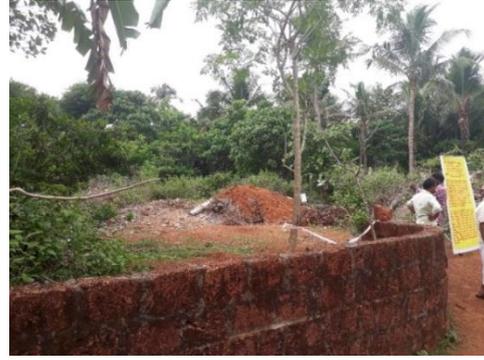
Figure 15 Zainudin's land where house situated

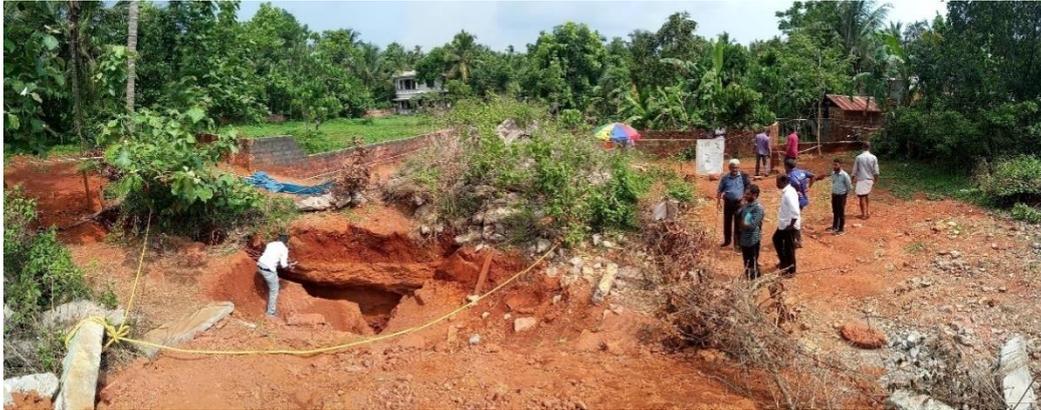
Figure 16 Ground fissure near Zainudin's house-2018

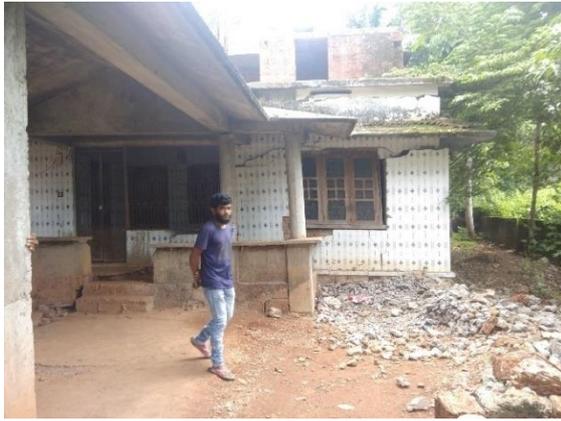
The RCC terraced house owned by Sri. Abdul Rahim, Pottachola, situated adjacent to Mr Zainudins house has been severely damaged (Photo 17 and 18) with ground cracks extending into the basement on the South and east side. The SE corner has suffered substantial damage and developed sub-horizontal cracks below the lintel level. The floor of the house and walls are cracked in many places.

Figure 17 Damaged house of Abdul Rahim

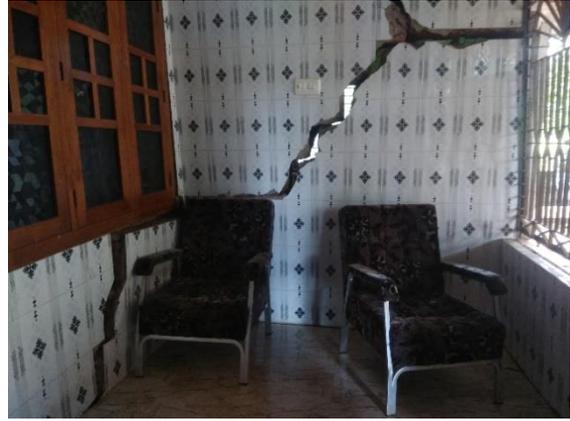
Figure 18 Cracked wall of Abdul Rahims house

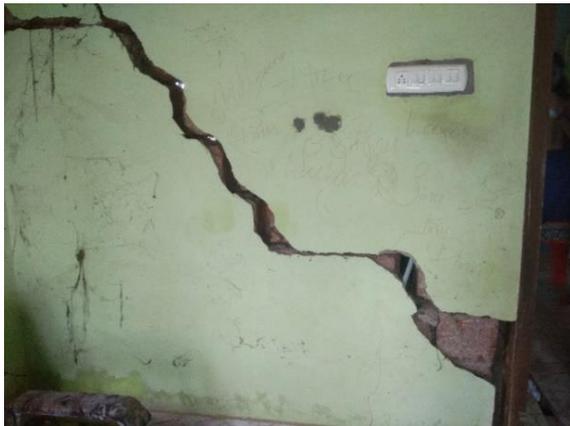
Figure 19 Abdul Rahims House wall

The cracks are discontinuous oriented mostly in east-west direction. The horizontal separation is about 25cms. The extension of the cracks into the building resulted in the development of cracks to the floor and walls of houses (photos 19 and 20). The floor of the houses appears to be tilted towards southeast. The windows and door frames have been separated from the walls with visible displacement. The house was damaged extensively and there is no scope of repair. Ground subsidence is progressing in this locality also and any scope of settlement and human activities cannot be allowed. The house is completely damage and not fit to live.

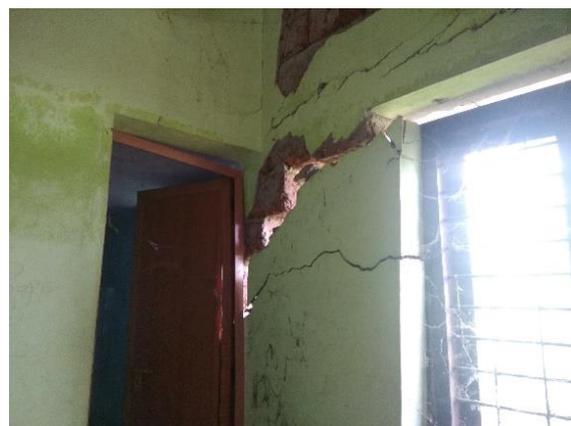
Figure 20 Cracks affecting the walls and beams
