Special Team for Mullaperiyar Crisis Management

INTRODUCTION

A field-based investigation was carried out on 21st August, 2012 in two different locations in Kottayam district of Kerala, following the press report on well collapse (Ref: 16th August, 2012, Malayala Manorama and Mangalam). It was reported that following the heavy rain fall of August 15th morning, two wells, one in Perunna, Chenganachery and other in Needoor, Near Ettumanor collapsed. A team from the Hazard Vulnerability and Risk Assessment (HVRA) Cell visited the above said locations and details were collected. The detailed features of individual events are described in the following sections.

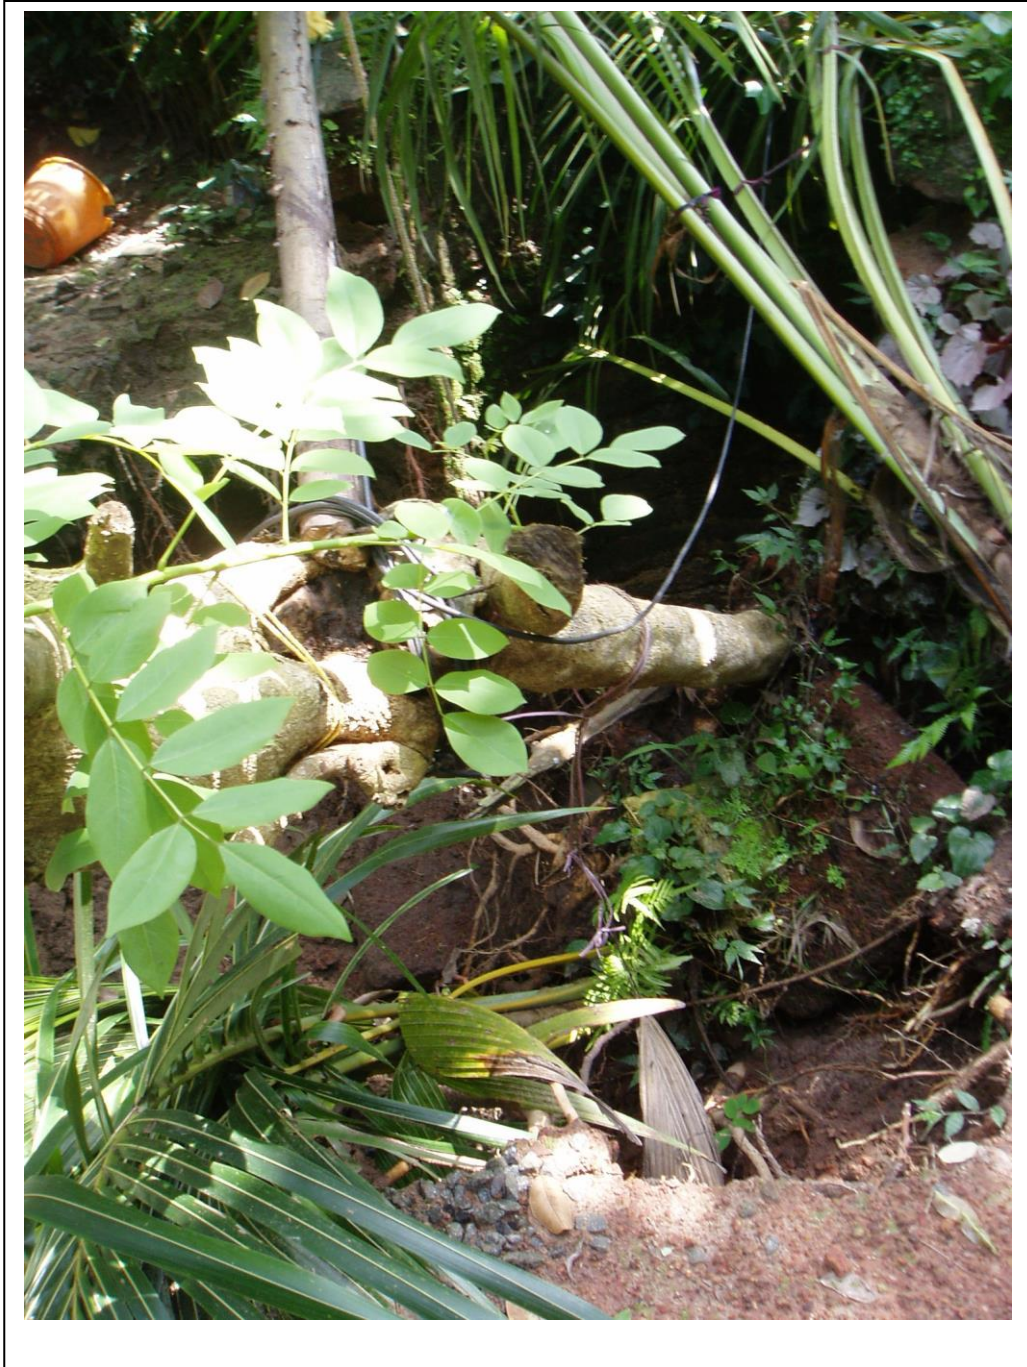
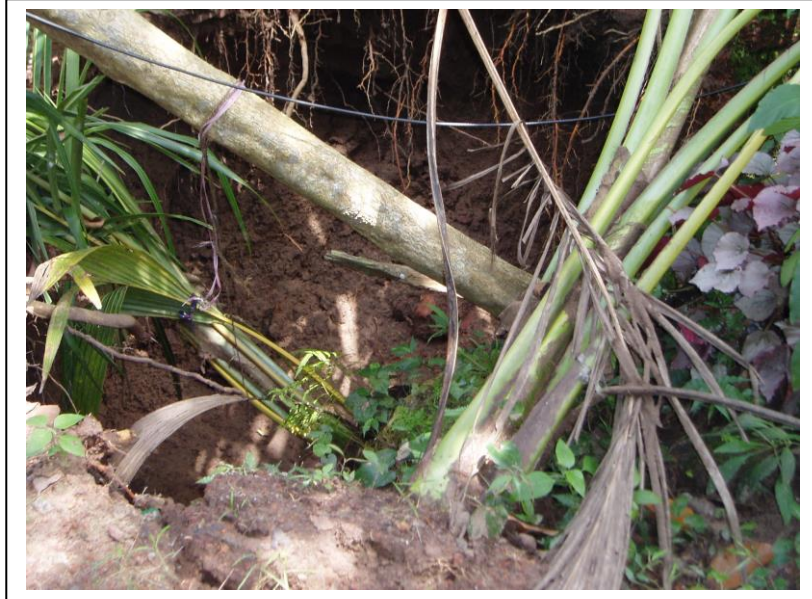
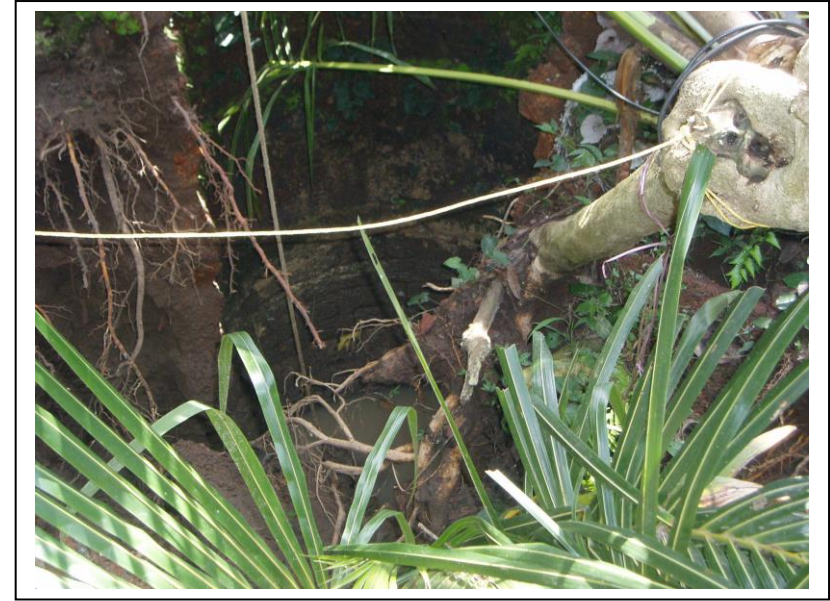
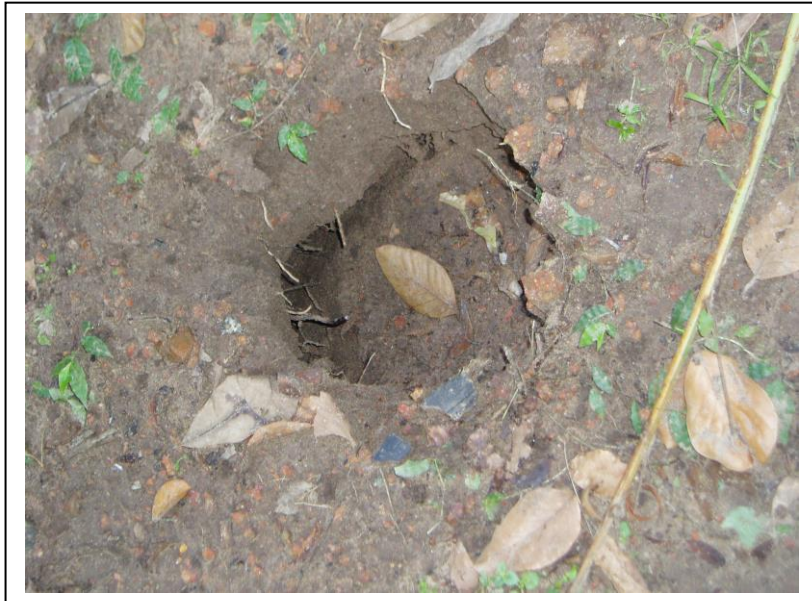
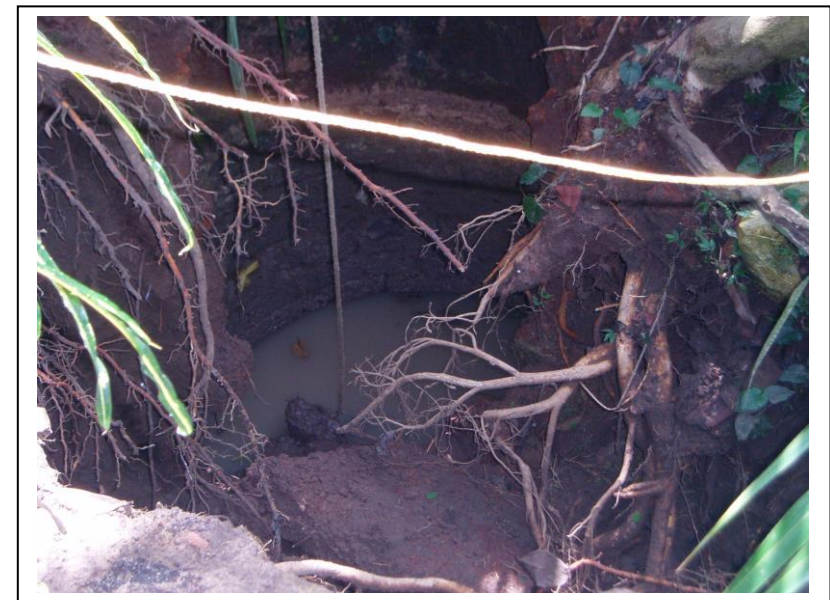
The first well was (N 9° 26' 11. 4" and E 76° 32' 30.2"; 34 m above MSL) in the plot of Mr. Kunjukunju K. Maruvathu, Kuthukallunkal, Panachikavu P.O., Perunna (Chenganacherry municipality, Chenganacherry village, Chenganacherry taluk, Kottayam District). The plot was slightly elevated from the road. The area comes in Upper Kuttanad and geologically is sedimentary in nature. The collapsed well has a diameter of ~1.2 m, with a depth of 50 feet. The well was dug 100 years ago, had laterite lining and was

perennial even during extreme drought conditions. About one month before the event happened, the water in the well started showing an orange colour with effervescence effect and a bad odour (rotten egg's). During the period small changes in water level was also observed.

On 15th August, around 08.00 am, a small sound similar to boiling water was heard from the well and change of colour, effervescence and slight crystallisation on the top of water were observed. On the same day around 10.00 am, water in the well up-welled with effervescence, following which with a big sound, one side wall of the well collapsed. At the same time a new hole with same depth of the collapsed well developed adjacent to the well and the walls of this sink hole collapsed within a few minutes. The colour of the water turned starch like and had the water felt thick; white suspended sediments were also found in the water.

The basement of a 200 years old house inclined towards the western side (opposite to the direction of the well) and a new crack developed near to the kitchen area.

In order to make a general assumption about the process, information regarding the wells in the neighbouring houses were also collected. None of the wells in the neighbouring houses reported any unusual phenomena. But neighbours heard a large sound like something falling from the top. The detailed investigation and field observation carried out in the plot indicate that, more number of small hollows present in the land. This phenomenon was come to notice, while the owner was taken a small pit for growing the vegetables. The pit he has taken was gone down without showing the bottom of the same. These kinds of more number of small holes were noticed around the collapsed well. From the field observation and feedback data collection, it was assumed that the well collapse and associated hole development was due to the activity of soil piping and the was accelerated by the ground shaking contributed by the earthquake on 22nd July, 2012.

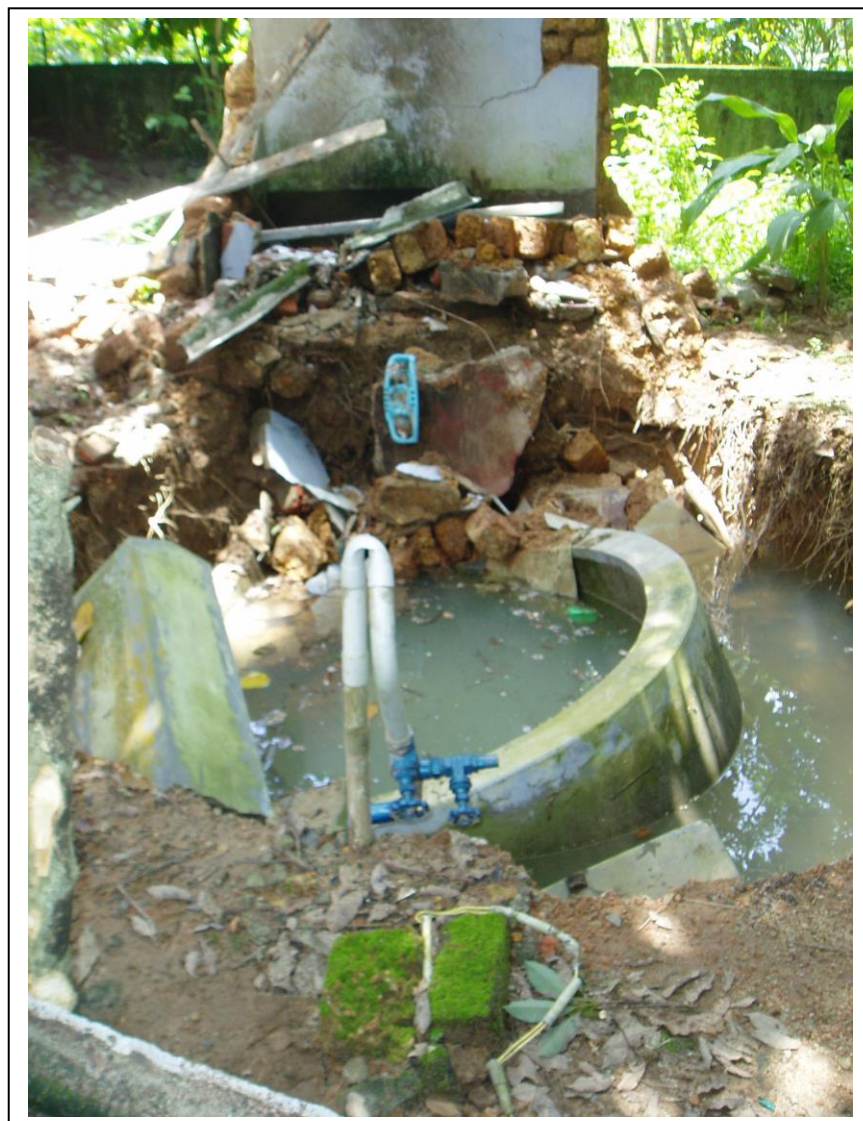
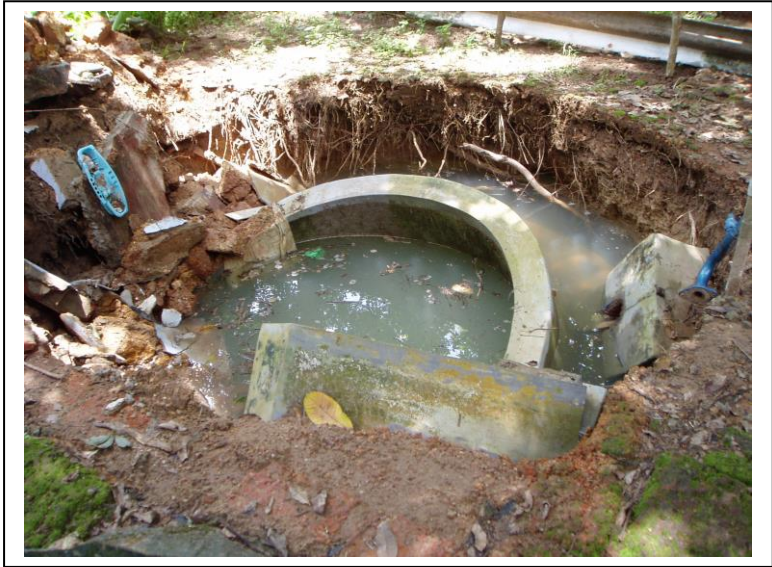
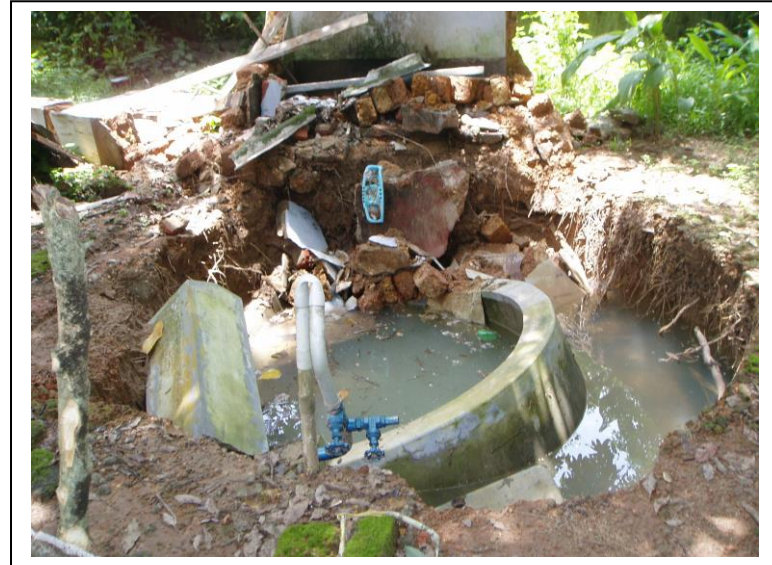
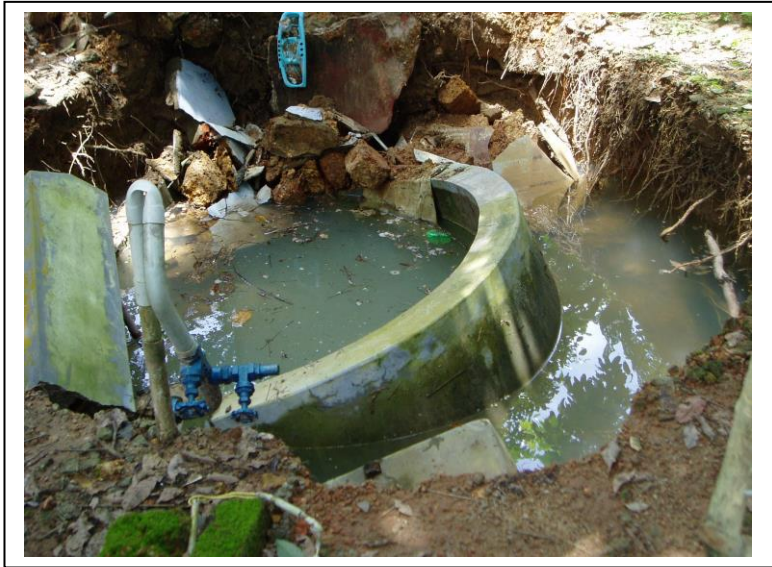
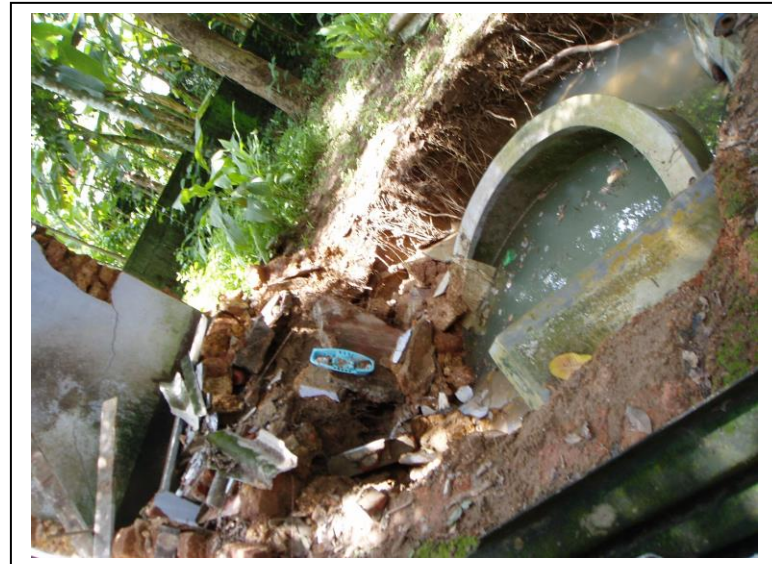
The second well was located in the northern side of Kottayam district, (N 90° 40' 33.8" and E 76° 30' 36.4" with an elevation of 24 m above MSL) in the plot of Mr. E.G. Gopakumar, Gokulam, Neendoor (Neendoor Panchayath, Onamthuruthu village, Kottayam taluk, Kottayam District). The house is located on the flank of small mound, with paddy field on other side. The collapsed well was of a diameter of 2 m with a depth of 25feets. The well was constructed on 30 years back and lined with Laterite bricks.

15th August, 2010, morning 08.30 am, slight inclination was observed in both pillars of the well, following the upliftment of side floors. At the same time, one wall of the bathroom adjacent to the well also detached from the main basement and other wall. Suddenly with a big sound, the detached portion of bathroom, pillars and rings of the well went down to the watered portion of the well. At the same moment, the surrounding land portion also collapsed into the well. An inventory of wells in the neighbouring houses were also carried out for enquire about the changes of water level and other related issues in the wells and no such incidents were reported from any where.

investigation. The well was constructed in the flood plain area, in which the bottom rest on sandy clay layer. The lining of the well was done with locally available laterite brick and two pillars were also constructed in the top. Few years back, some of the laterite bricks, which are used for the lining, were fallen down and no maintenance were done for the same. This has enhanced the movement of side filling material into the well bottom, which become made a huge void in the well wall. Due to heavy rain and associated infiltration of rainwater, this void acted as a conduit for easy down movement of the materials. This caused the loss of support and cohesion of the side wall material, which lead to the collapse of the well. This finding was supported by the field photographs, which shows the direct central down movement of the overburden, which contains the remaining lining material and pillars of the well.
