FIELD BASED ASSESSMENT OF THE EFFECTS OF RECENT EARTHQUAKE IN KOLLAM DISTRICT OF KERALA

Hazard, Vulnerability and Risk Assessment (HVRA) Cell
Department of Revenue and Disaster Management, Govt. of Kerala

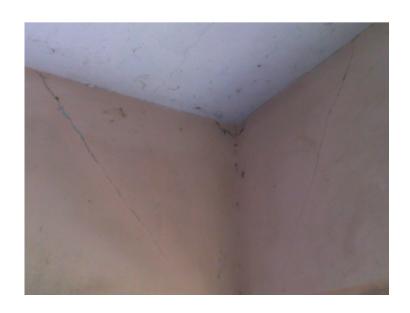
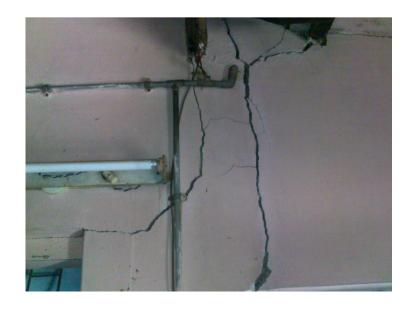
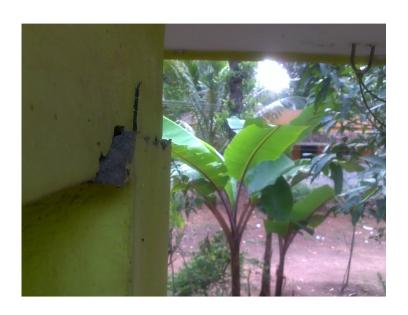
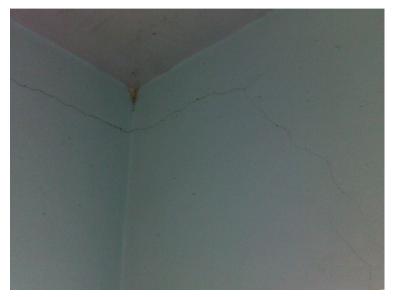
was observed that, the epicentre was located in the contact zone between sandstone/clay with lignite intercalations and granite biotite sillimanite gneiss with graphite (Fig. 4). Lithological contact zone just above the focus of earthquake enhanced earth vibration and caused damages to building and other masonry structures.

Photographs of cracks developed over masonry structures during the earthquake

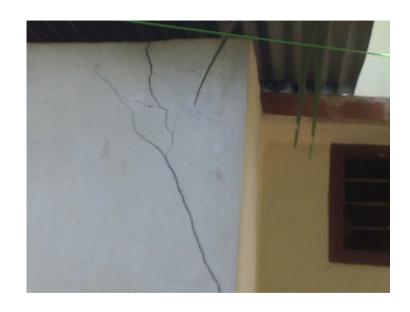
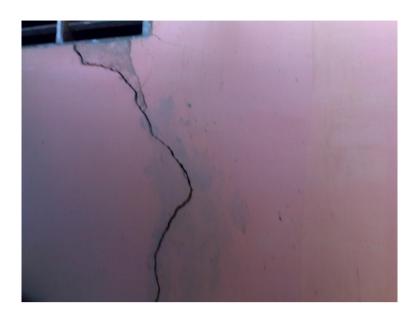
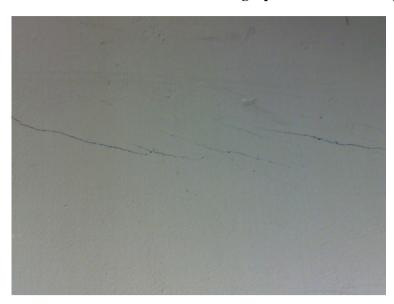
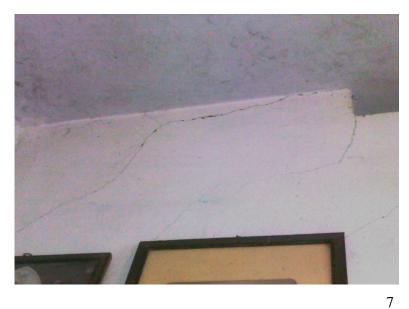
Photographs of cracks developed over masonry structures during the earthquake
