**LAND SUBSIDENCE AND EARTH FISSURES IN WEST KALLADA
AREA OF KOLLAM DISTRICT**

**Dr. VIJITH H
Mr. PRADEEP G.S
Ms. PARVATHY S**

Hazard, Vulnerability and Risk Assessment (HVRA) Cell
Department of Revenue and Disaster Management, Govt. of Kerala
2nd Floor, Institute of Land and Disaster Management
PTP Nagar, Thiruvananthapuram 695038
Tel/Fax: 0471-2364424. Email: hvracell.gok@gmail.com
Web: disasterlesskerala.org

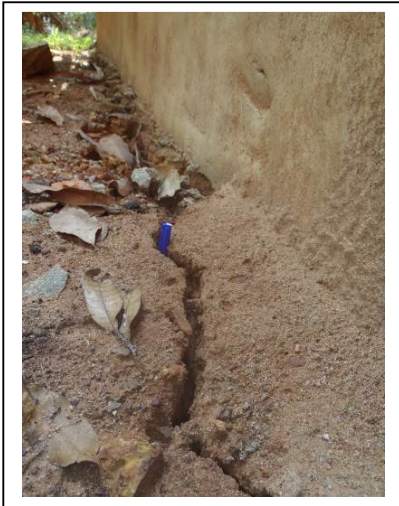
Figure 4: Earth fissures in Vilanthara area

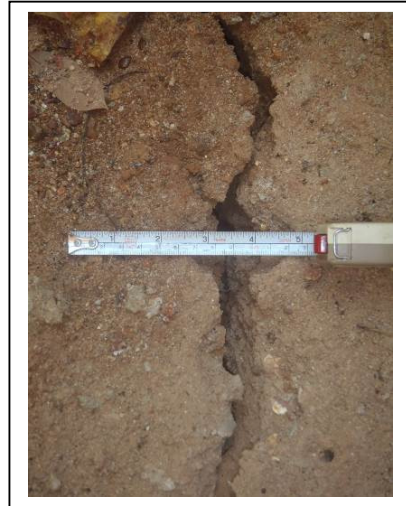
Figure 5: Showing the width of earth fissures (3.5 cm approx.).

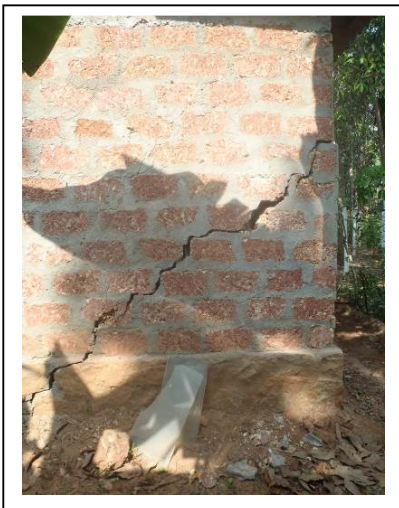
Figure 6: Wall crack developed due to land subsidence

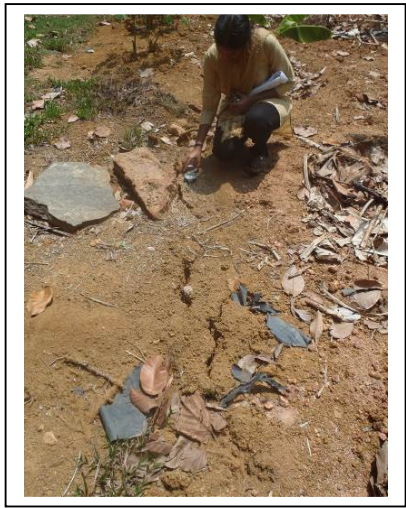
Figure 7: Measuring strike of ground fractures developed

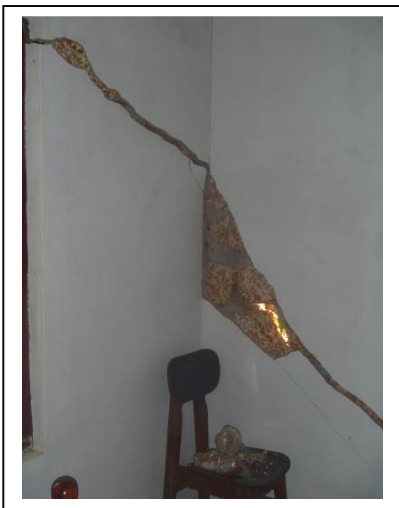
Figure 8: Cracked and collapsed wall of newly built house

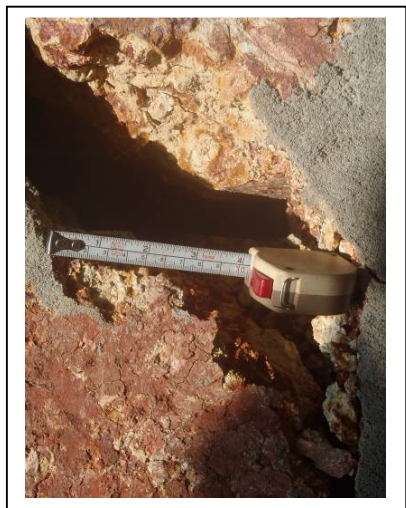
Figure 9: Block separation in the wall cracked

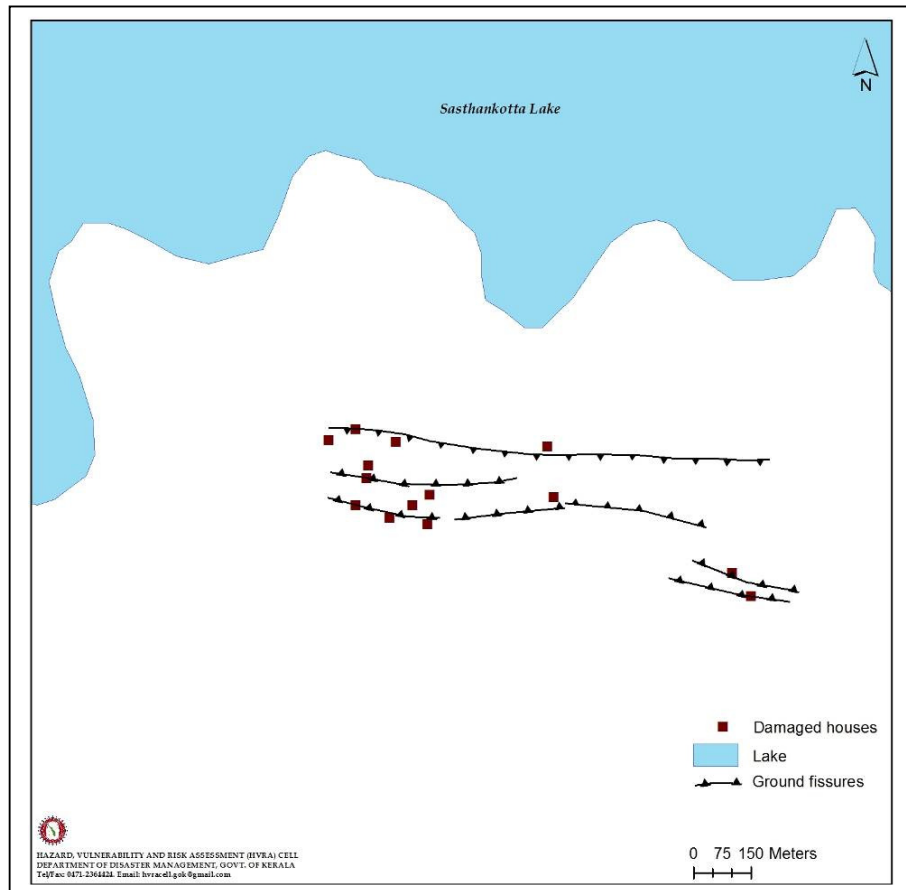
the surrounding areas) and were noted in the western and eastern side of Vilanthara. The earth fissures seen in the Vilanthara area have shown a general strike of East-West and East South East-West North West directions with several hundreds of meters in length (200 to 400 mts). In some areas the fissures showed non-continuous and curvilinear character (Fig. 10).

Figure 10: Strike extension map of ground fissures and damaged houses in Vilanthara area of West Kallada village in Kollam district.

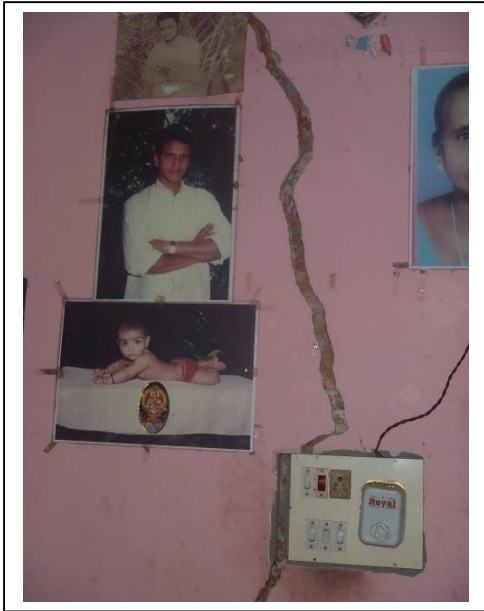
Figure 11: House cracked during the subsidence event

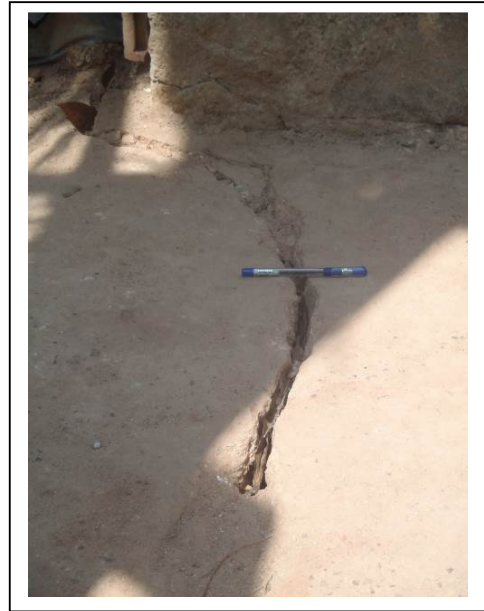
Figure 12: Curvilinear extension of ground fractures

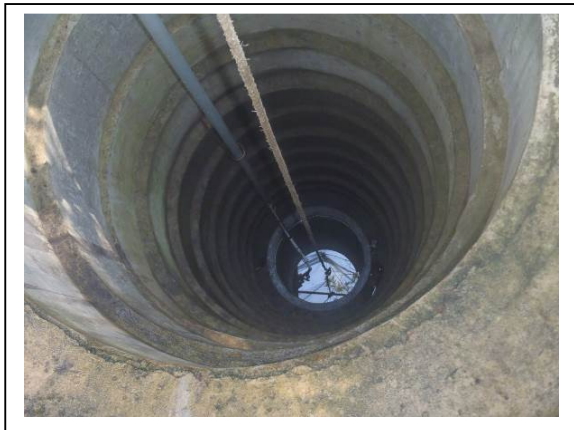
Figure 13: Well with concrete ring collapsed during the land subsidence (Western side of the valley)

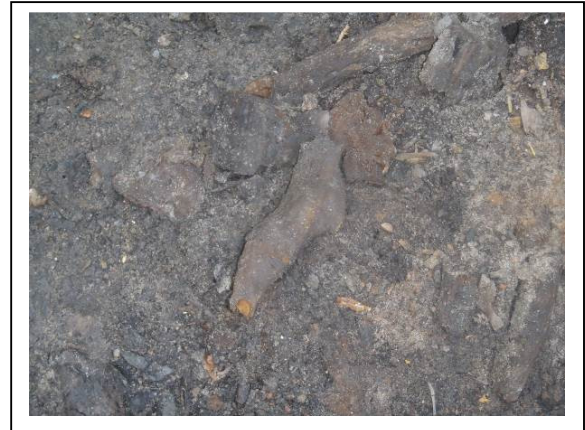
Figure 14: Unaltered wooden debris recovered from the collapsed well. It seen as mixed with clay

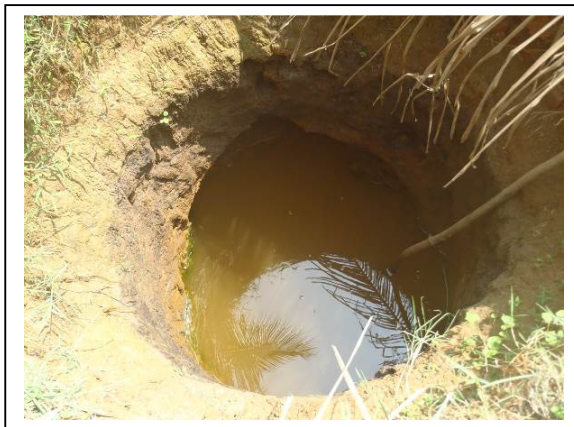
Figure 15: Water quality altered and water level lowered in the well (middle portion of the valley)

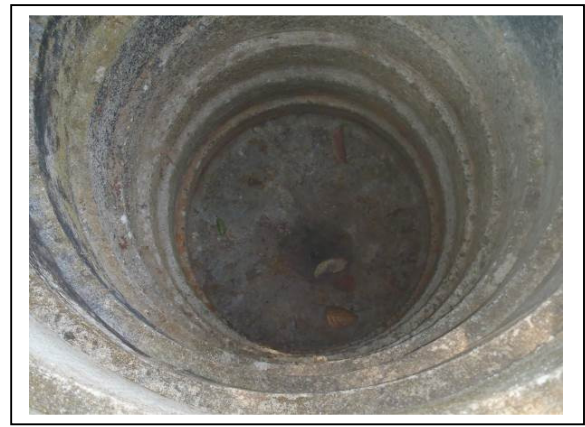
Figure 16: Totally dried in the month of February (This was first time in the area)

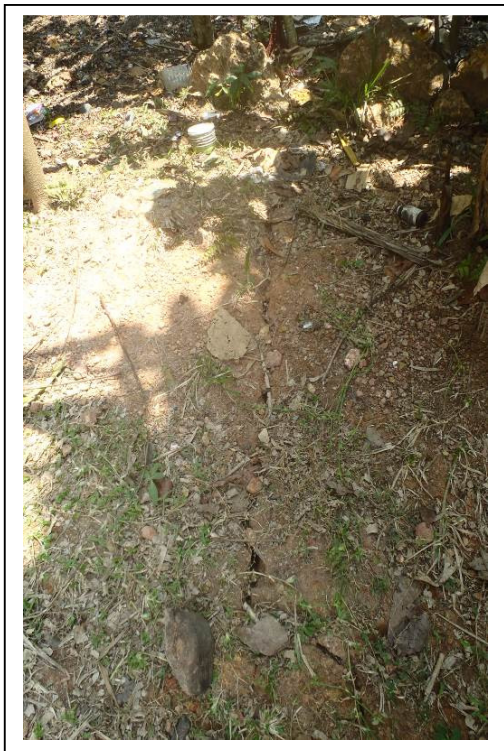
Figure 17: Continuous extension of ground fissure seen in the Eastern side of the valley

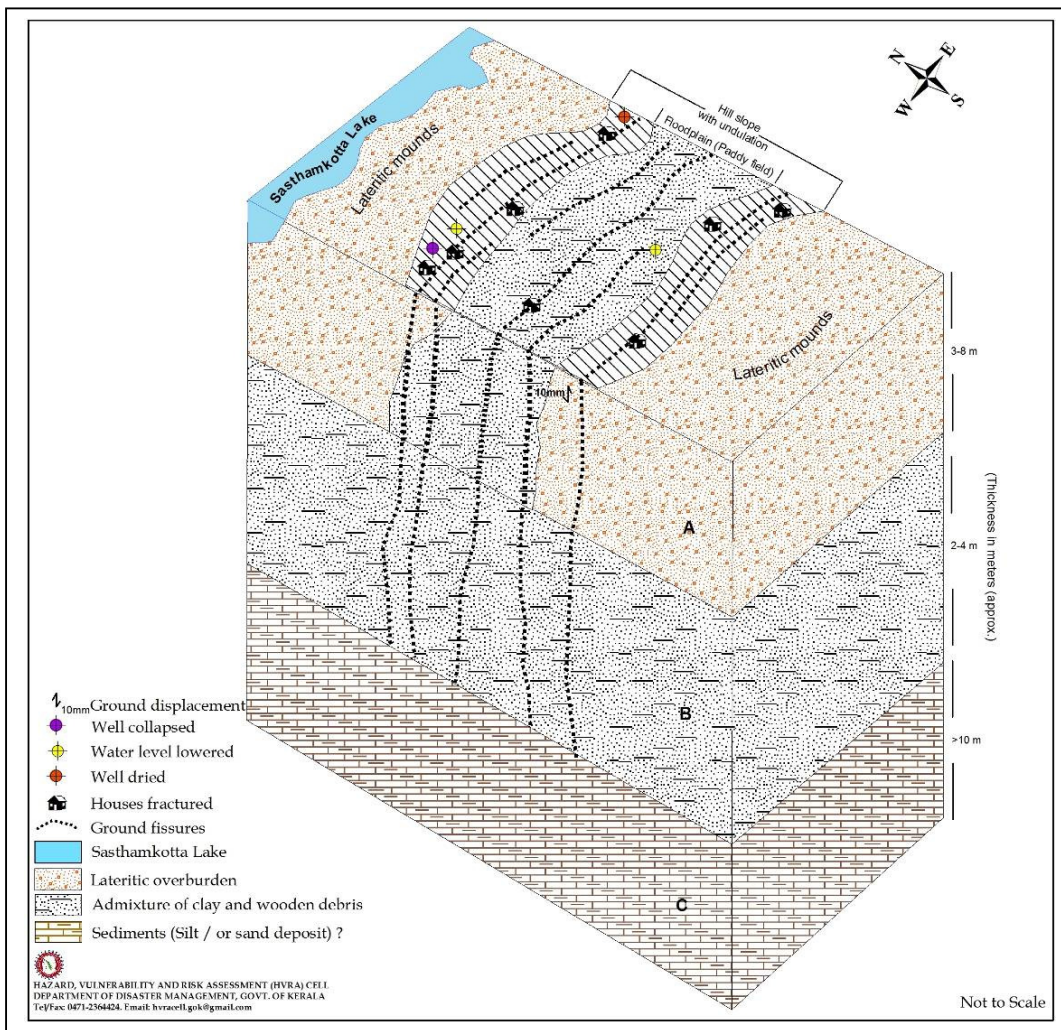
Figure 19: Cross sectional profile of sub-surface lithology and surface morphology of terrain with earth fissures

Geologic profile of the area inferred from the wells point towards the presence of carbonaceous clay layer (admixture of clay and wooden debris) between the overburden and aquifer. The area in general is composed of loose sediments and sedimentary rocks over which unconsolidated lateritic soil is seen as capping. Thickness of this lateritic overburden is varying from 3 to 8 meters and acting as good transmitter of rain water to subsurface and underground aquifer system. Dug wells in the area are constructed on the porous unconsolidated material and are fed by rainfall. Just below the lateritic capping, carbonaceous clay with unaltered wooden debris having a thickness of 4 m (sometimes greater) is seen. This is not seen all along the area but seen adjacent in the floodplain area of river Kallada. Below the carbonaceous clay deposit, vast deposit of sand was observed with varying thickness. Groundwater is present in the vadose zone and act as the source of drinking water. The vadose zone is constantly fed by the Sasthamkotta lake, from which

water is extracted to meet the increased domestic and agricultural demand of Kollam City and parts of Sasthamkotta, Sooranadu (South), West Kallada and Manrothuruthu panchayats in Kollam district. The well inventory carried out in the area pointed towards prolonged dry spell during the year (_____), which was contributed by deficiency of rainfall followed by severe drought and over exploitation of groundwater. A recent investigation by the Centre for Earth Science Studies (CESS) had revealed that the lake was losing its water level at an alarming rate of 1 cm per day due to deficiency in normal rainfall. Due to this Kerala Water Authority had to stop operating a few pumping stations, which was heavily depended by Kollam corporation and adjoining panchayaths. Continuous groundwater extraction during a long period of time, when discharge greatly exceeded recharge may have caused the vadose zone to completely dry out resulting in the non-reversible consolidation of the materials in the respective zone. During this period, the deep aquifer may have experienced considerable loss of artesian pressure and increase in effective stress, and subsequent strain and deformation resulting in ground fracture development and land subsidence. Lowering of water table caused by severe drought and over exploitation of groundwater along with the over burden weight may have forced the loose, unconsolidated subsurface layer to compact slightly, which resulted in ground fracture development and subsequent land subsidence.
