# A Brief Report on the Site Inspection at Thaliparamba Taluk, Kannur District, Kerala

**Location:** Thaliparamba Taluk

**Dates of Inspection:** 22-09-2018 and 23-09-2018

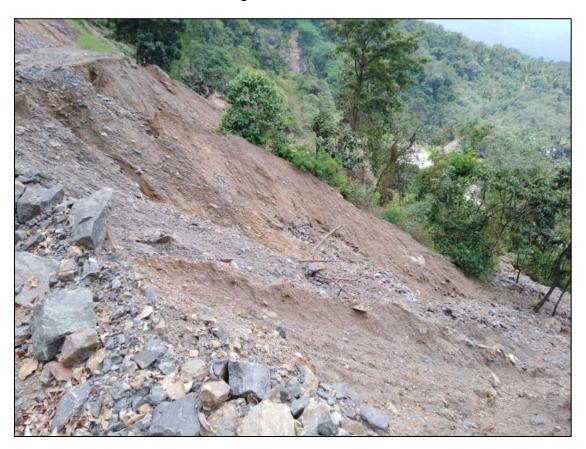
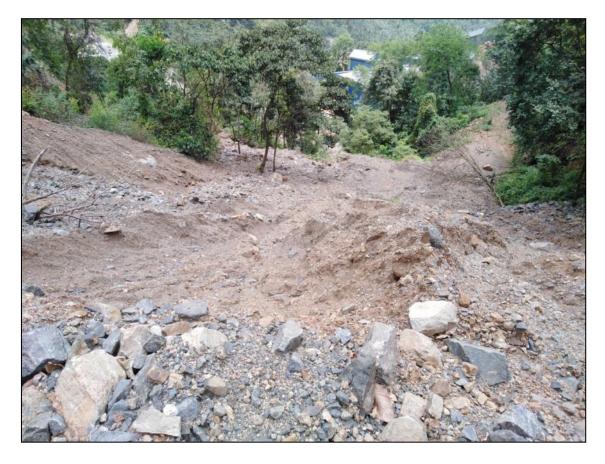
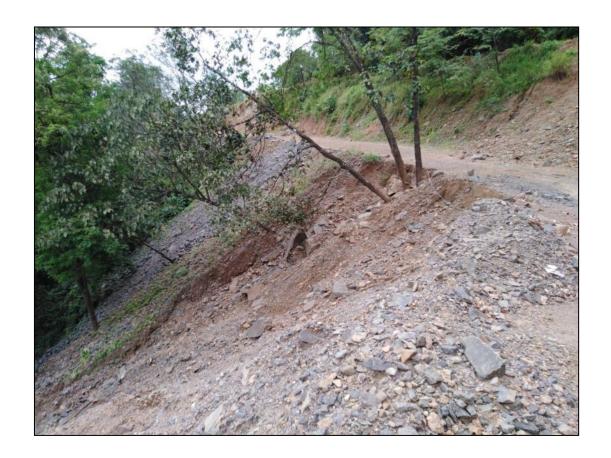
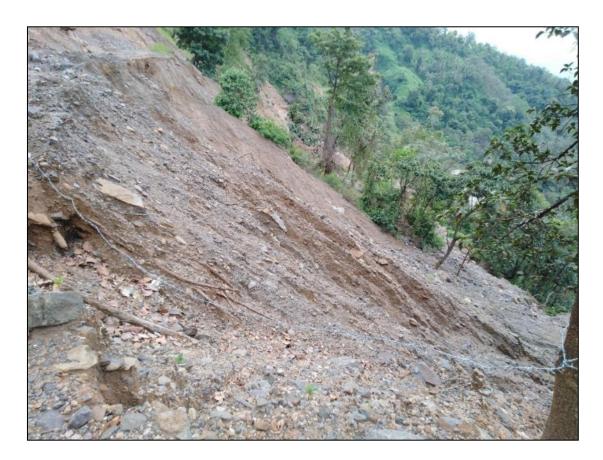
## **QUARRY SITE 1**

On September 22, 2018 Morning, after the meeting with the Deputy Collector (DM) we met Mr. Jennyfer Varghese, Udayagiri Village Officer and discussed the matter. The village officer told us that he has noticed a minor soil slip in the Malabar Sand & Stones Pvt. Ltd. quarry premises. We visited the Malabar Sand & Stones quarry site along with the Udayagiri Village Officer. One debris flow\* and one minor landslip with flow marks have been noticed. In our opinion this landslip can be categorized into a minor debris flow. The details are included in the table.
