SITREP - 19, 2000 hrs on 10/06/2025

Sinking of MSC ELSA 3 (IMO no – 9123221, Flag Liberia) South West of Kochi

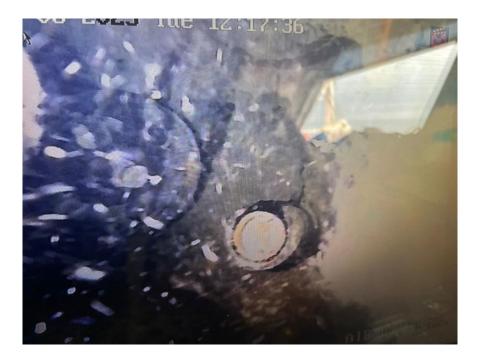
Air Diving operations from SEAMAC III have entered a stabilised phase. The initial dives focused on clearing underwater obstructions, during which floating mooring lines were located and removed. A leak from the sounding pipe of Fuel Oil Tank 22 was successfully sealed using layered capping comprising plastic and polyester cloth. Separately, a loose cap on another sounding pipe was tightened by divers, and further secured with plastic and polyester bagging, effectively stopping a minor leak. A new case of seepage has been detected from either Main Engine Lube Oil Tank 25 or 26; preparations are underway to carry out sealing procedures.

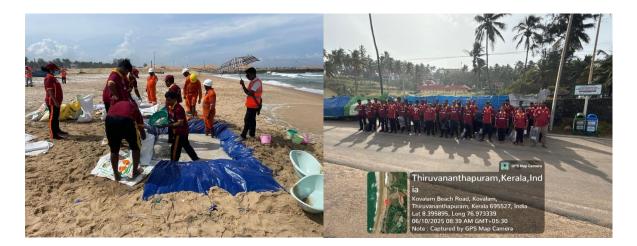
Meanwhile, MERC and volunteers continue beach cleanup across Trivandrum and Kanyakumari. As of 1500 hrs, volunteer activity at Veli, Perumathura, and Kovalam beaches was completed for the day. MERC team and volunteers came up with the idea of makeshift water bath which is working well.
