Directorate General of Shipping

SITREP – 10, 1800 Hrs on 17/06/2025

Explosion on WAN HAI 503 (IMO no – 9294862, Flag Singapore) West of Kerala

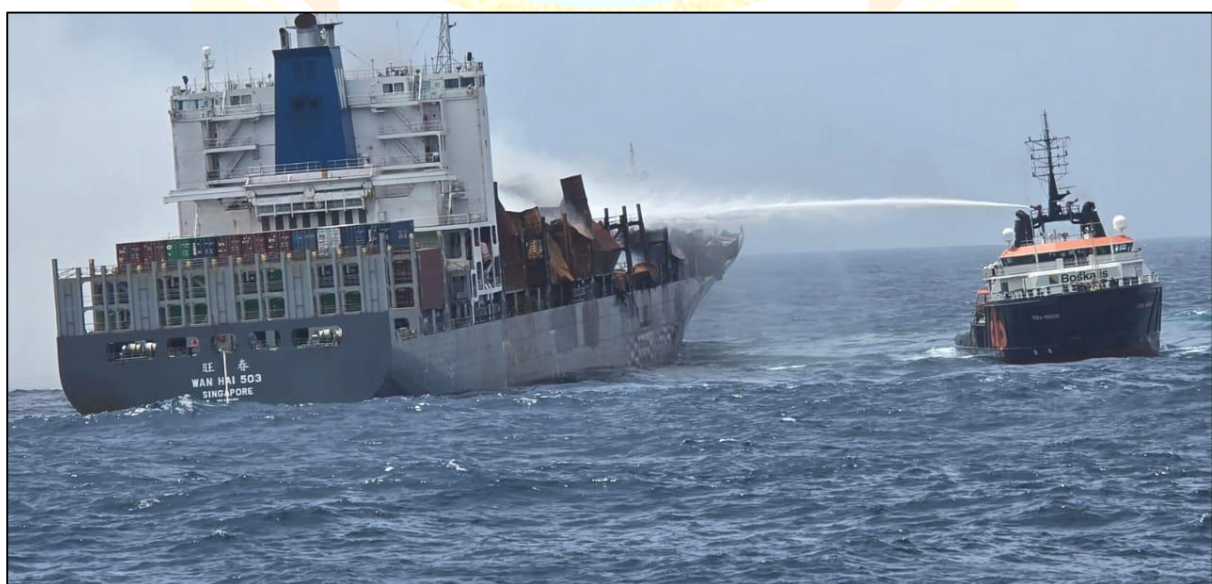
Figure 2: Tug 'Boka Winger' conducting fire operation

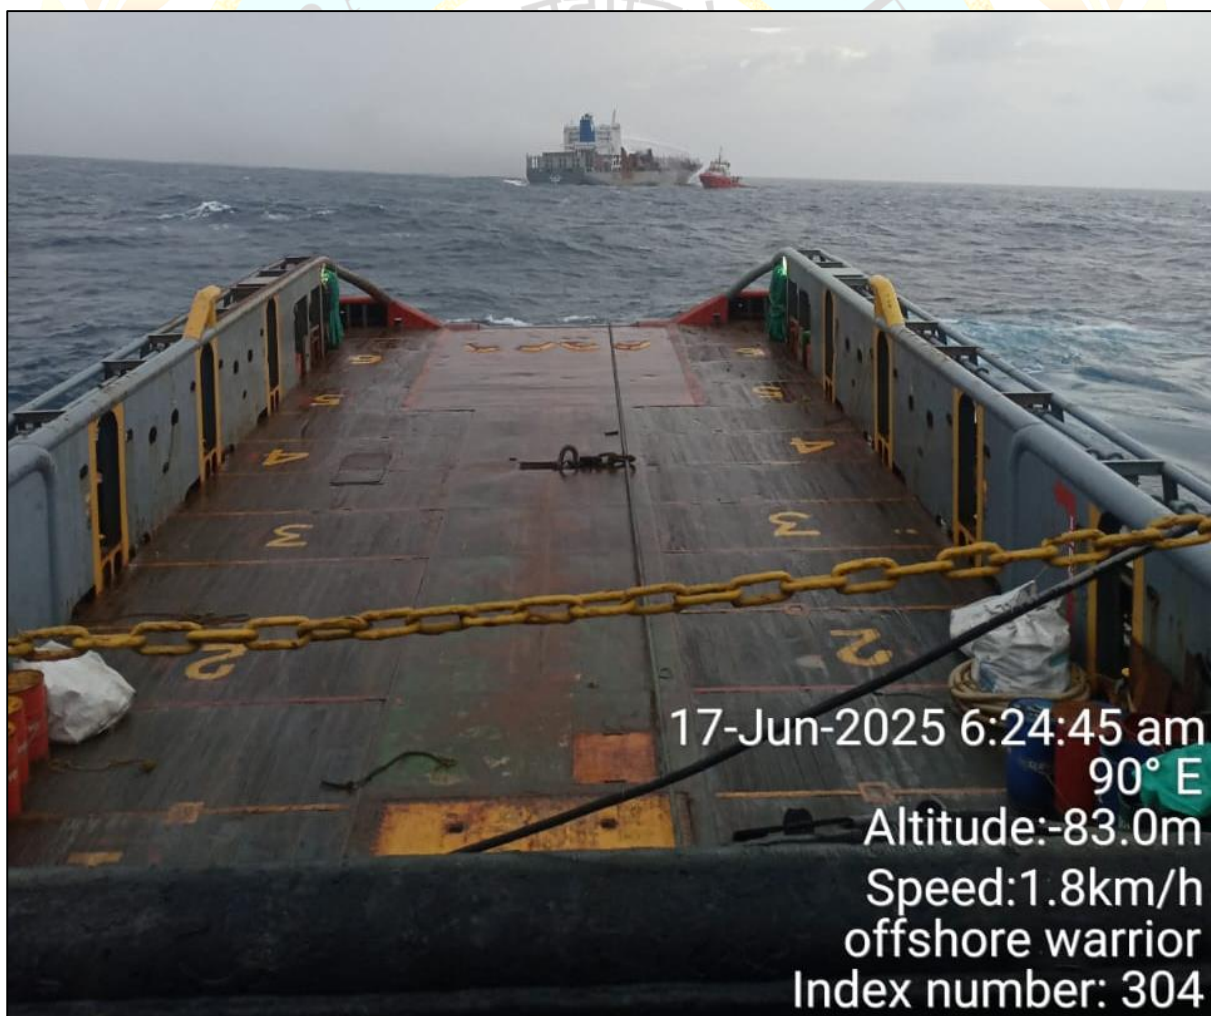
Figure 3: Towline connected to Offshore Warrior
