## **Directorate General of Shipping**

**SITREP – 19, 1800 Hrs on 26/06/2025**

### **Explosion on WAN HAI 503 (IMO no – 9294862, Flag Singapore) West of Kerala**

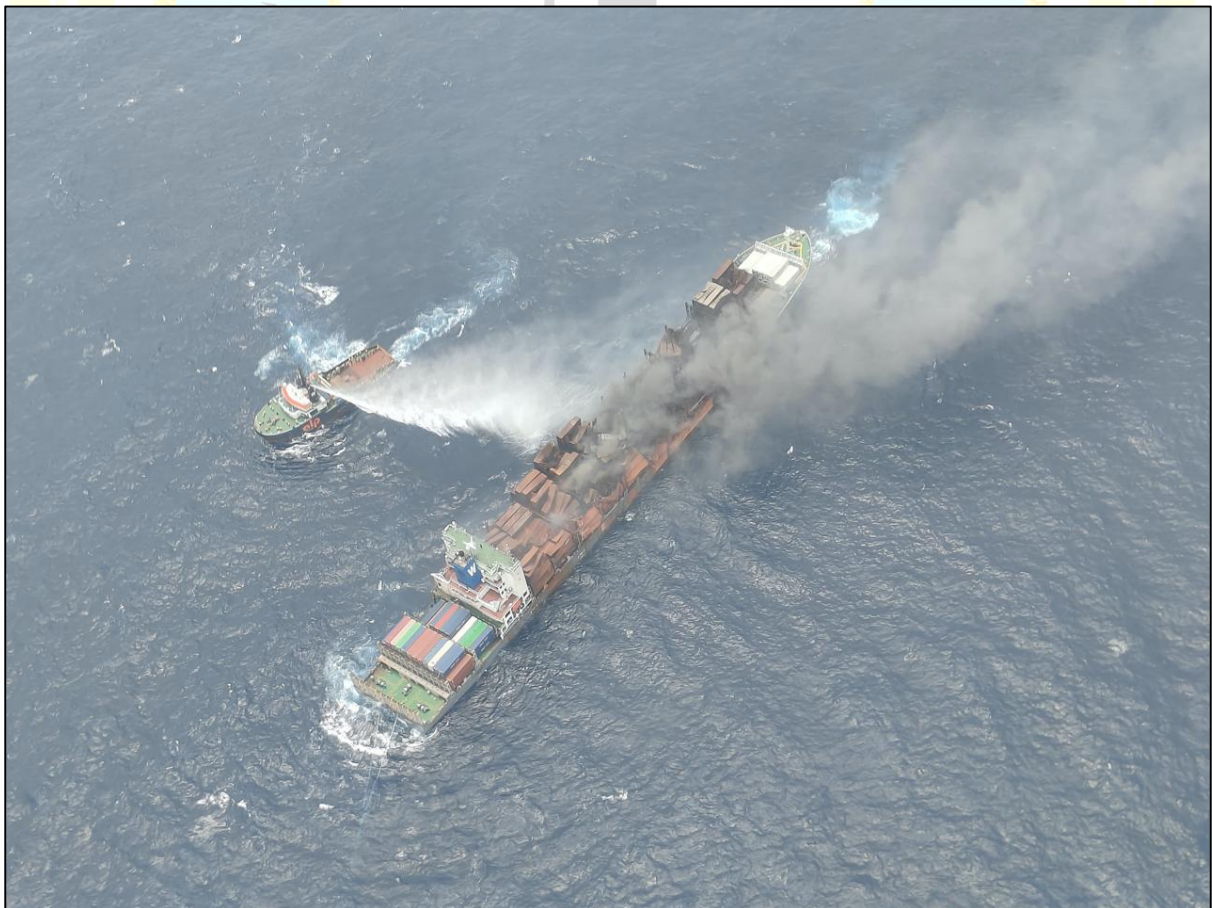
The fire situation in cargo hold no. 4 remains critical. Structural failures, including a partial hatch collapse and container stack collapse in the forward section, have increased ventilation, allowing strong winds to exacerbate the smouldering fire, particularly in containers storing plastic resin. Thermal imaging indicates hotspots at frames 83, 93, and 103 with temperatures peaking at 228°C. Dense black smoke continues to emit from hold no. 4, with boundary cooling being conducted continuously by tugs Saksham and Water Lily from both port and starboard sides.

The port midship draft markings remain obscured due to heat-related paint damage, not submersion. Stability remains a concern due to flooding in the engine room and limited dewatering capability at present.

*Figure 3: Vessel condition on 26 Jun. 25*

Weather conditions are expected to improve temporarily, providing a narrow window for critical actions. The Directorate has instructed that, weather permitting, salvage teams must prioritise boarding to commence dewatering of the engine room, conduct necessary fire suppression within accessible areas, and assess hull and pipeline integrity before CO<sub>2</sub> deployment.

The Directorate also emphasises that salvors must test the engine room water for contamination prior to diving operations to safeguard personnel. Should conditions permit, divers may seal internal pipe leaks to isolate the engine room and enable effective dewatering. Immediate focus remains on stabilising the vessel, maintaining fire control, and securing a safe tow beyond Indian jurisdiction.
