# **Directorate General of Shipping**

## SITREP - 22, 1800 Hrs on 30/06/2025

# Explosion on WAN HAI 503 (IMO no – 9294862, Flag Singapore) West of Kerala

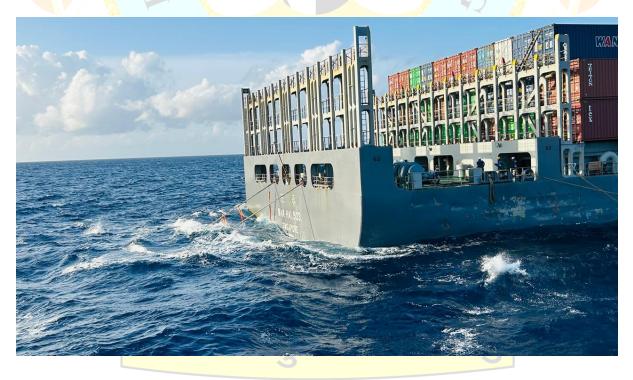
#### Figure 2: Condition of the vessel

The vessel's drift remains controlled through coordinated towing operations. Light smoke continues to emanate from the area forward of the accommodation block, indicating residual smouldering within cargo hold no. 4, though no visible flames have been reported.

The fire situation remains contained, with only light smoke observed, the presence of plastic cargo within cargo hold no. 4 continue to pose smouldering risks. The sustained operation of five pumps has shown positive results in managing engine room flooding, but full dewatering remains essential to assess damage to machinery spaces and restore emergency power systems.

Preparations are in place to maintain uninterrupted dewatering overnight. Salvors aim to stabilise internal flooding to facilitate safe boarding and enable further fire suppression measures, including enhanced boundary cooling and application of additional firefighting agents as weather permits.
