Directorate General of Shipping

SITREP – 25, 1800 Hrs on 03/07/2025

Explosion on WAN HAI 503 (IMO no – 9294862, Flag Singapore) West of Kerala

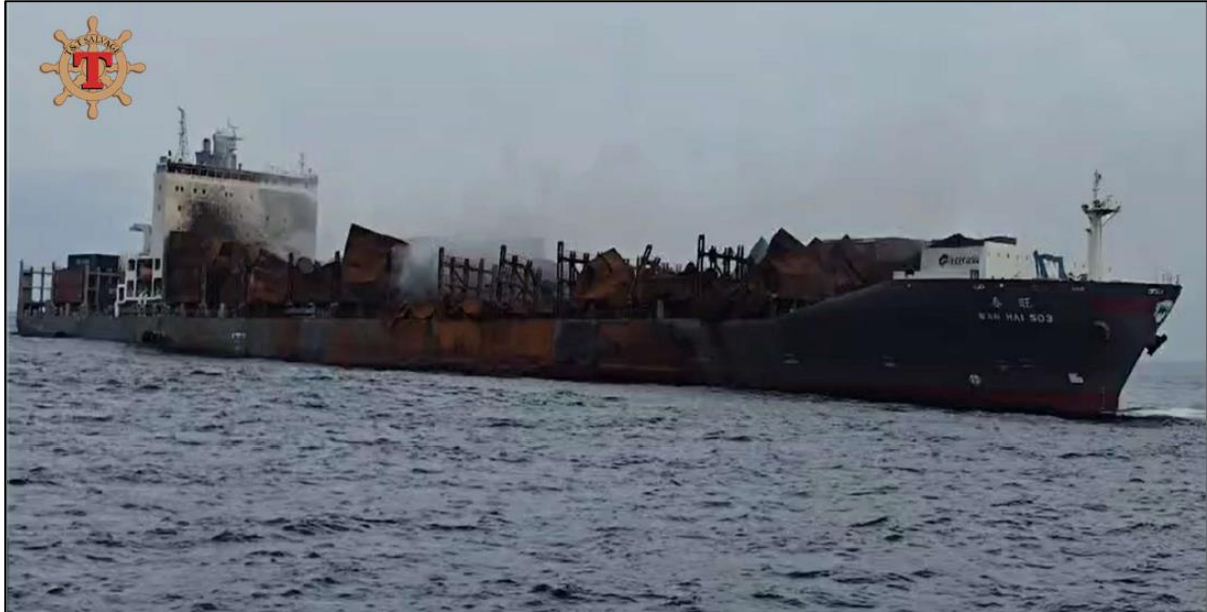
Figure 2: Condition of the vessel

The vessel is emitting light grey smoke from the cargo hold area between Bay 35 and Bay 45 as of 03rd July 0001 hrs. Dewatering operations have been progressing steadily, with around 4.5 meters of water successfully pumped out from the engine room space. The salvage team has maintained continuous monitoring of hull and hold temperatures in accessible areas to assess the fire and structural situation onboard.

Engine room dewatering has lowered water levels to approximately 3.5–3.7 meters, enabling soundings and inspections. Salvage teams onboard are conducting continuous dewatering operations, with the primary focus on tracing the source of ingress, likely from cargo hold no. 3.

Hull temperature surveys on both port and starboard sides show elevated readings, particularly on the starboard side, which remains the main fire-affected zone. Hold no. 1 recorded temperatures of 82°C, with holds 4 and 5 still retaining heat, though no active flames are visible. Residual combustion remains localised and contained, with temperatures gradually trending downward.

Towline replacement with a steel/dyneema line is underway, subject to sea conditions. Hull temperatures and structural conditions are being closely monitored. Salvage teams continue structural assessments. A formal risk assessment remains a prerequisite for any enclosed space entry, prioritising personnel safety over operational expediency.
