Directorate General of Shipping

SITREP – 8, 2200 Hrs on 15/06/2025

Explosion on WAN HAI 503 (IMO no – 9294862, Flag Singapore) West of Kerala

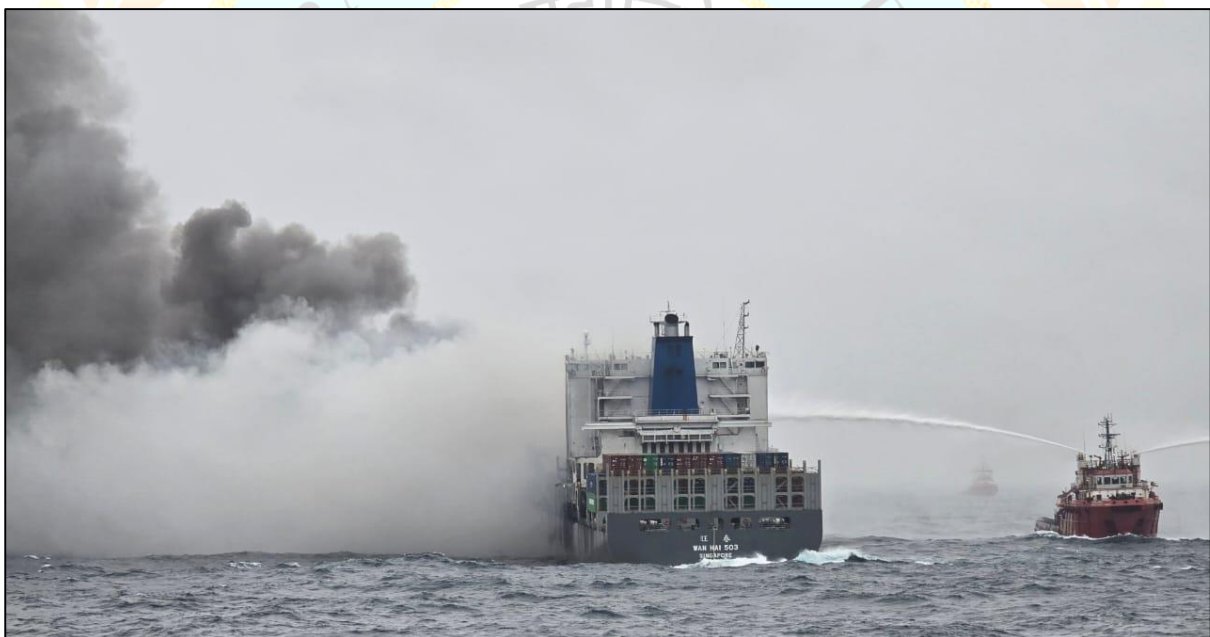
Firefighting efforts have been considerably successful in suppressing major fires. No active fire is now visible at Frames 49–51, where only light grey and white smoke continue to rise. However, isolated fire pockets persist, particularly near the forecastle on the port side, while dense smoke continues to emit from Frames 93 to 103. The primary zone of ongoing combustion remains concentrated in the forward section near Frame 113, which continues to require close firefighting attention to prevent flare-ups and ensure containment of chemical fumes. These residual fires, though significantly reduced, continue to release hazardous fumes that require close monitoring for the safety of personnel and for any potential environmental impact.

Figure 2: Smoke emitting from the vessel
