Directorate General of Shipping

SITREP – 9, 1800 Hrs on 16/06/2025

Explosion on WAN HAI 503 (IMO no – 9294862, Flag Singapore) West of Kerala

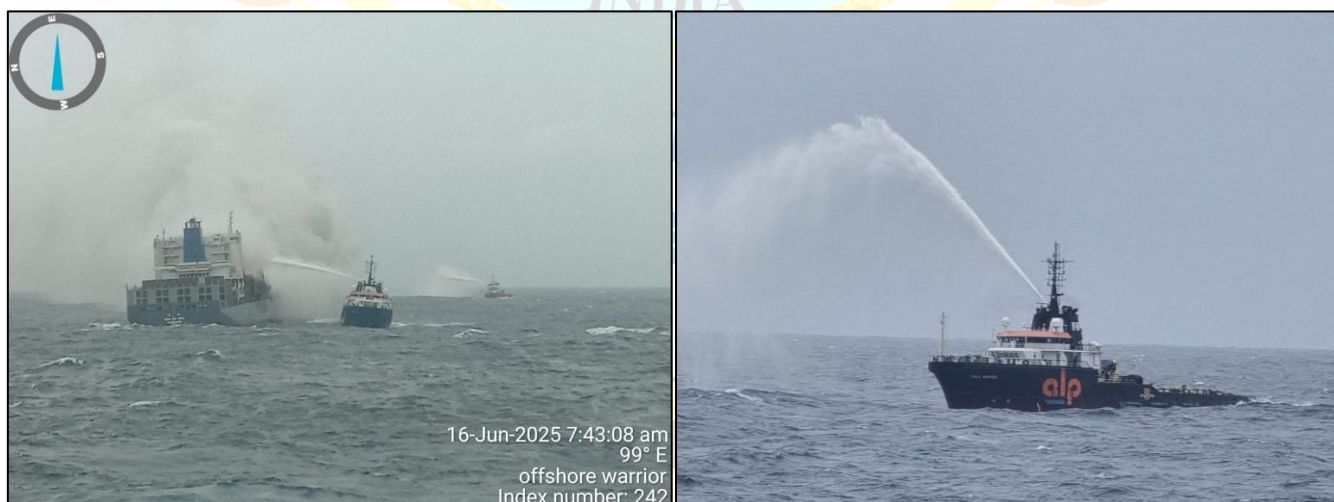
The Directorate has maintained continuous multi-agency deployment to sustain both firefighting and towing operations. Seven tugs — *Offshore Warrior*, *Triton Liberty*, *Boka Winger*, *Saroja Blessing*, *Saksham*, *Garnet*, and *ETV Water Lily* — are deployed on site, executing boundary cooling in rotation, targeting high-risk cargo bays and maintaining the vessel's structural temperature balance.

Figure 2: Tugs conducting fire fighting operation

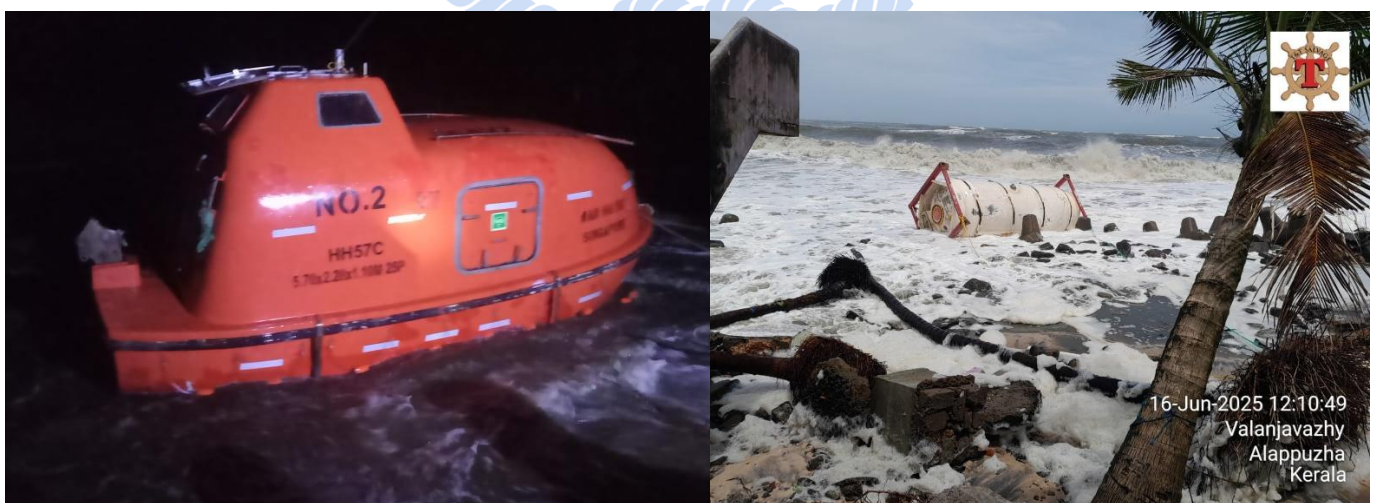
Additionally, salvage teams have successfully removed a washed-up container and a lifeboat from coastal areas; these remain under customs control pending transfer to bonded facilities. ITOPF continues to provide shoreline monitoring, environmental modelling, and contingency planning support in coordination with

Figure 3: Lifeboat and container landed onshore on late hours on 15 Jun
