Directorate General of Shipping

SITREP - 13, 1800 Hrs on 20/06/2025

Explosion on WAN HAI 503 (IMO no – 9294862, Flag Singapore) West of Kerala

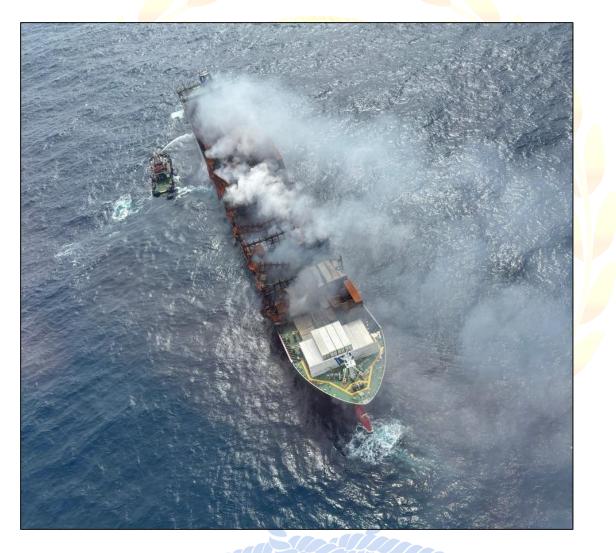
Weather conditions remain moderate, with westerly winds between 12–16 knots, allowing salvage teams to sustain operations onboard. Smoke emissions persist in multiple sections of the vessel, with light white smoke rising from Bay 14, light grey smoke observed near Bay 35, and white smoke also seen from Bay 50. These emissions are being contained through ongoing boundary cooling.

Figure 2: Aerial assessment indicates only white smoke, no flames sighted

Firefighting, boundary cooling, and fire watch continue in rotation by Saksham and Water Lily as per the six-hour operational plan.

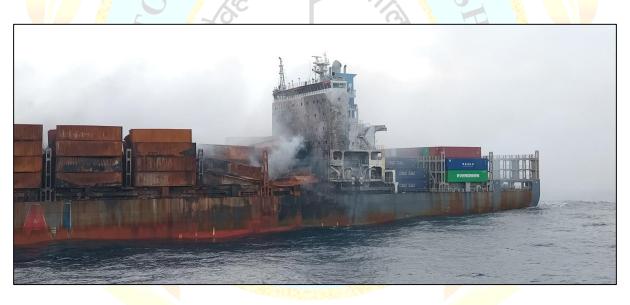
Figure 3: Condition of the vessel on 20 Jun. 25

The firefighting effort continues to show progressive containment, with no visible open flames and gradual dissipation of dense smoke in most affected areas. Nonetheless, persistent smouldering and inaccessible zones require continued boundary cooling and targeted suppression. Structural stability assessments confirm that the vessel remains afloat with no major compromise to overall integrity, although isolated compartments, particularly Bay 3, remain under monitoring for signs of water ingress. Cell guide collapse and deck damage have been noted, but the forecastle remains largely intact.
