## **Directorate General of Shipping**

**SITREP – 14, 1800 Hrs on 21/06/2025**

### **Explosion on WAN HAI 503 (IMO no – 9294862, Flag Singapore) West of Kerala**

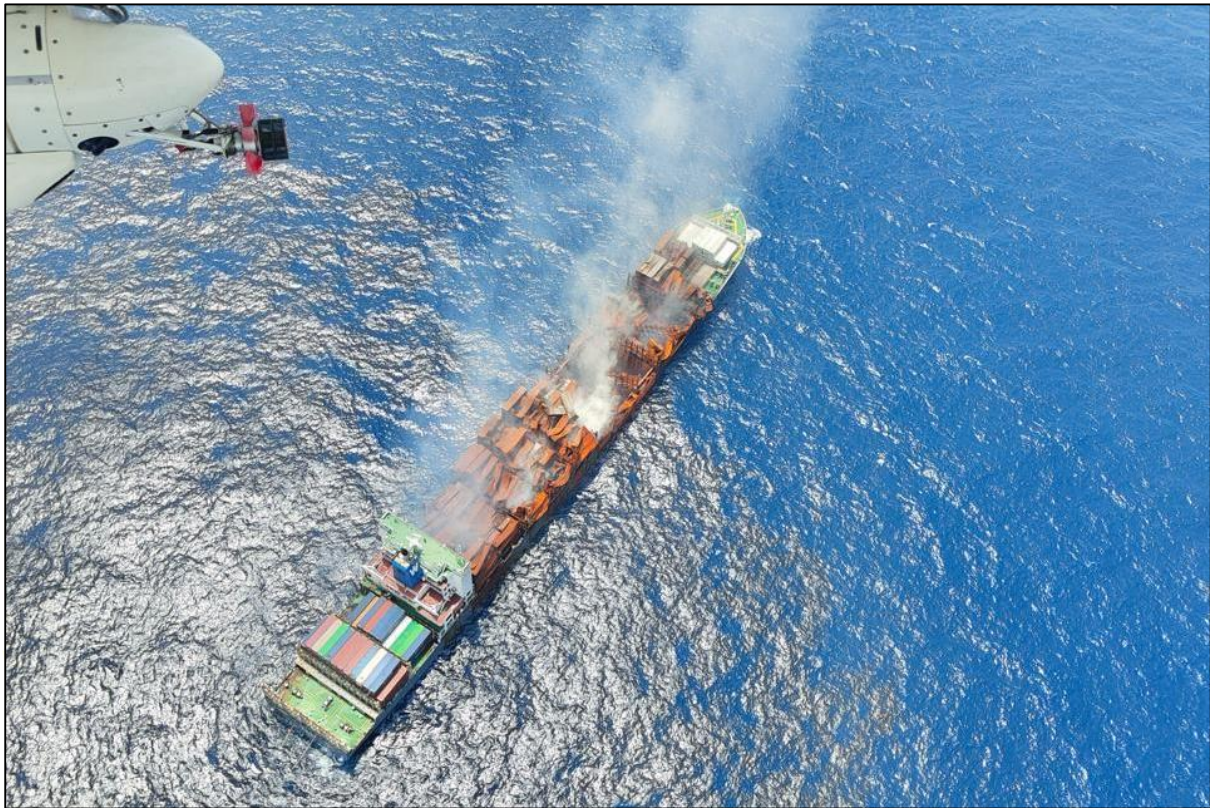
*Figure 2: Aerial assessment indicates only white smoke, no flames sighted*

Fire conditions onboard have improved, though localised smoke emissions persist. Grey smoke continues to rise from cargo hold areas between Bays 4–9, while light grey smoke is noted at Bay 14 and near Bay 37–39. Grey smoke from the hold area is also visible near Bays 33–35. No flames are currently visible on either port or starboard sides. Thermal imaging indicates a general decline in temperatures across the vessel. The hottest zones were recorded around Frame 123 (Bay 33) with a temperature of 55°C, and Bay 35 at 48°C, while areas such as Bay 39–50 now register ambient heat levels (32–36°C), suggesting that the fire has been largely suppressed.

Firefighting, boundary cooling, and fire watch are being carried out in rotation by *Saksham*, *Water Lily*, *Saroja Blessing*, and *Boka Winger*. At 1406 hrs, three personnel, a Salvage Master and two professional firefighters, boarded the casualty to conduct onboard inspections. Notably, ingress of water has been identified in the engine room, with estimated water levels of approximately 10 metres. The emergency generator appears unaffected and could be repurposed to power internal systems. Two Self-

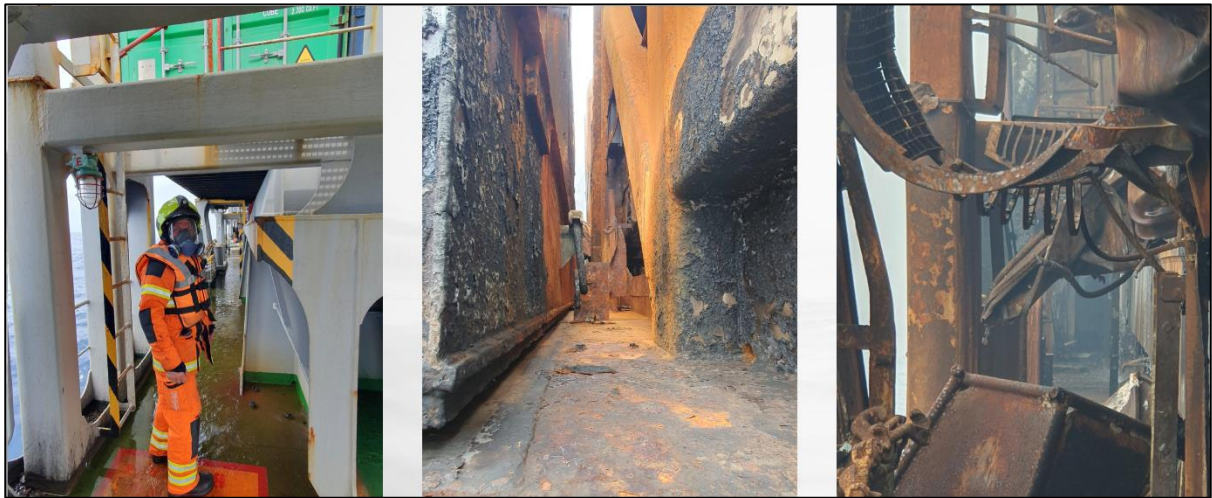
Figure 3: Personnel onboard assessing the vessel condition

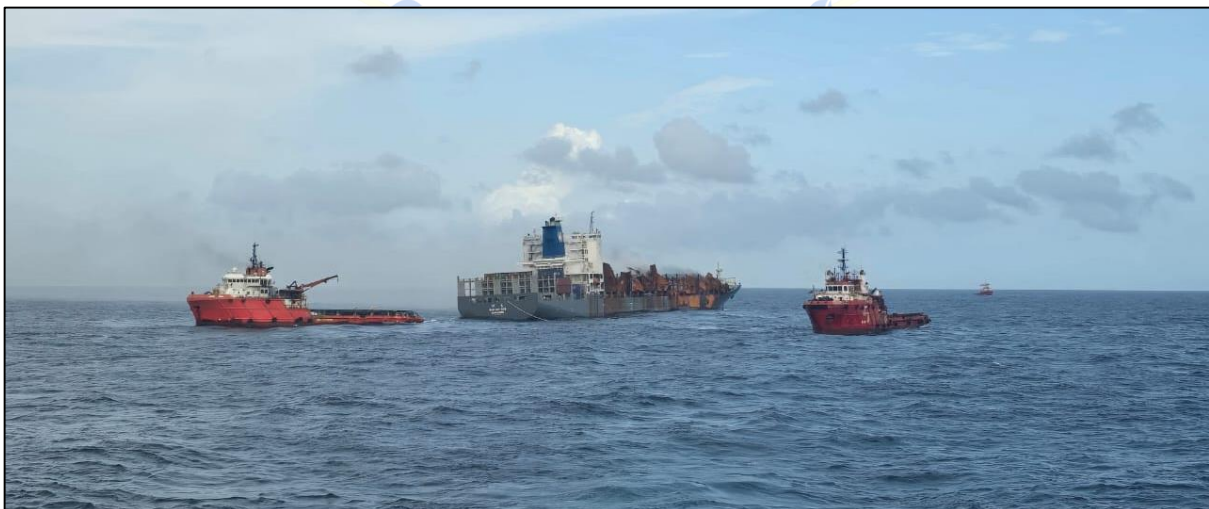
Figure 4: Vessel being towed by Offshore Warrior while Boka Winger remains available for additional firefighting support

The second tow rope—measuring 96 mm—was successfully connected to the casualty on 20 June, and the previously chafed rope from Boka Winger has been replaced. Current towing is being managed by Offshore Warrior, while Boka Winger remains available for additional FiFi (firefighting) support. Salvage personnel onboard continue to expand access inside the vessel, supported by equipment and supplies transferred via support tugs. Temperature gauging operations are being conducted

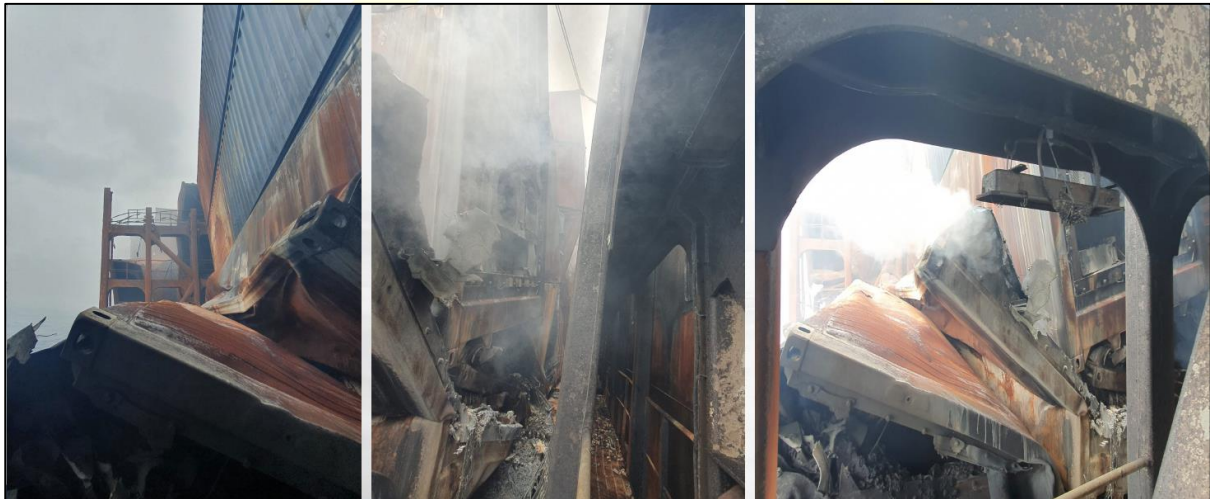
The emergency generator's operability provides a critical opportunity to restore partial onboard power, supporting safer navigation through debris and improved internal communication. Structural assessments by T&T indicate buckling of steel components

in the midsection, likely caused by temperatures reaching 800–900°C during peak fire exposure. Collaboration with DNV's Emergency Response Service (ERS) is ongoing to assess structural strength and vessel stability for long-haul towing to a Port of Refuge.

*Figure 5: Onboard assessment of the vessel*
