Directorate General of Shipping

SITREP – 30, 1800 Hrs on 11/07/2025

Explosion on WAN HAI 503 (IMO no – 9294862, Flag Singapore) West of Kerala

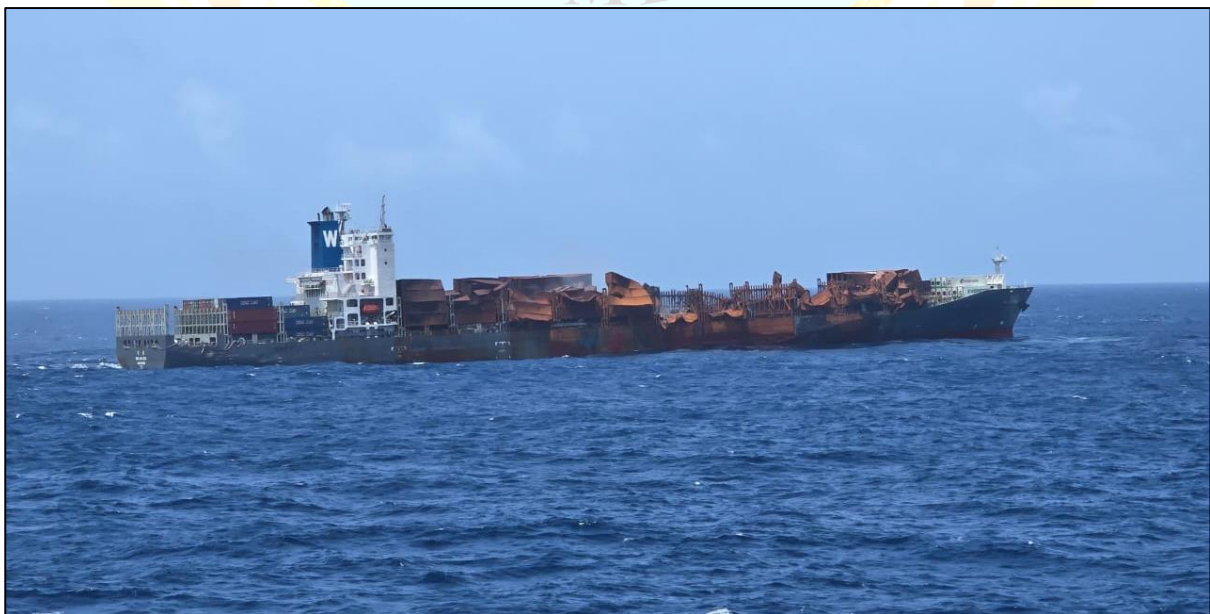
There is light white smoke emanating from cargo hold Bay Nos. 33 to 37. This smoke is consistent with residual smouldering and heat retention in cargo hold No. 4, which has shown persistent elevated temperatures. However, there are no reports of visible flame or escalation of fire at this stage. The on-board salvage team has confirmed that five pumps are operational and that continuous dewatering efforts are ongoing. The engine room water level is now below the floor plate, and preparations are underway to inspect the suspected ingress path through the pipe duct as water levels allow.

Figure 2: Condition of the vessel on 11th July 2025
