# **Directorate General of Shipping**

#### SITREP - 31, 1800 Hrs on 14/07/2025

### Explosion on WAN HAI 503 (IMO no - 9294862, Flag Singapore) West of Kerala

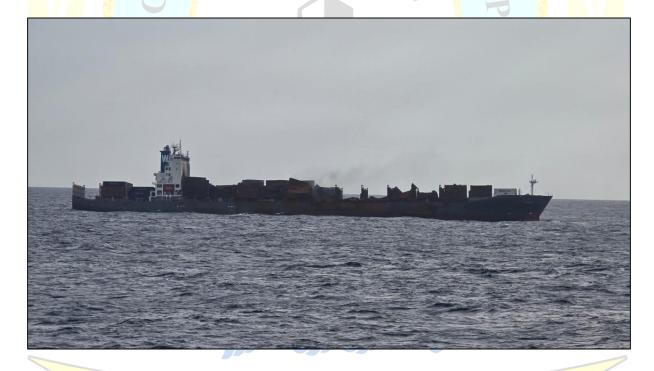
Light grey smoke continued to be observed from cargo bay numbers 33 to 37. The condition is reported as stable, with no visible escalation. However, the onboard salvage team also reported a strong ammonia smell emanating from Hold No. 7, which may be attributed to rotting organic cargo. Preliminary indications suggest the possible presence of hydrogen sulphide (H<sub>2</sub>S), presenting hazardous enclosed space conditions. Formal chemical assessment and safe chemical neutralization procedures are being explored.

The condition onboard *Wan Hai 503* is stable but continues to require sustained support. Hold No. 6 is reportedly being dewatered, and preparations are ongoing to control and monitor other affected holds. The ingress of water into cargo holds is also a result of boundary cooling operations in deck hatch gaskets, as observed in other similar incidents. Due to water in the engine room, dewatering must be carried out with portable pumps on a hold-by-hold basis.

Figure 2: Condition of the vessel

The salvage team emphasized that firefighting is currently limited to containment rather than full extinguishment, and complete suppression will likely require the vessel to be alongside in a Port of Refuge. A comprehensive Port of Refuge proposal has been compiled and is under review authorities. Phase II planning, including debunkering, hazardous cargo handling, and final fire suppression, will be initiated
