ROCK SLOPE STABILITY: TECHNICAL STUDY REPORT

.....
Name of Client : District Collector, Disaster Management
Authority, District Collectorate, Kudappanakunnu
.....
.....

Job No. : CET/ITC&SR No. 558/22-23
.....

**REPORT ON ELECTRO-TELLURIC SURVEY AT VELLAR,
PACHALLOOR, TRIVANDRUM**

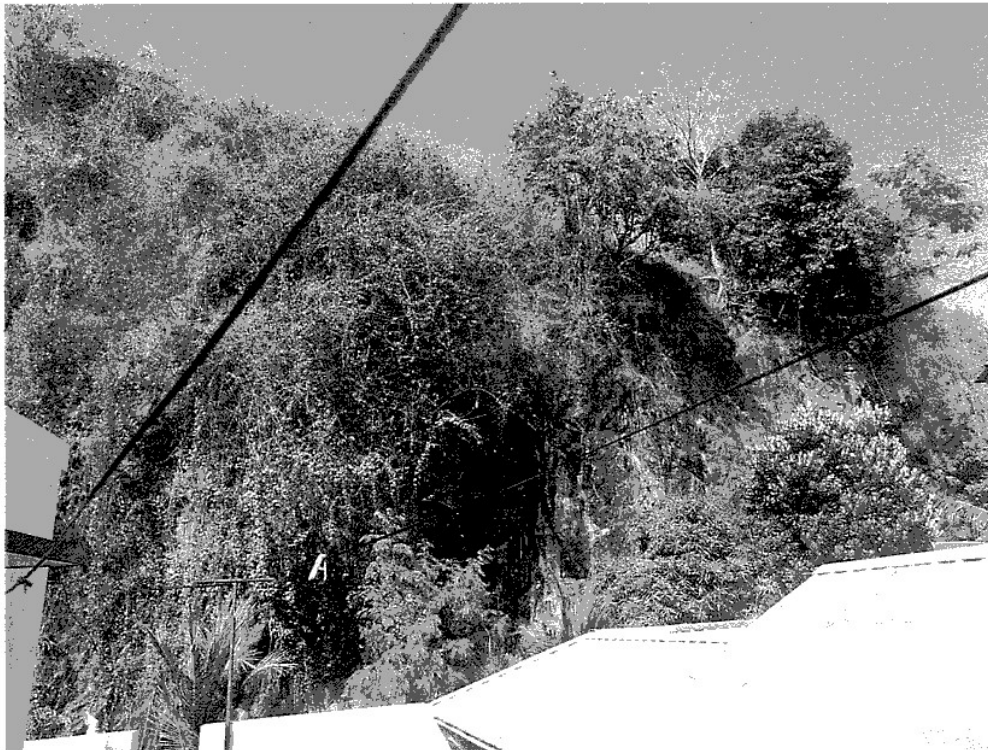
Photo 1. Stretch of rock cutting

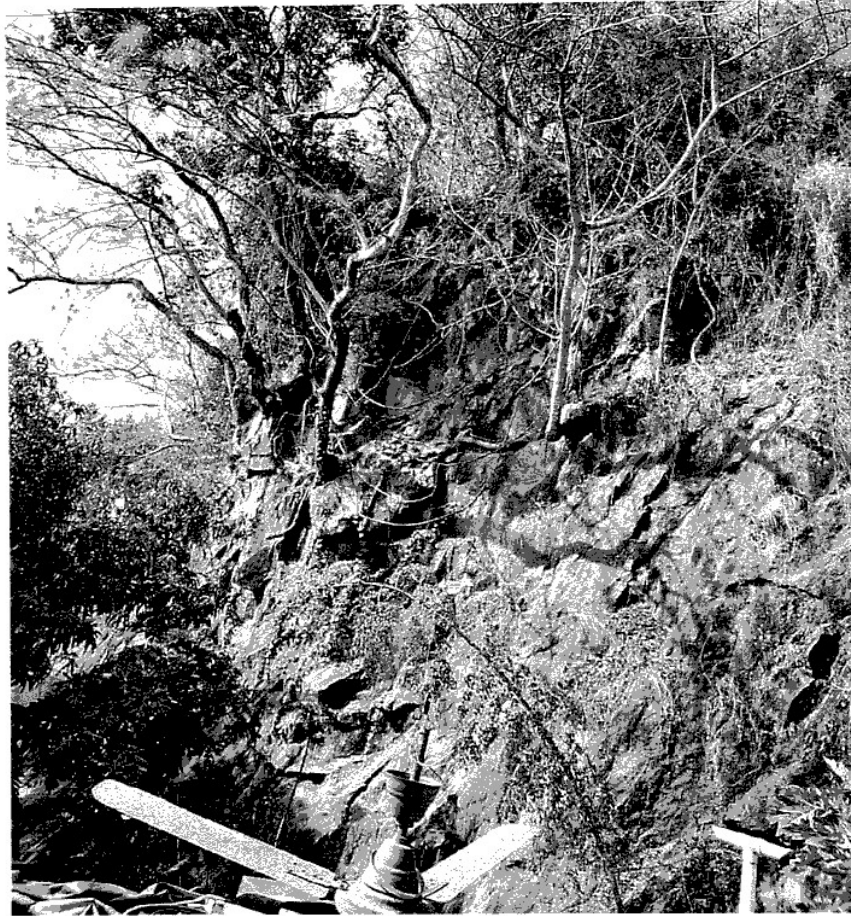
The site is primarily composed of a top layer of lateritic soil, which is covered with vegetation. Beneath this, the subsurface comprises fractured rock, followed by a layer of hard, intact bedrock. Notably, the root systems of mature vegetation have penetrated the fractured rock layers, accelerating the disintegration and weathering of the rock mass, thereby potentially affecting slope stability.

Photo 2 Crumbling Rocks and Falling Trees

- Clear vegetation and debris to access the slope safely.
- **Remove loose and unstable rocks using hand tools or crowbars to a depth of 3 to 5 meters, extending 3 to 4 meters behind the rock slope face.**

- Avoid the use of mechanical or hydraulic excavators, as they may trigger large-scale failures that could lead to disastrous consequences.
- Install steel bolts to anchor stable rock masses

- Apply sprayed concrete to bind the rock face and prevent further weathering or erosion.
- A flat surface shall be created by applying grouts in to the fractured rock.

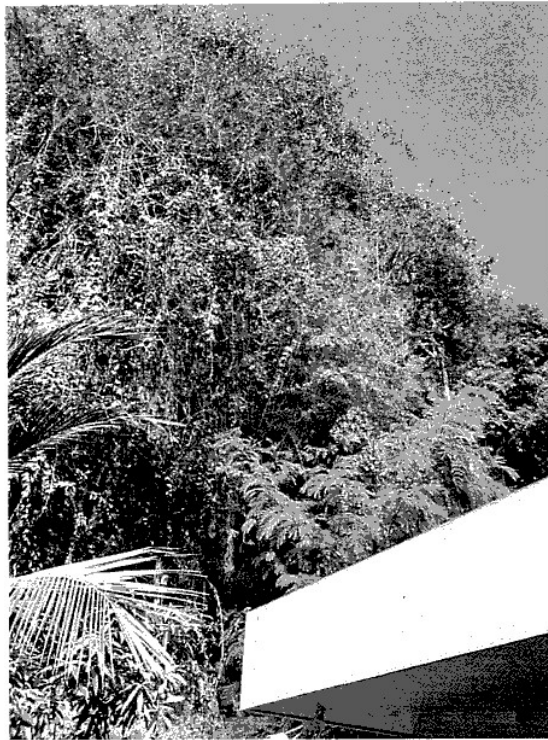
Photo 3a. Proximity of Buildings to the Slope Face

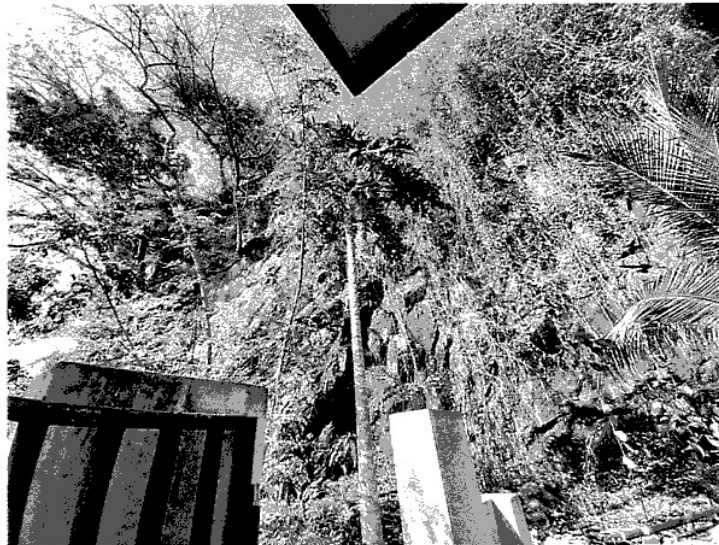
Photo 3b. Proximity of Buildings to the Slope Face

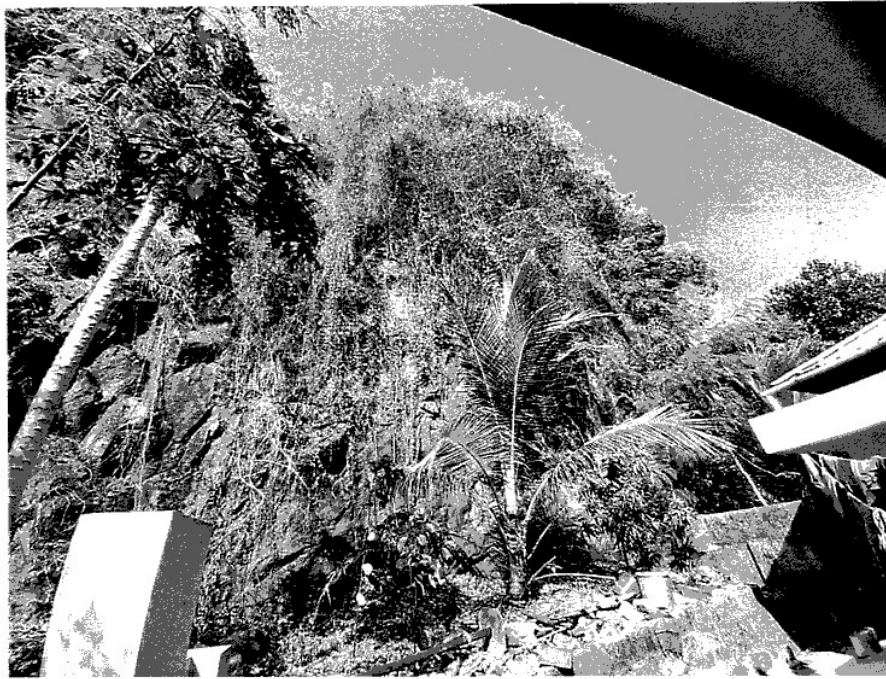
Photo 3c. Buildings Located in Close Proximity to the Slope Edge

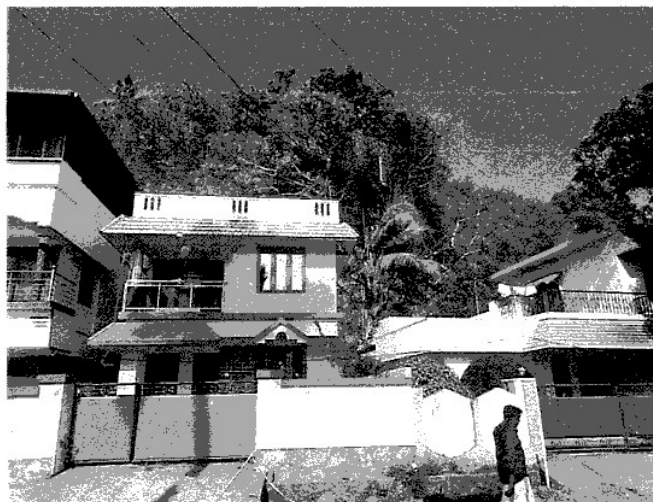
Photo 3d. View Showing the Nearness of Structures to the Slope

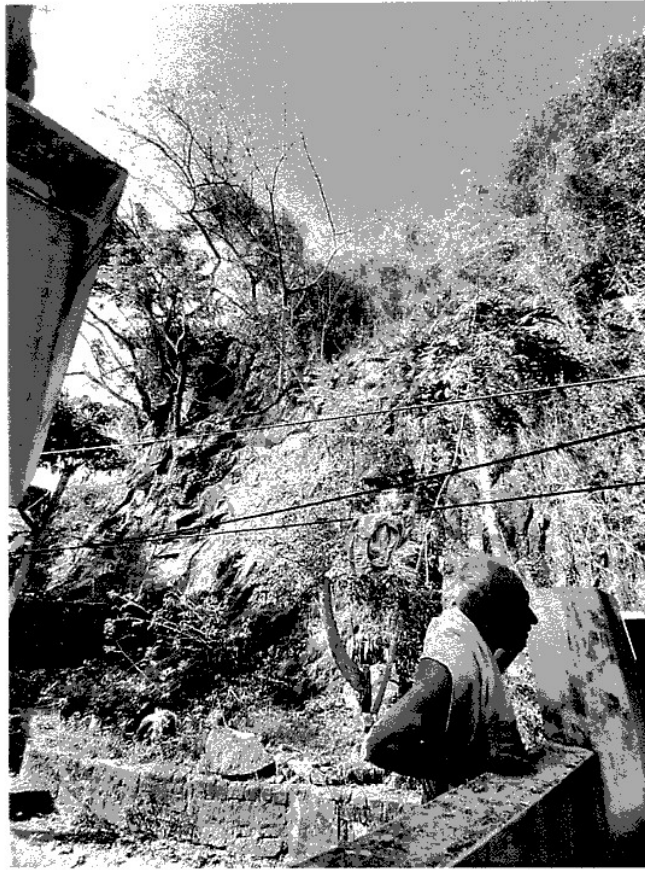
Photo 3e. Illustration of Buildings Situated Adjacent to the Cut Slope

- **A structurally designed RCC retaining wall, 1.50 meters in height, should be constructed 3.00 meters behind the rock slope face to control debris and water flow down the slope.**

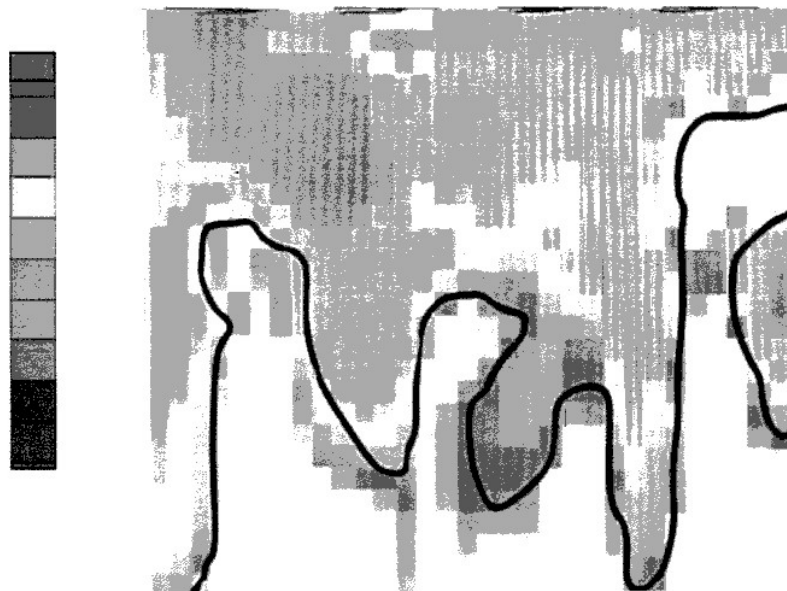
Fig. 1. Profile of the section averaged to the Transect taken

Figure 1 presents the section derived from the tellurograms obtained in this study. These visual representations of telluric currents aid in a comprehensive analysis of subsurface geological structures, including fracture planes and weathered horizons, and their correlation with the geological understanding of the terrain. The key features identified from the study are summarized in Table 1.

Depth range (in metres)	Characteristics (averaged)
0-0.5	More soil, fewer rock blocks
0.5-1	Soil fills the gaps between underlying larger rock pieces
1-2	Disoriented rock pieces of 0.5m - 1m lying with soil and active plant roots filling the spaces.
2-5	Larger blocks of rocks, appearing to be more detached from the in-situ rock due to root growth inside. The presence of humidity and root zones are identified by lower resistivity in tellurograms. Removal of the vegetative cover would destabilize the present configuration of the rock /soil pack.
5 -15	The rock is slightly weathered, and influences of root zone weathering are observed. Surface water that sinks on the surface may drain here. At location (4-6 m south of the northern end of transect) the basement rock protrudes up to 5m and more towards the surface. A physical removal of rocks by heavy machineries at this location below 5m needs special attention.

15 and below	The country rock is highly intact, with less disturbance during quarrying, as tellurograms point to a high-resistant body. To the western end, the rock is more weathered to a depth of 15m and below.

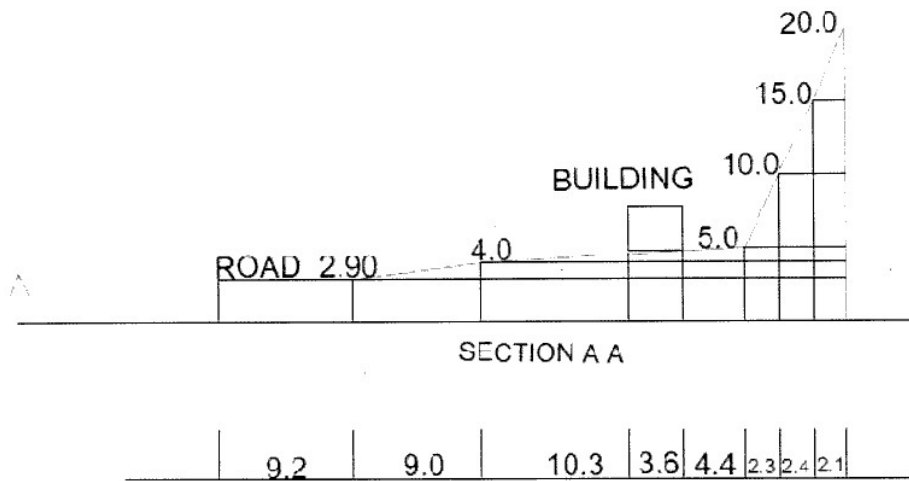
Fig. 2. Topographical Section

Figure 2 shows the topographical section of the region across the road. The buildings are located in close proximity to the fractured face of the rock slope, which has an average height of approximately 20 meters.

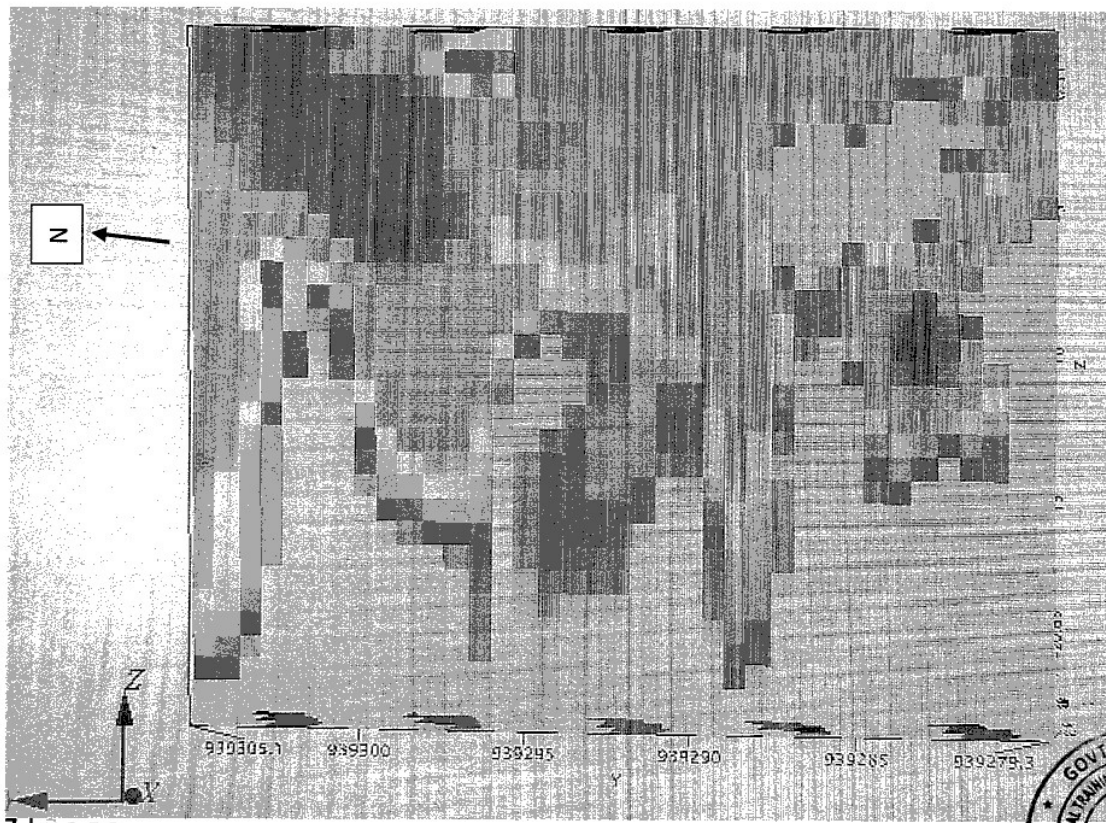
Figure 7-Profile of the section averaged to the Transect taken

Soil deposits in the fracture planes and weathering within them have promoted plant growth. The tellurogram clearly shows that plants have developed roots into the rock through rock contacts, foliations, fractures, and weaker planes. This activates weathering and hence lowers intactness.

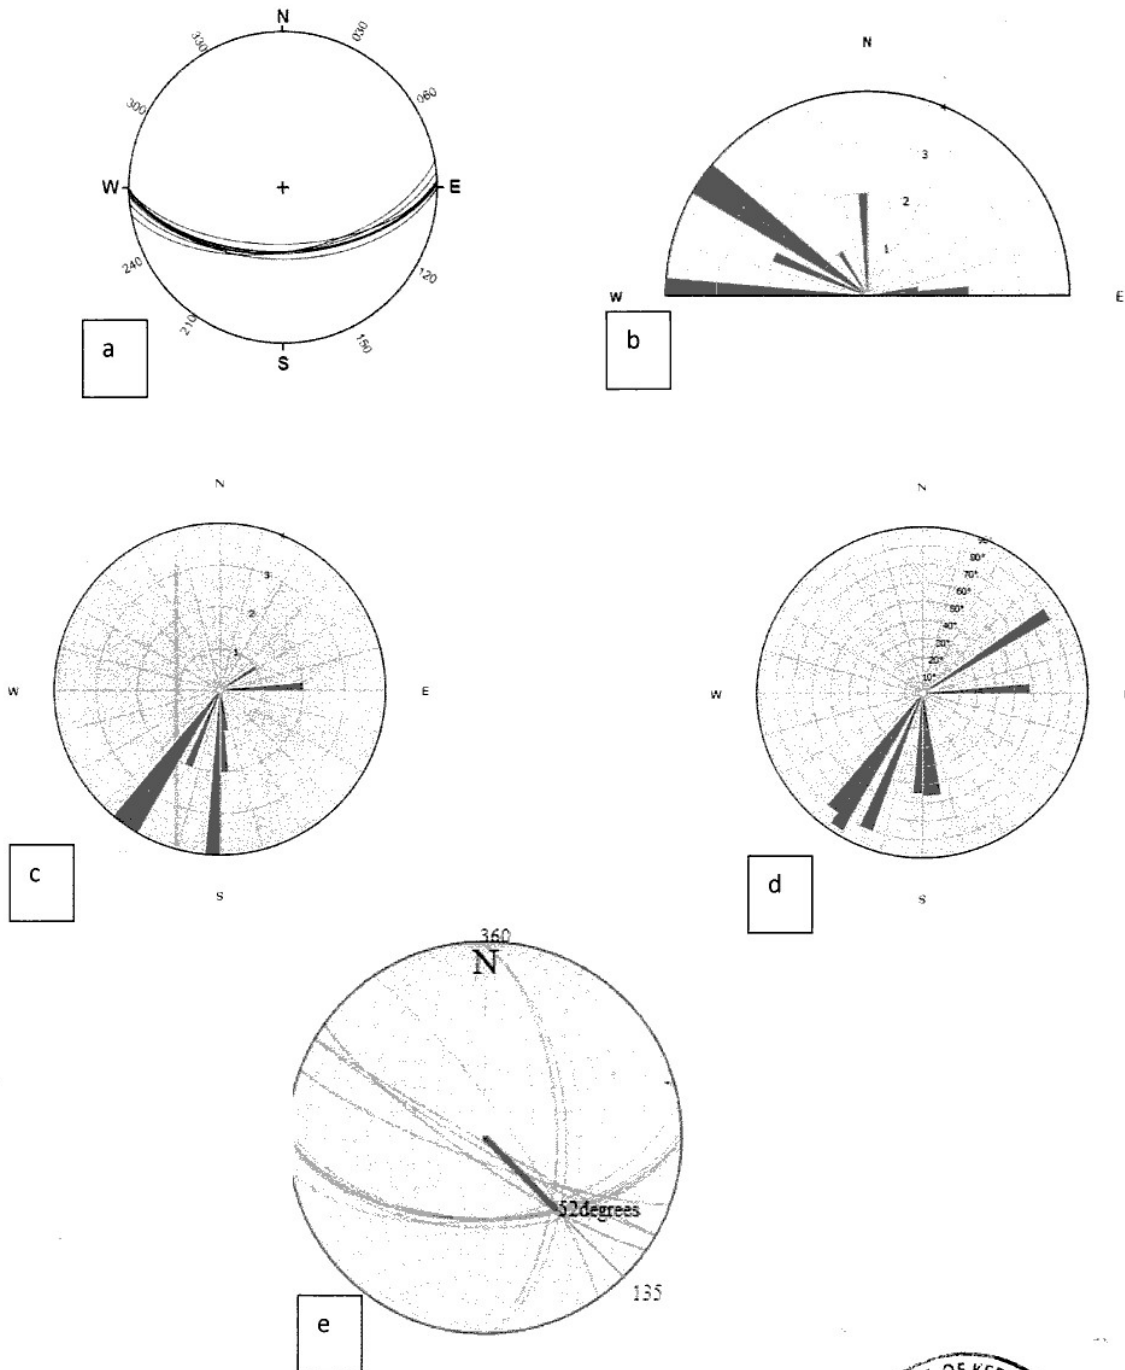
Figure 12-The stereo plot of structural planes of weakness observed in the rock Outcrop

Foliation planes in gneiss (dipping 50° to N178°) with alternating bands of quartz, feldspar, and garnet, can create planes of weakness, influencing how the rock breaks during quarrying and weathers over time in the quarry walls. The orientation of foliation will significantly affect slope stability.

The density of joints and fractures (dipping 80° towards $N300^\circ$) in the bedrock (gneiss and granulite masses) represents discontinuities that can influence the mechanical properties of the rock mass. In an extremely fresh outcrop where a quartzite pegmatite intruded into the gneiss, 5 fractures were counted per 1 square foot. However, these fractures are not as clearly evident in the rest of the weathered rock. However, the persistence of these discontinuities are critical in determining how the rock mass behaves during excavation and the stability of the quarry slopes.

Geological studies categorize rocks with foliations and fractures as harder rocks. Structural analysis indicates a resultant weakness towards N135° at an angle of 52°
