SITREP - 6, 2000 hrs on 28/05/2025

Sinking of MSC ELSA 3 (IMO no – 9123221, Flag Liberia) South West of Kochi

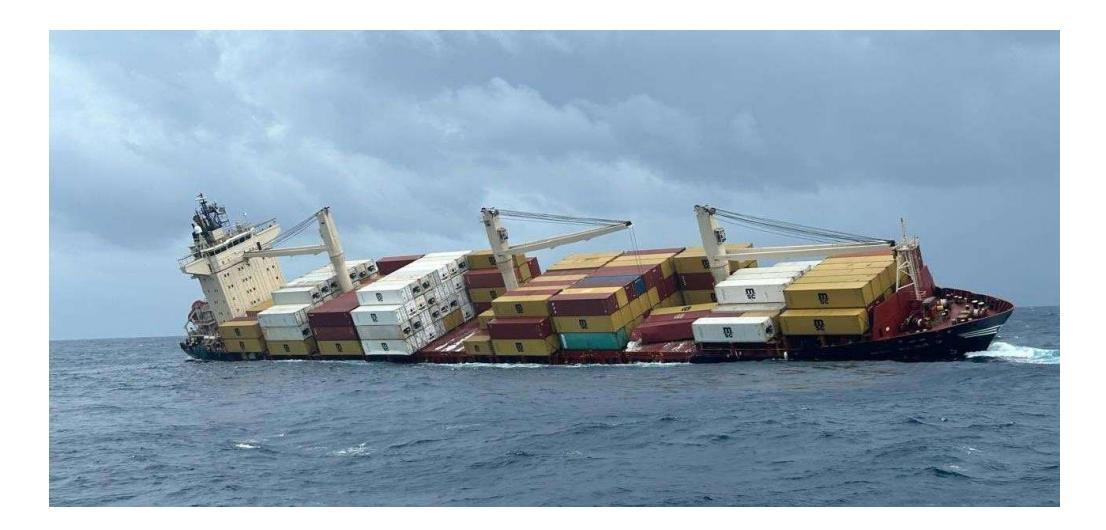
On 24 May 2025 at approximately 1300 hrs IST, the container vessel MSC ELSA 3, operated by MSC Ship management Ltd., developed a severe starboard list while enroute from Vizhinjam to Kochi, about 30 nautical miles southwest of Kochi Port. By 1515 hrs IST, the list had increased to 30 degrees and stabilized, with no further progression observed.

Figure 1: MSC ELSA 3

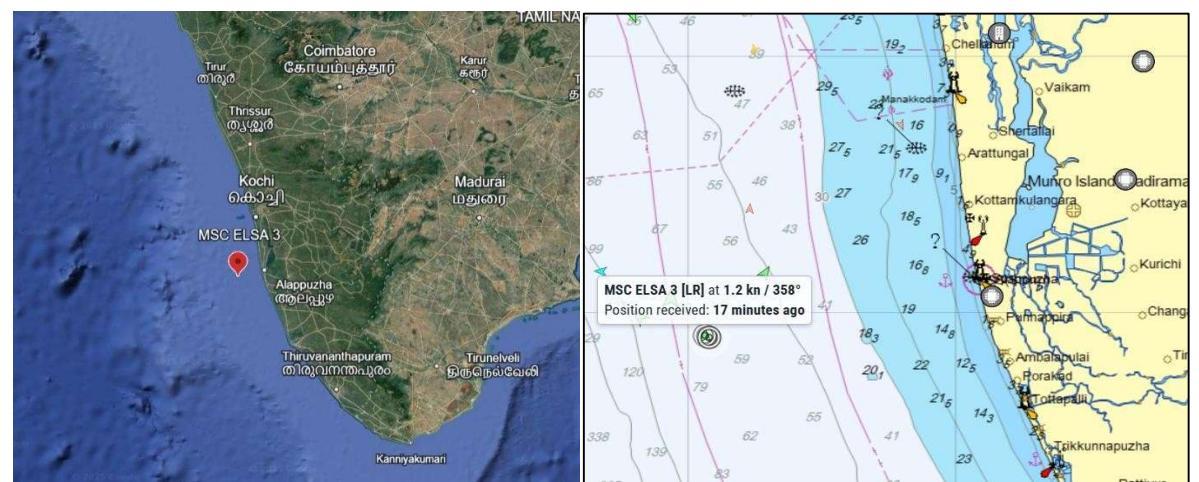
Figure 3: Position of the wreck after sinking at 0750 hours on Figure 2: MSC ELSA # position at 2130 hours on 24th May 2025 25th May 2025

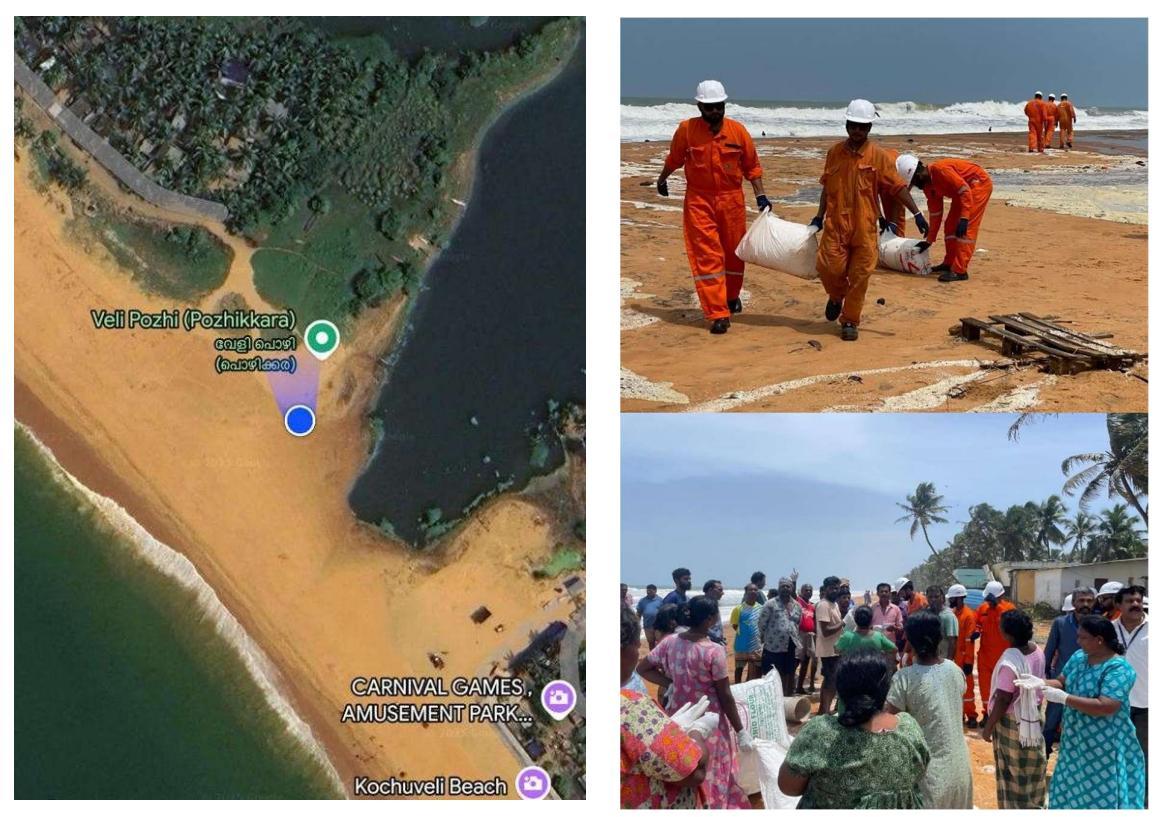
Plastic Pellets (Nurdles) have been observed along the shoreline near Thiruvananthapuram. Immediate manual clean-up operations have been initiated to mitigate environmental impact by the salvors, with about 100 personnel at the site. Additionally, the local government has deployed 600 personnel for the clean-up activities. Plastic nurdles have spread over 20 km, a caution has been provided by ITOPF that nurdle contamination could spread along a 100-km coastline and emphasized the need for elevated storage and mechanical assistance (front-end loaders or excavators) for cleanup. A detailed plan for nurdle collection, transportation, and disposal is to be submitted by the salvors within 2 days.

Figure 4, 5 & 6: Shore Cleanup for Plastic Pellets

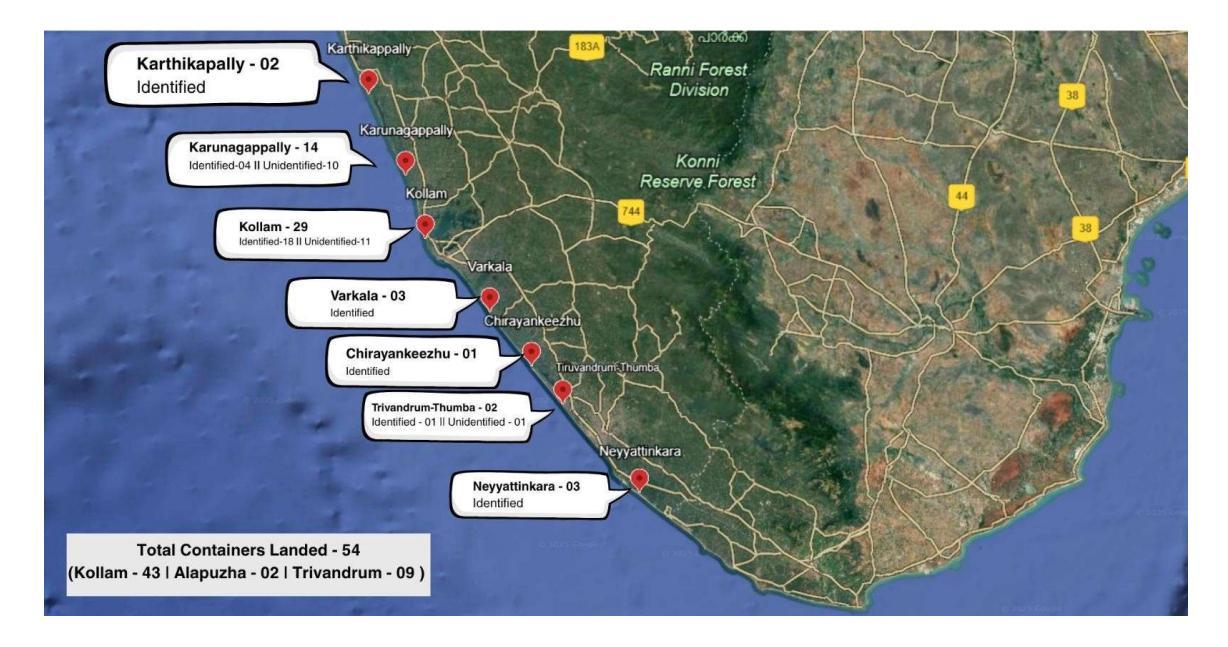
A total of 54 beached containers have been identified by Kerala State Disaster Management Authority along a 120 km coastal stretch, with personnel being mobilized accordingly. The salvors have identified 47 containers and recovered 23 of them from the coastline. Designated safe areas for storage are identified and container numbers of recovered units are being verified against the manifest, and open or damaged containers are being examined under customs supervision. MSC will continue to deploy personnel accordingly to these sites. The Coast Guard continues aerial surveillance; no hazardous containers have been found as yet, and according to recent surveillance, no containers have been spotted on the coast or afloat as of now.

Figure 5: Containers recovered on the Coastline and adrift

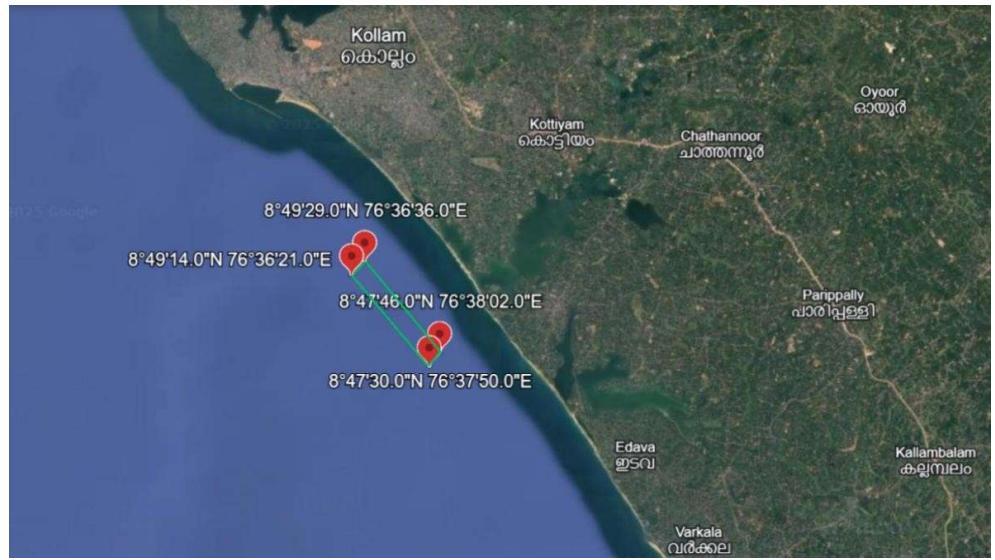
Further, ICG, as part of its aerial surveillance identified and reported the presence of an oil sheen extending approximately 1 nautical mile around the vicinity of the sunken vessel MSC Elsa 3. The ICG has provided the exact coordinates of the observed oil sheen to enable targeted environmental sampling and containment efforts. These coordinates are being used to guide the deployment of oil pollution response equipment, support aerial and drone surveillance, and inform further salvage operations in the affected maritime zone.

Figure 6: Coordinates of the Oil Sheen spotted during aerial surveillance

The salvors have been clearly instructed that plugging of the tanks/airpipes to contain oil and bunker must be completed without any further delay, with immediate emphasis on expediting the operation. Given the depth and complexity of the task, it has been conveyed that reliance on anchor-handling tugs currently proposed by the salvor will not suffice. Deployment of a Diving Support Vessel (DSV) is being treated as a priority, and negotiations for its hiring must be initiated without delay. In parallel, the option of naval support—both in terms of divers and platforms—is to be kept open should commercial arrangements prove inadequate or time-consuming. The urgency of the situation has been strongly reiterated, and the salvors have been directed to proceed on a war footing to ensure the leakage is plugged at the earliest.

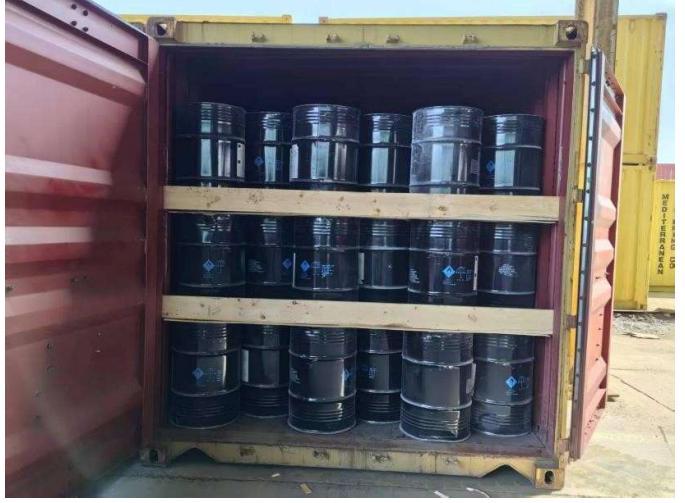
The adrift containers not only pose a navigational hazard but also represent a significant environmental threat, particularly given the nature of the cargo involved. The vessel was carrying approximately 367 tonnes of Heavy Fuel Oil (HFO) and 64 tonnes of Diesel Oil at the time of the incident. With the wreck located in close proximity to the Kerala coastline, there is a heightened risk of an oil spill. Further, 13 containers of IMDG 4.3 cargo carrying calcium carbide and 65-70 containers of plastic pallets

have been identified which may hazardous. Five of the IMDG containers which were carried onboard are adrift, however, none have been currently washed up to the shore. Such cargo & oil may have serious ecological consequences, including damage to marine biodiversity, coastal ecosystems, and local fisheries.

Figure 7: Packed Calcium Carbide Container
