**REPORT ON THE INVESTIGATION CARRIED OUT IN THE LANDSLIDE  
AFFECTED PUTHUSSERY AREA OF PALAKKAD DISTRICT**

**Ref: LRH2/42794/2012 dated 19/11/2012**

## **Puthussery Landslide Event**

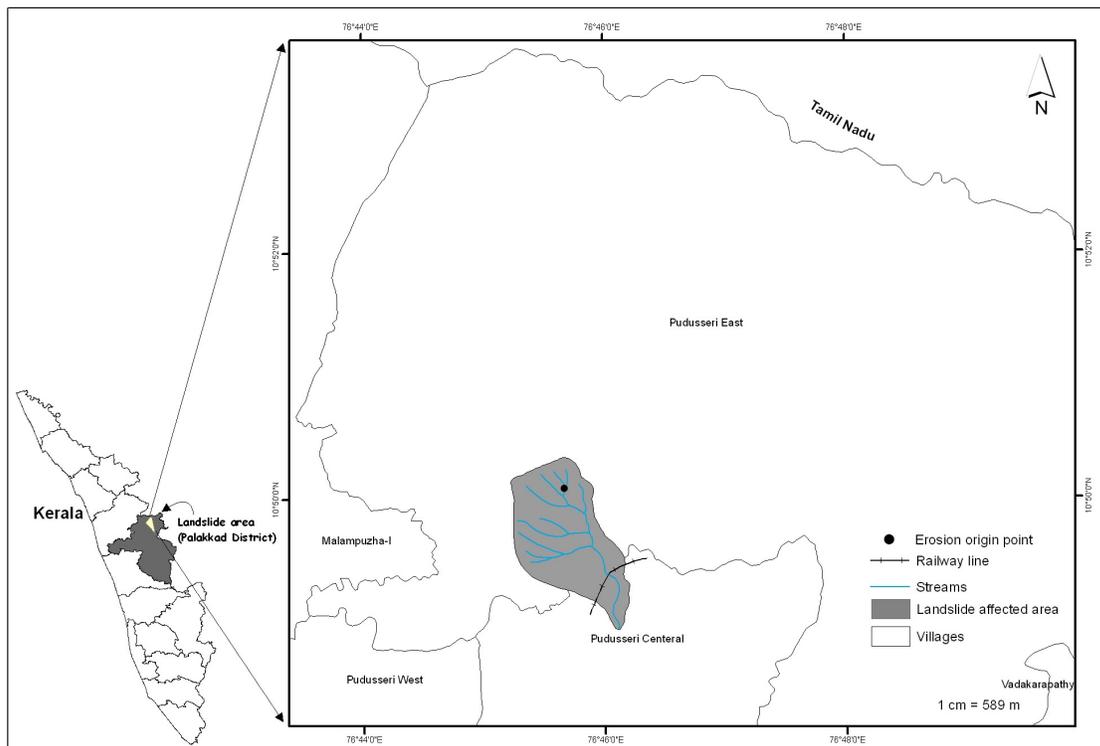
Figure 3. Map showing the study area with location of railway line, streams and neighbouring village.

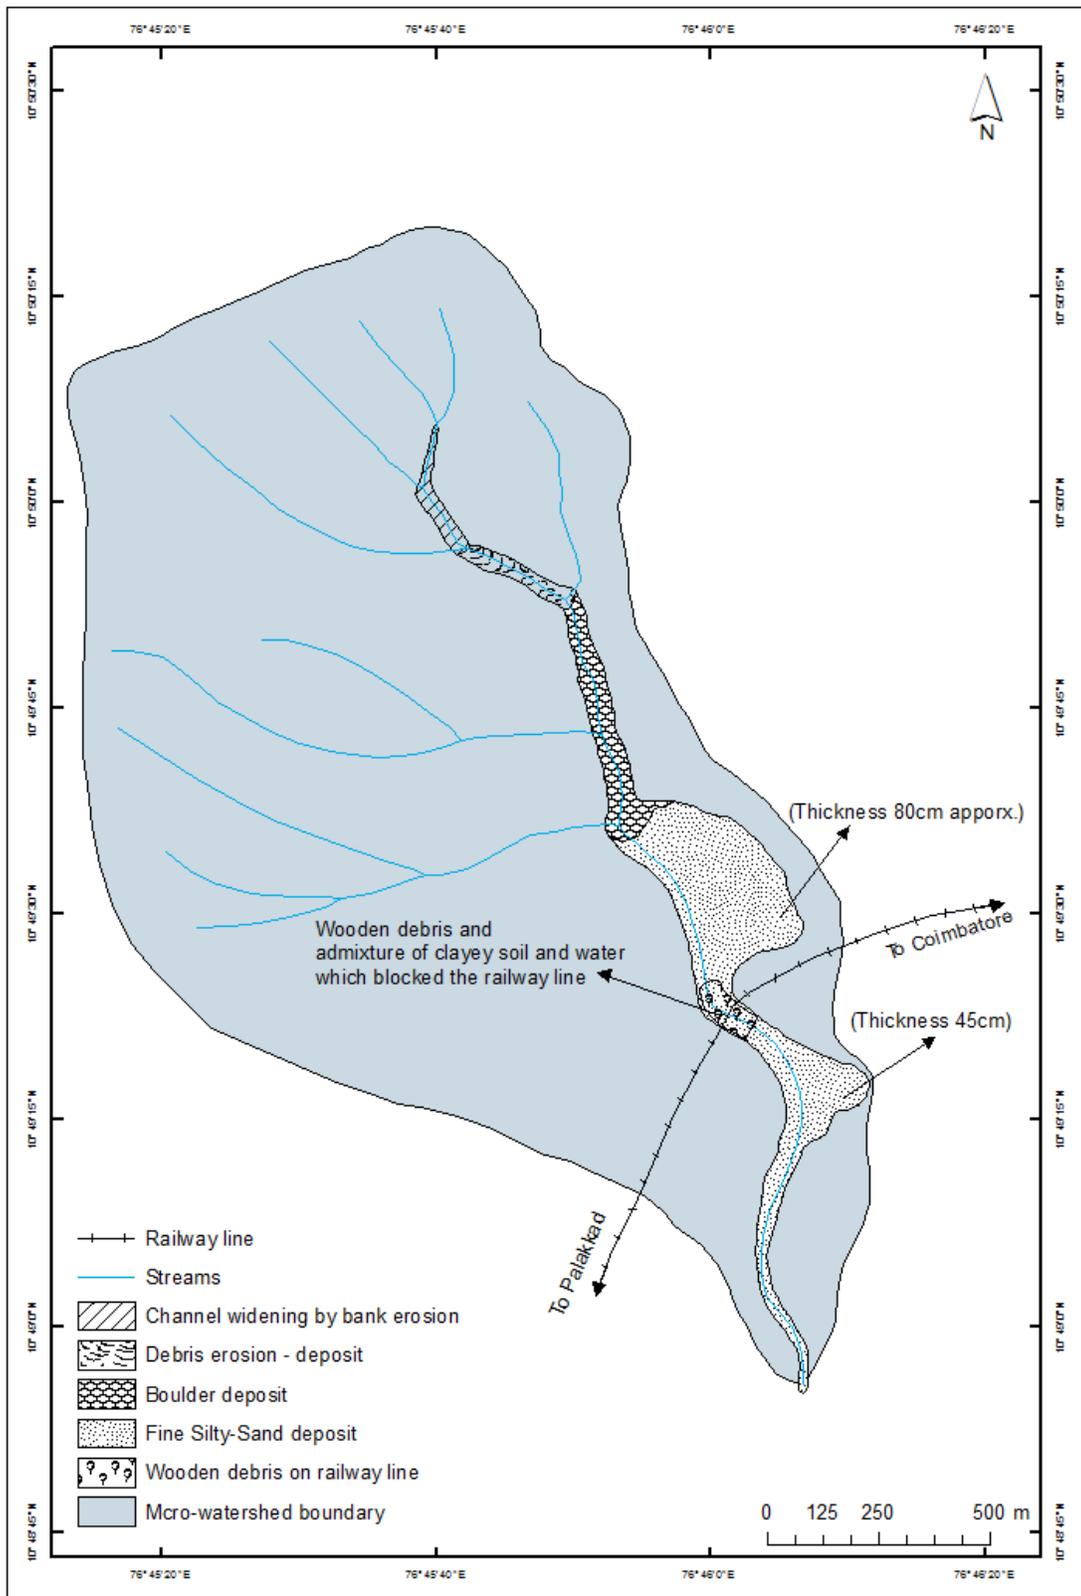
The area affected by the landslide was mapped with details of all the features and characteristics and is given below in figure 4. It can be divided into four segments viz. a) zone of initiation b) zone of channel widening with removal of entire material on either banks c) widened channel with deposition of large boulders and d) zone of deposition of gravel and fine grained material. The event was initiated on the upper slope at about 500 m amsl from where thin debris has been dislodged by heavy precipitation down the slope and the flow probably confined to a narrow section on either side of the existing stream. This is a steeply sloping segment which is relatively barren and exposes rock outcrops. Sheet flow is the dominant process. The debris is negligible but the force of flow of water channelled on slope is high. Channel widening is evident down the slope from where the confluence of the main stream with other streams is seen. The thickness of debris increases from this point down the slope. The channel is widened with removal of entire overburden including all vegetation. Further down the channel shows further widening with removal of entire material. 2-3 m thick material has been removed in a width of about 10 m on either side of the existing stream bed. Reduction in natural slope has further resulted in the accumulation of large size boulders brought from the elevated areas. Undulations in the stream bed with reduction in slope have caused blocking of these boulders but the finer material has been further washed down by the swift flowing waters. In this section there is a gradual reduction in the size of the boulders from higher elevation to lower elevation. However large tree trunks are rare in this zone. Further down there is abrupt change in gradient as well as direction of flow. From this point onwards gravel is seen deposited with fine grained material. The relatively flat land above the railway line where mango orchard is seen, 1-2 m thick sandy deposits are seen nearly levelling the land. Further down is the affected railway line located on the foot slope part which was damaged during the event. A stretch of 150 mts of railway line and some of the

Figure 4: Detailed sketch of the event that occurred in the Puthussery village in Palakkad district.

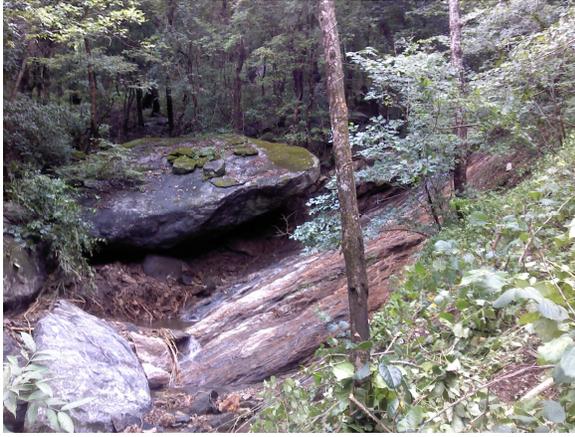
Figure 5: Initiation point of erosion.

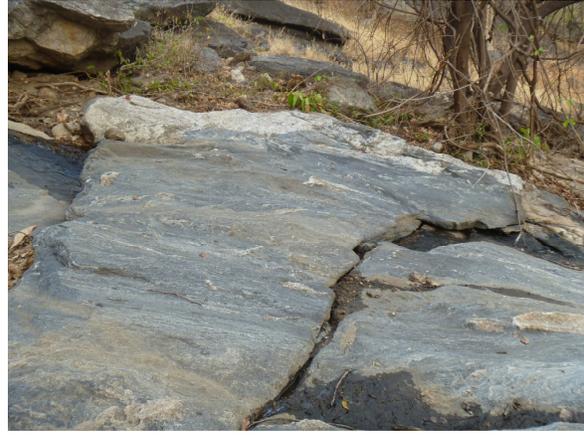
Figure 6: Release joints identified near to the initiation point.

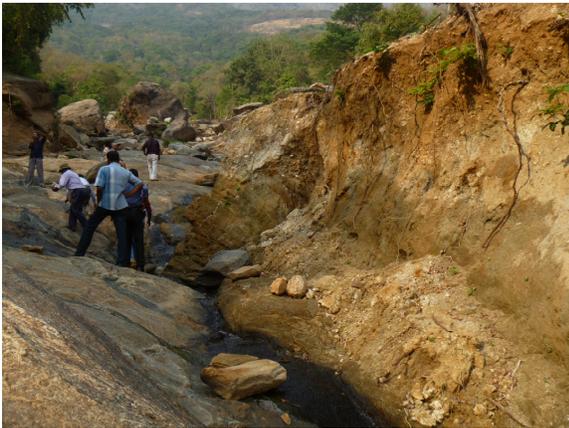
Figure 7: Stream bed and bank erosion. Entire material in the stream bed and 5 meter thick sidewall was also removed.

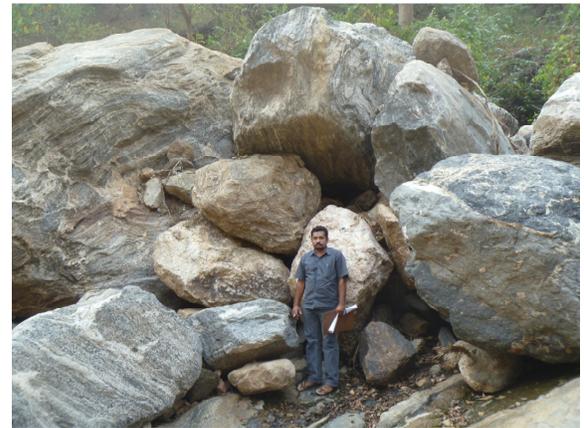
Figure 8: Large boulders deposited in the stream bed.

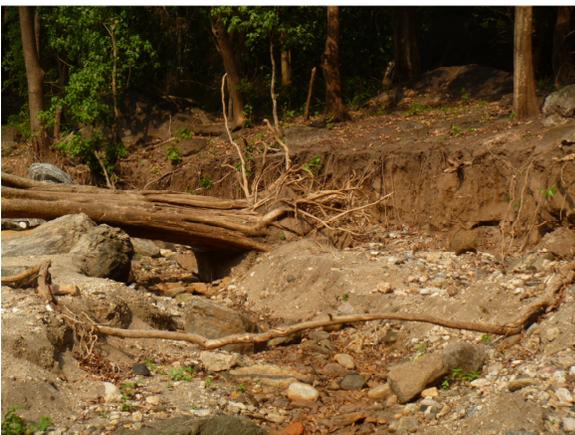
Figure 9: Wooden debris and medium sized boulders over the stream channel.

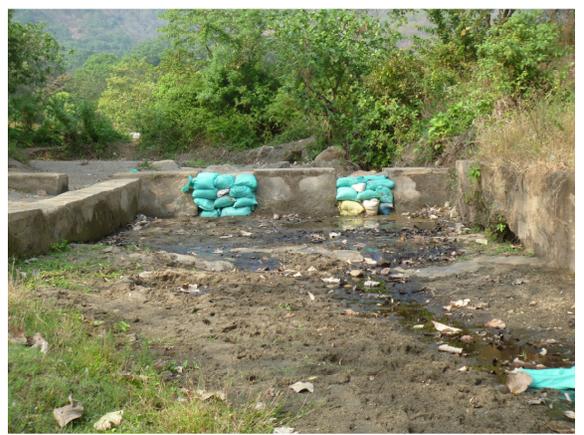
Figure 10: Damaged check dam lower reach of the stream.

electric posts were damaged due to this event. Incoming flood waters along with fine material and tree trunks covered the track. At the time of the event, a goods train which was running to Coimbatore with full load of cement had to be stopped and all water and the slurry which entered into the wagons damaged all the material in the train. Support had to be given to the wagons to prevent derailment. Two days were taken to remove the slurry and muck from the railway line and to repair the damaged railway line and electric posts. The check dam for diverting the water for irrigation purposes was also damaged partly.

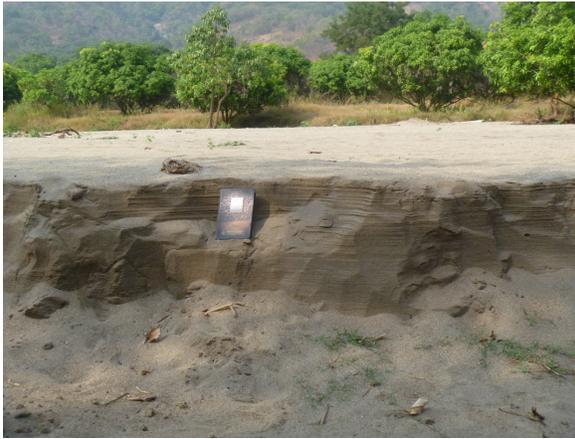
Figure 11: Fine grained sand and silt deposit in the relatively plain area near mango orchard. Note the thickness of the fine grained material deposited with sub-horizontal layering.

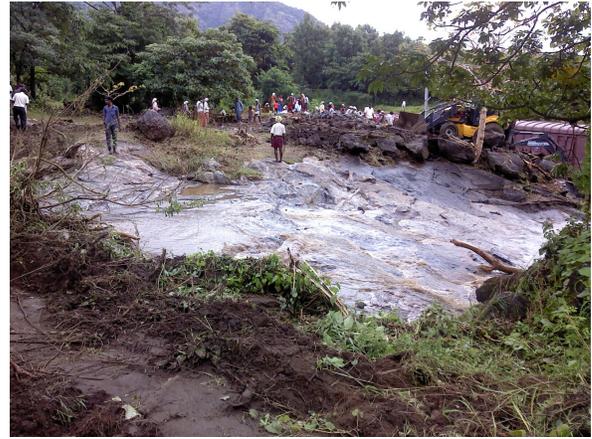
Figure 12: Photograph of the railway track affected by landslide. Note the large tree trunks brought from the upper slopes. The wagons in still in supported condition.

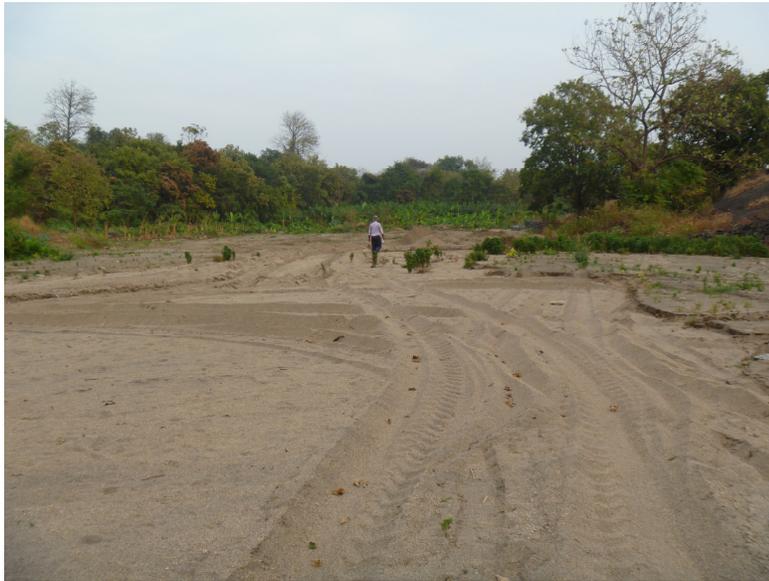
Further down the railway track Paddy fields are seen. The incoming silty material got deposited in this area damaging the standing crops. As much as 1 m thick deposits are seen in the head region of the valley. The tanks in the area used for irrigation has been filled up. The flow of water and material was further channellised through the narrow depression for considerable distance.

Figure 13: Fine grained material deposited below the railway track. Paddy fields, plantain plantation and a pond in the areas were covered with the alluvium and was extended to the narrow channel further downward with less dimension.
