# **Report on disaster proneness of Pulingome and Thirumeni Villages**

(Reference: Submission to the Principal Secretary, Revenue and Disaster Management by Kottathalachy Hill Eco-Protection Council and direction by Principal Secretary to Head, HVRA Cell for urgent enquiry and report dated 3 May 2012)

Hazard, Vulnerability and Risk Assessment Cell  
Department of Revenue and Disaster Management, Govt. of Kerala  
2<sup>nd</sup> Floor, Institute of Land and Disaster Management  
PTP Nagar, Thiruvananthapuram 695038  
Tel/Fax: 0471-2364424  
Email: hvracell.gok@gmail.com

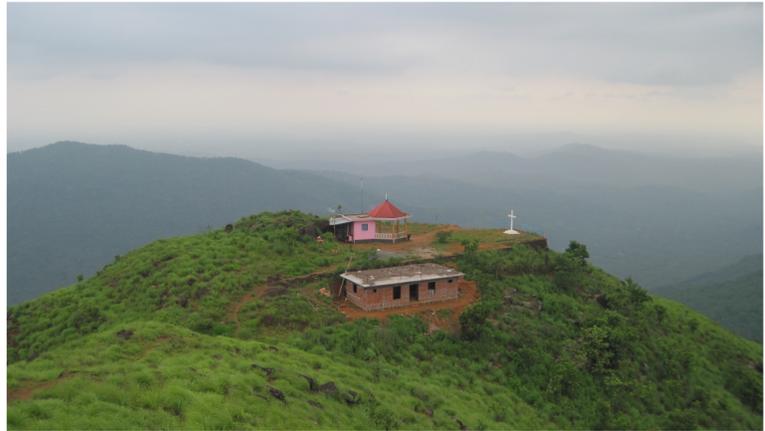
*Figure 2: Panoramic view of the valley of Kottathalachy hill*

Christian community. Figure 2 shows a panoramic view of the Kottathalachy hill. The affected locality is situated in the highland region with elevations reaching up to 801m in the Kottanthalachi mala. Average slope of the hill is roughly 30° with many parts of the hill being near vertical. Soil thickness is about 7 m on an average with rocky exposures present in the most areas. The Kottathachi mala is characterized by radial drainage indicating its shape. Many lower order streams originate from this hill. ‘Thirumeni chal’ a third order stream and its tributaries drain through the locality. Charnockite rocks dominates Precambrian crystalline basement of the area. The overburden material above the basement is clay rich loamy soil.

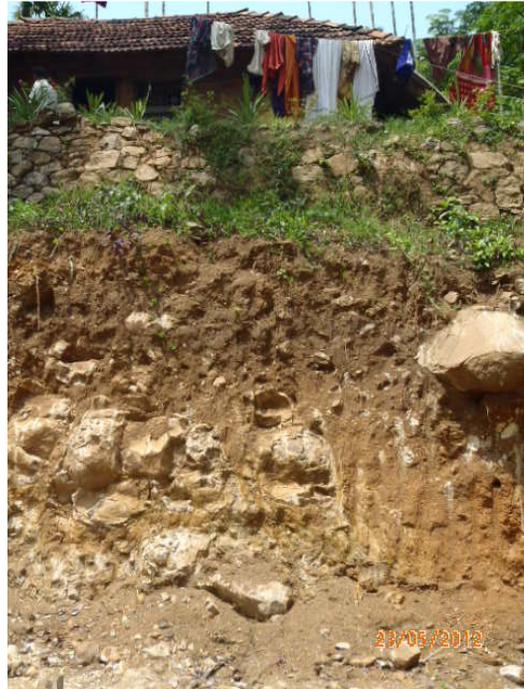
It was evident from the field work conducted by the team that the slopes of Kottathalchi hill has been affected by land degradation processes such as rock fall and debris flows since time immemorial. The presence of numerous cobbles and boulders entrapped in the B and C horizons of the soil, and the numerous loose boulders along the slopes of the hill are evidences of such events in the historic past.

Figure 3 shows a typical soil profile of the region. It is evident that these land degradation processes are active event today, given the occurrence of landslides in the years 2004, 2006 and 2010. The slope, rainfall conditions and anthropogenic activities prevalent in the area favors landslides and rock falls. Numerous loose boulders and large rock fragments were seen to be located precariously on the slopes of Kottathalachi hill. Such rocks and boulders which were found to be detached from the parent bed rock are susceptible to toppling if subjected to severe vibrations such as that resultant of quarry related blasting.

*Figure 3: Entrapped boulders and cobbles in the B & C horizons*

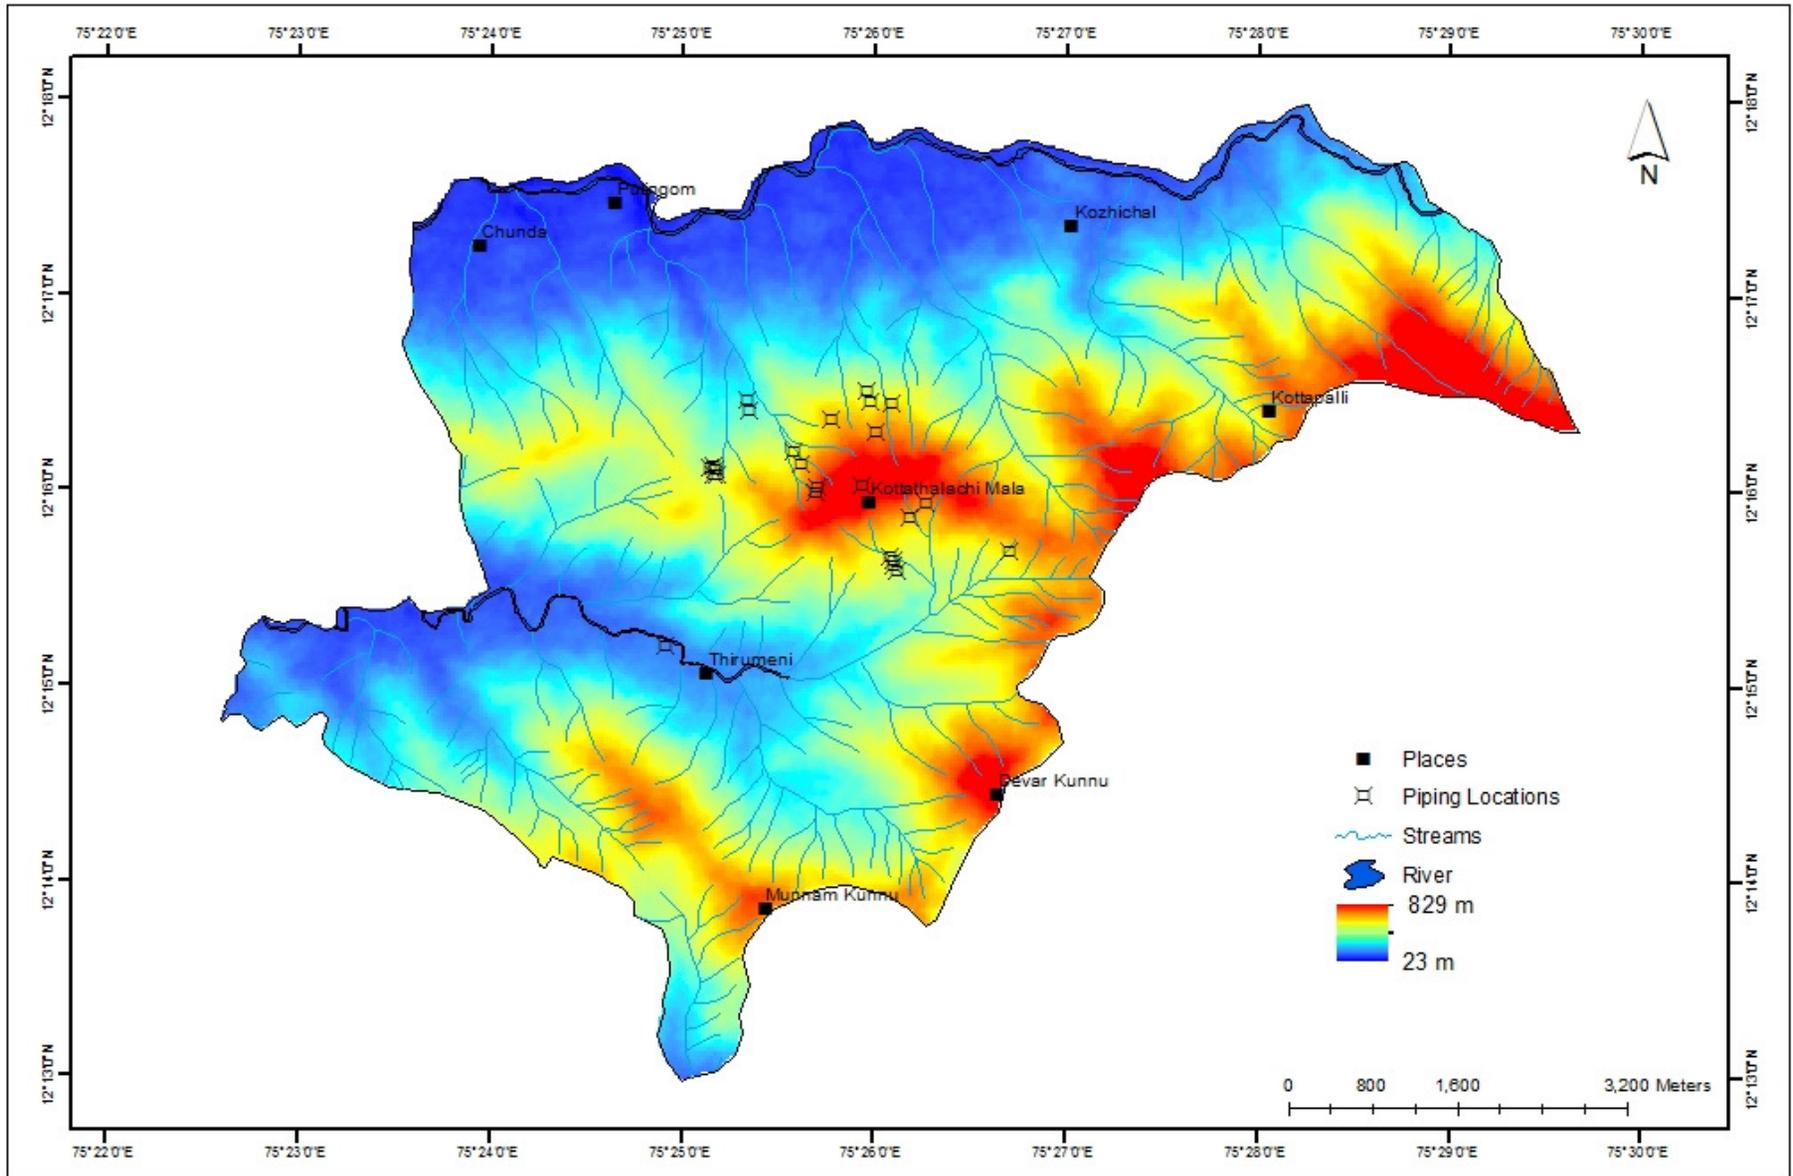
In addition to the above stated geo-hazards, the presence of soil pipes (tunnels due to natural subsurface erosion) makes the land further fragile. A total of 20 pipes and pipe outlets were marked and cataloged. Three pipes were investigated physically. It was evident from the investigation that many of these pipes are decades old in terms of their origin and existence. Investigations inside the pipes revealed that the baseline of the pipes is often bed rock. Figure 4 shows the locations of the investigated pipes overlaid on the digital elevation model; Figure 5 shows the locations of the pipes overlaid on the drainage map.

Figure 4: Locations of soil pipes cataloged, overlaid over the Digital Elevation Model

The near original state of these soil blocks and the fact that the soil has not been washed off by running water indicates that they were recent in origin. This indicates that the processes which triggered piping are still active in the region and numerous undetected pipes may be present in the soil strata of the region. Table 1 shows the slope and elevation of the various pipe inlets and outlets cataloged during the site visit. From the table it is evident that pipes are located on steep slopes on altitudes above 150 m (cf. Figure 4). Figure 6 shows the sketch of an investigated soil pipe.

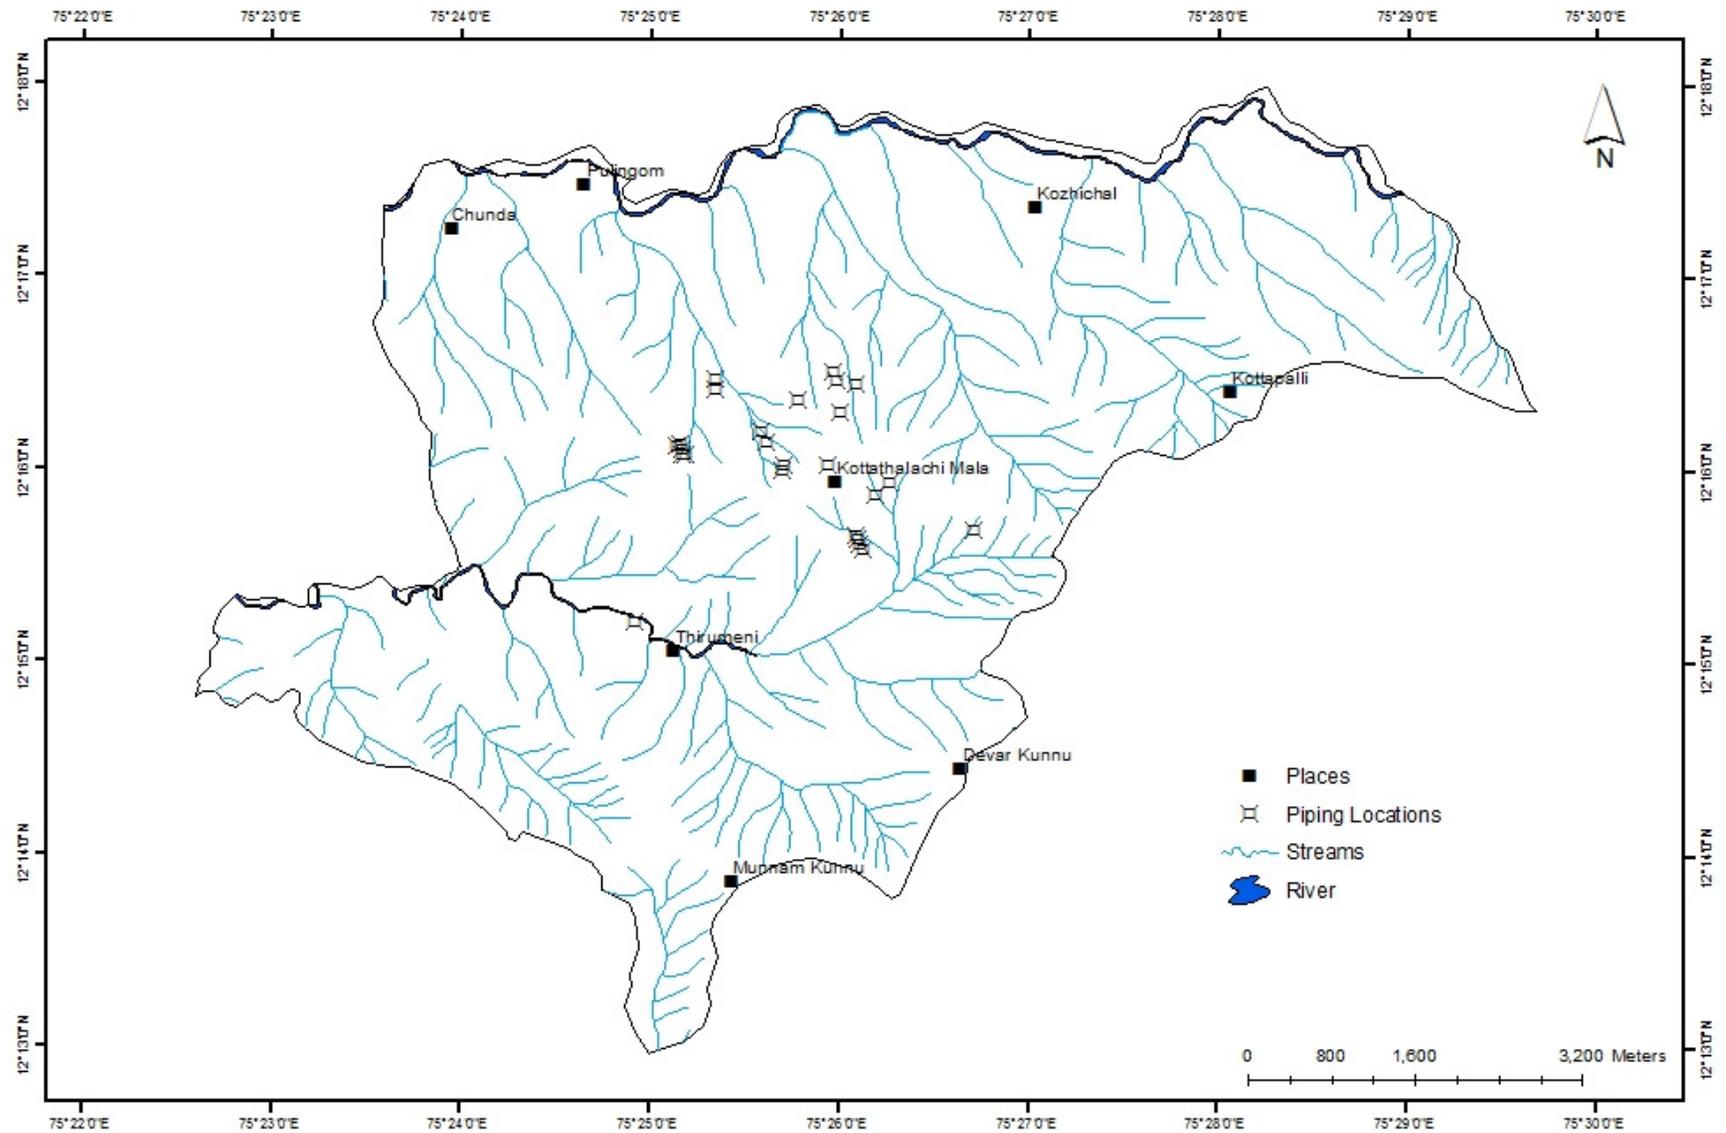
Figure 5: Locations of soil pipes cataloged, overlaid over the drainage network

The pipe inlets and outlets were in close proximity to the 1<sup>st</sup> order drainage channels in the region (cf. Figure 5) which is an indicator of the hydrological influence of these entities. The ground water level of the region also seems to be influenced by the presence of these pipes. It may be noted that such large soil pipes would collapse and result in significant loss of agricultural land if severe ground disturbances such as blasting, piling etc. and resultant ground vibrations propagate through them. The roofs and sidewalls of such pipes are unstable and the soil strata in the region do not seem to be possessing sufficient cohesion to withstand such vibrations. Figure 7 shows some photographs of the investigated soil pipes.

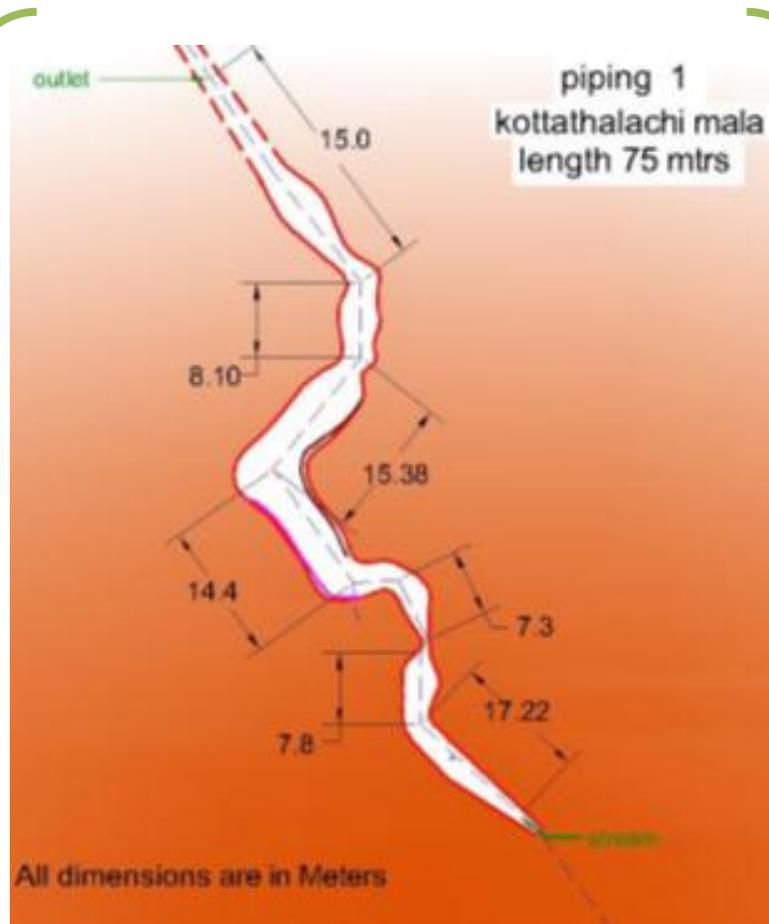
Water flow channels were observed inside the pipe. Evidences inside indicates that most pipes experiences pipe-full discharge during the peak seasons.

Indications of fluvial erosion such as water flow striations were evident on the side walls as well as the roof. As bed rock arrests down cutting, the investigated pipes were seen to be experiencing lateral erosion along the side walls. Presence of peat or peat like organic strata was found almost near the baseline on the side walls of the investigated pipes and this stratum was found to be bedding parallel to the slope. Some parts of the pipes were found to be stable. The walls and roofs of the stable segments were found to be made of saprolite. Major part of the investigated pipes was still experiencing lateral erosion. The relatively active parts of the pipes were found to be lined by thick soil strata that were being eroded. Loose soil blocks that got detached from the roof were found on the floor of the pipes.

Figure 6: A sketch of an investigated soil pipe

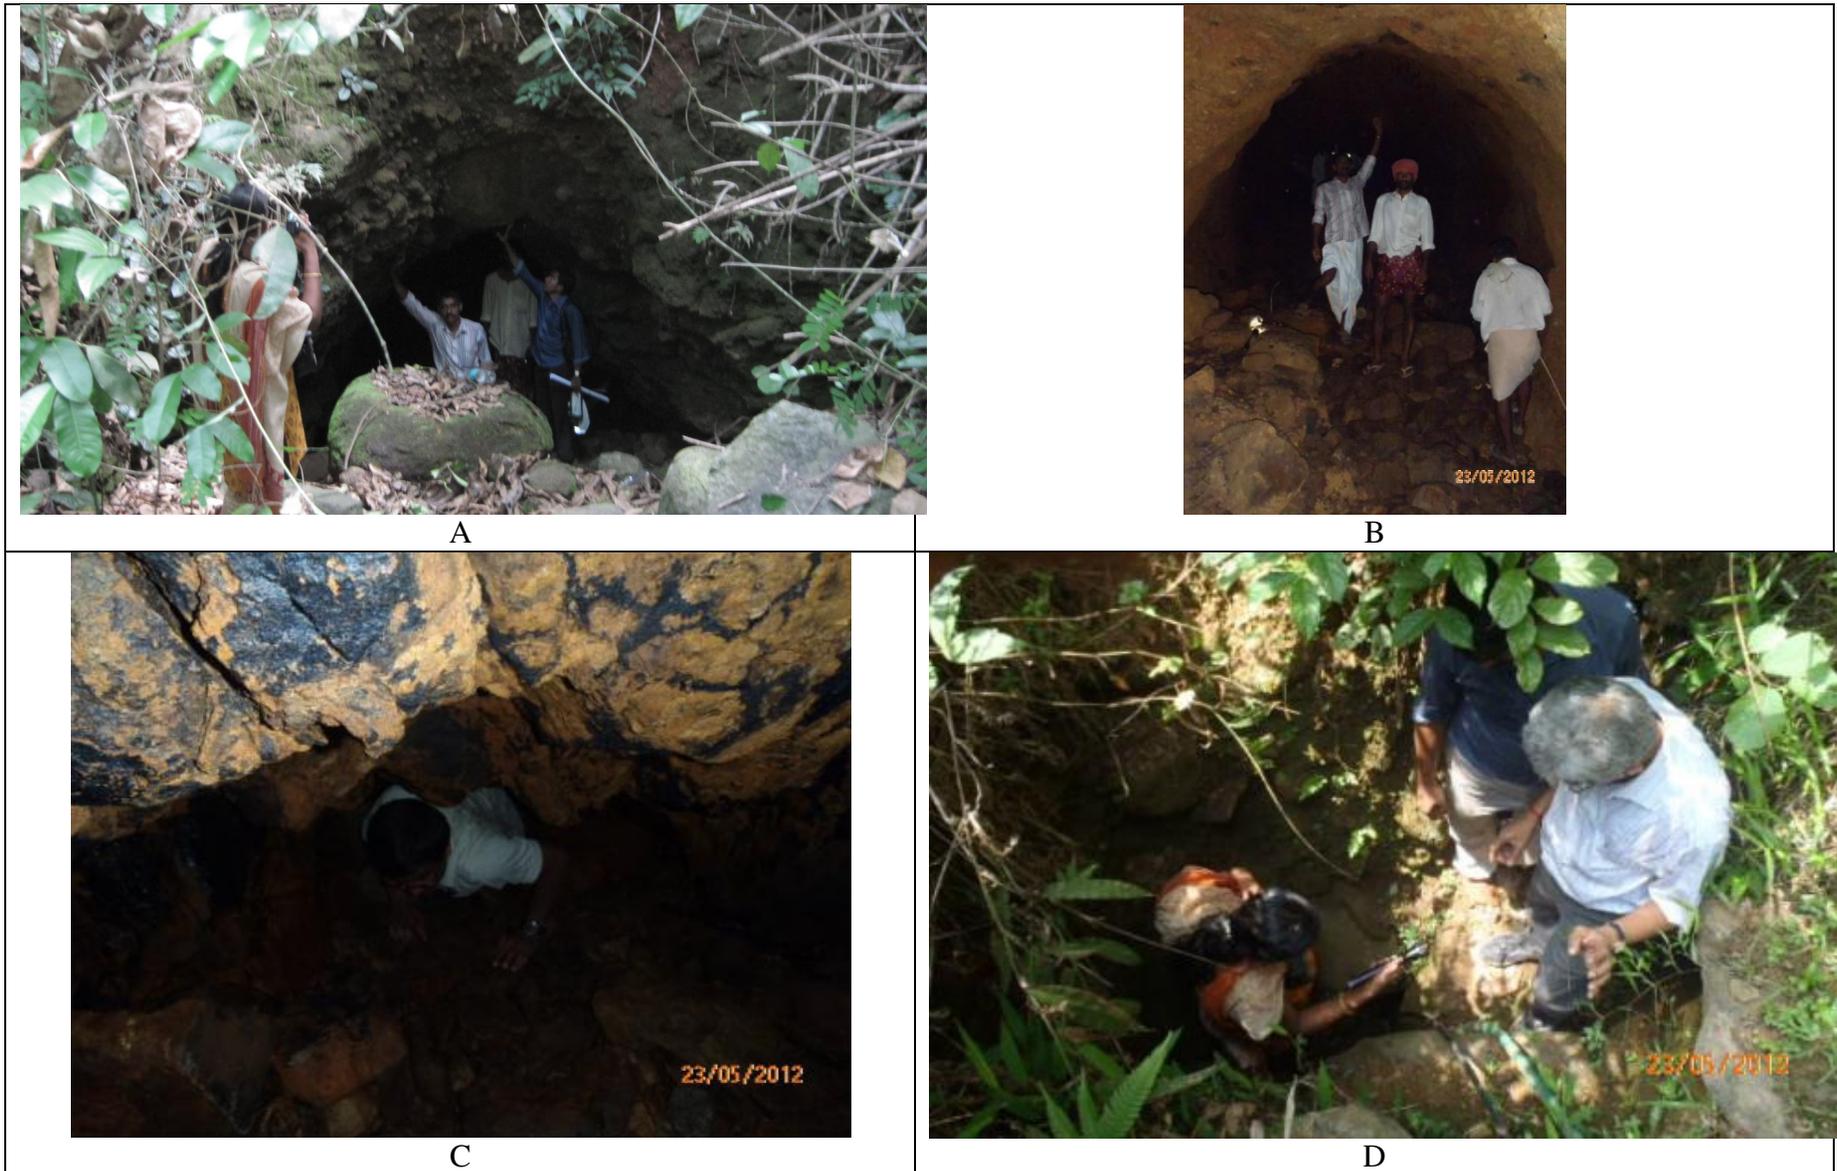
Figure 7: A – Inlet of a pipe; B – 20 m inside a soil pipe; C – 45 m inside a soil; D – Inlet to another soil pipe

4. Public must be alerted that they should not construct houses without undertaking a thorough investigation to know if any sub-surface soil pipes exist at the sites proposed for construction.

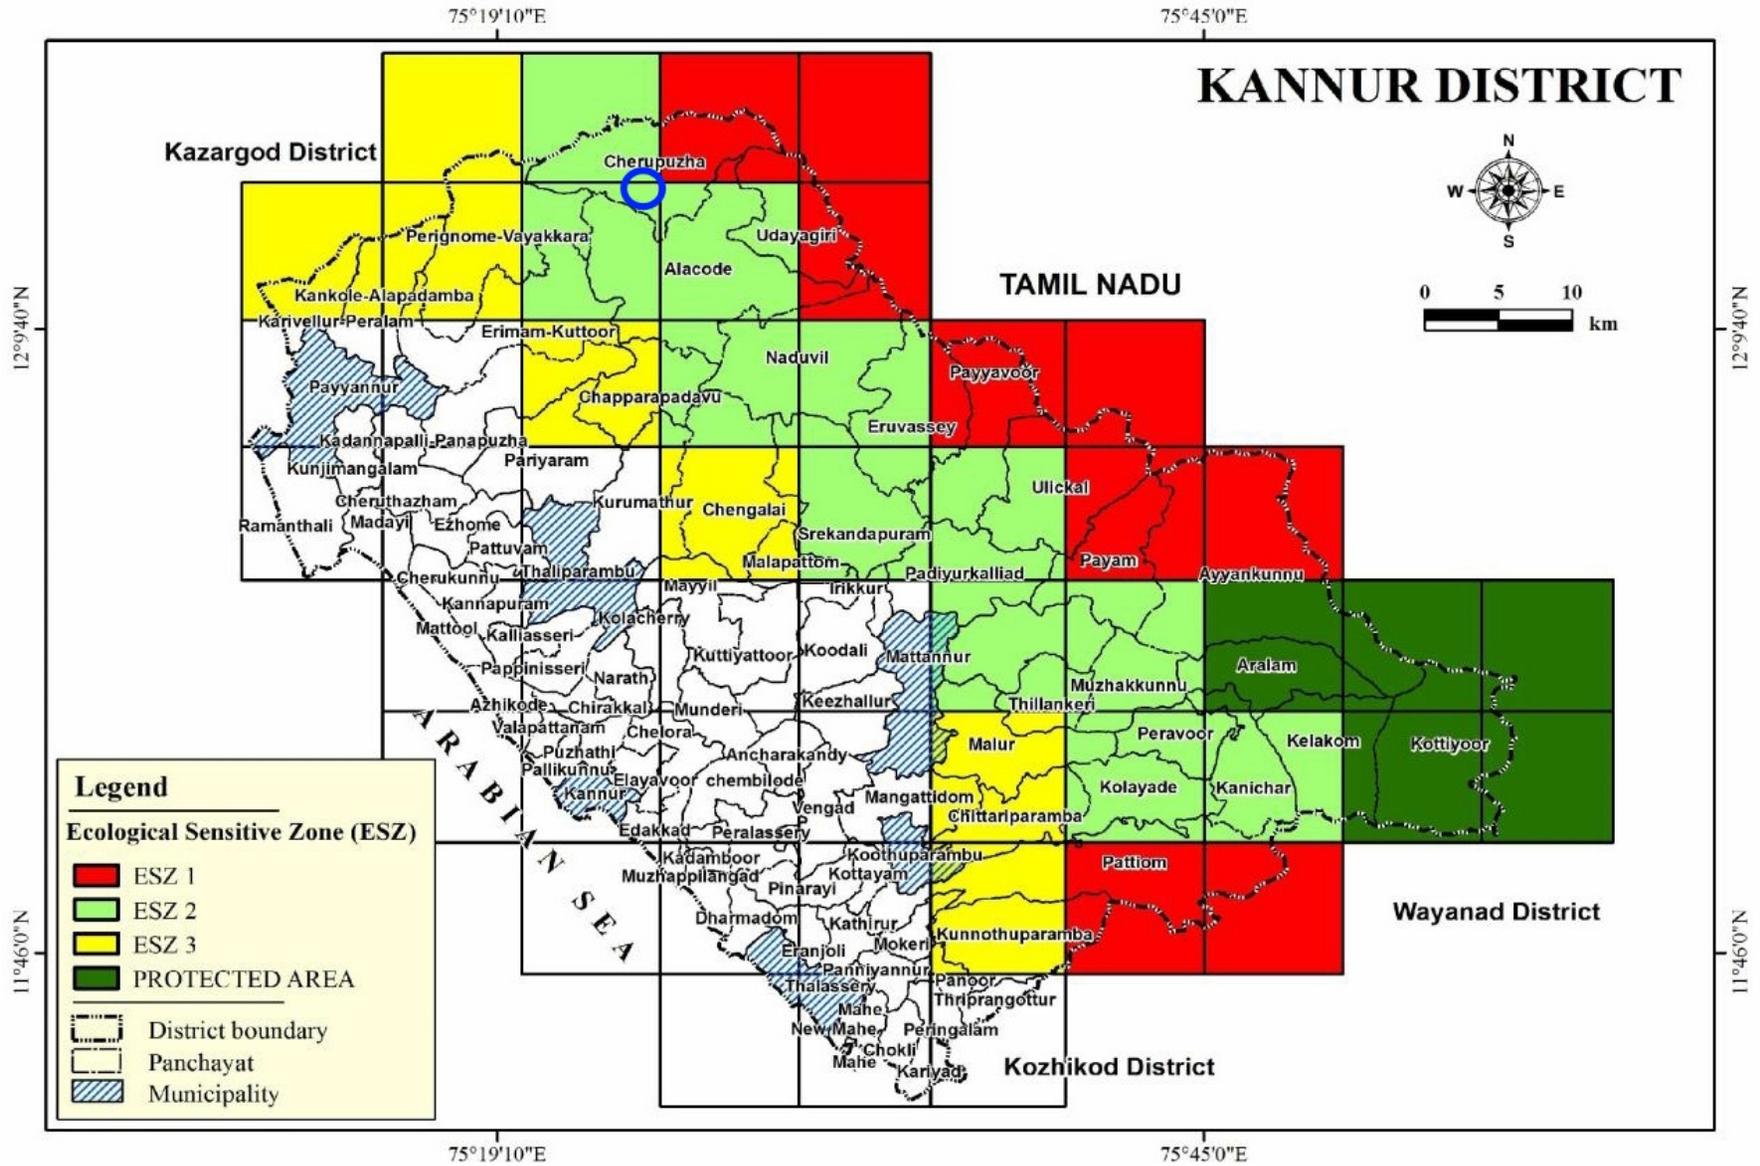
The ecological fragility of Taliparamba Taluk (cf. Figure 8) has been noted in the 'Report of the Western Ghats Ecology Expert Panel – Part 1, 2011' appointed by the Ministry of Environment and Forests, Govt. of India. The report, known as '*the Madhav Gadgil Committee Report*' identified Taliparamba taluk as 'Region of high sensitivity' and has classified it as Ecological Sensitive Zone 2 (*Appendix 3, Page 95, WGEEP Report 2011*). The WGEEP Report 2011 further states 'Change in land use is not permitted in ESZ 2 from forest to non-forest uses or agricultural to non-agricultural, except agriculture to forest (or tree crops) except when extension of existing village settlement areas to accommodate increase in population of local residents' (*Table 6, Page 41, WGEEP Report 2011*).

Figure 8: ESZs in Kannur (Blue circle in the map indicates the relative location of Kottathalachi hill)  
 (Reference: Understanding WGEEP, Kerala State Biodiversity Board 2012)

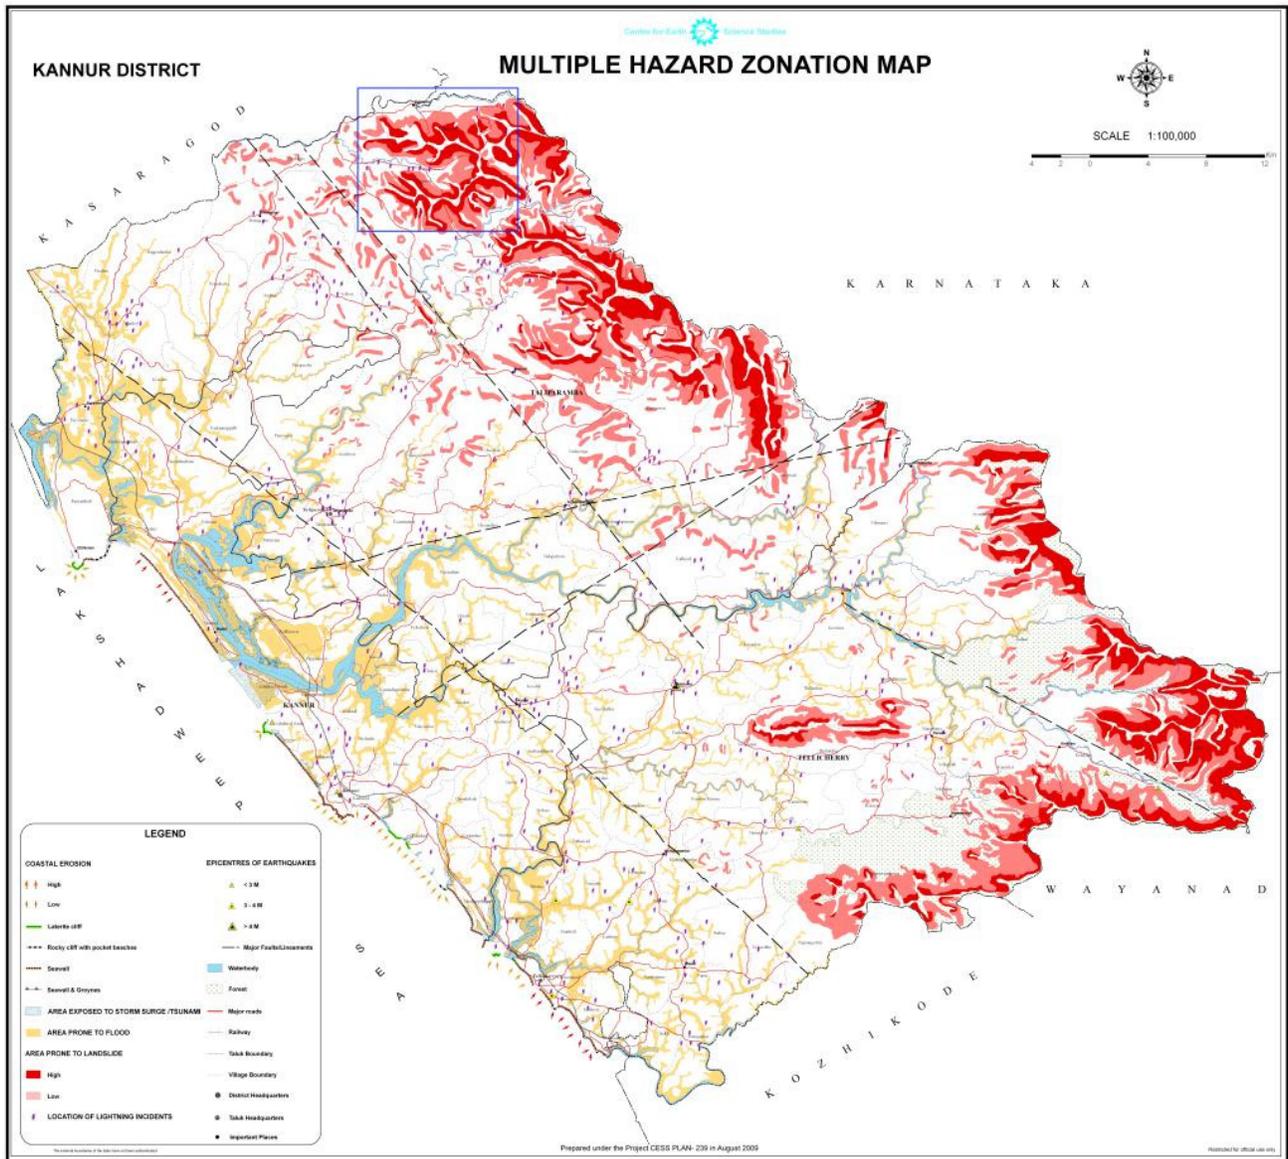
Further, in a report prepared by Centre for Earth Science Studies (CESS) in the year 2010, Thirumeni and Pulingome villages have been classified as highly landslide prone and lightning prone. Figure 9 shows the hazard susceptibility of Kannur district in which the villages Thirumeni and Pulingome are highlighted.

Figure 9: Hazard zonation map prepared by CESS for Kannur district. In the blue box are Pulingome and Thirumeni villages
