Studies on land disturbances due to soil piping affecting the critical zones in Western Ghats of Kerala

(A project funded by the Kerala State Disaster Management Authority)

Final Report

ESSO-National Centre for Earth Science Studies

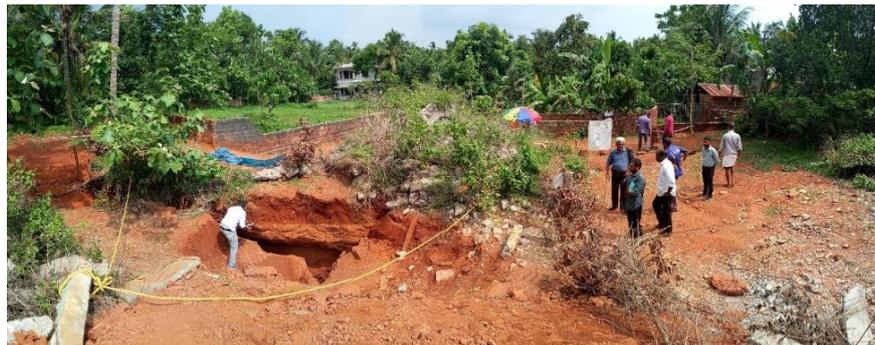
Fig 1.1 Land subsidence occurred due to soil piping in Kottaykkal, klari in 2018

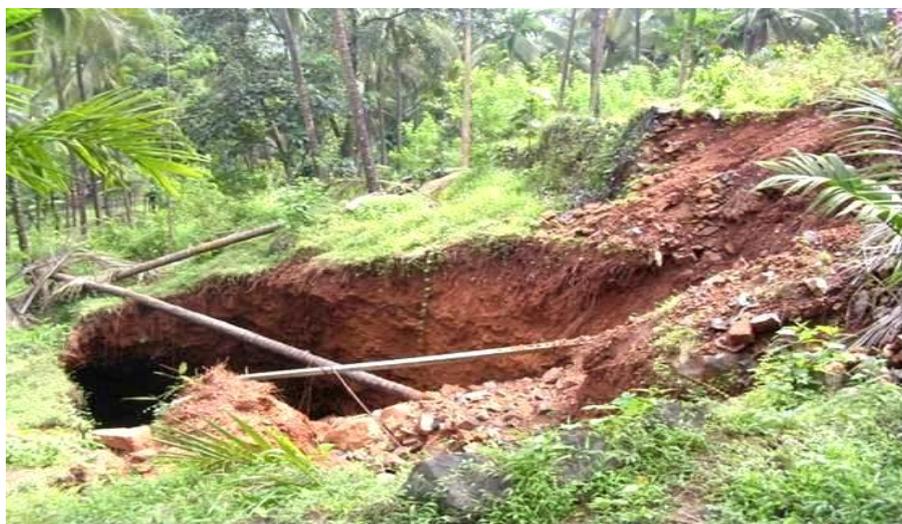
Fig 1.2 Land subsidence occurred due to soil piping in Chattivayal in 2005

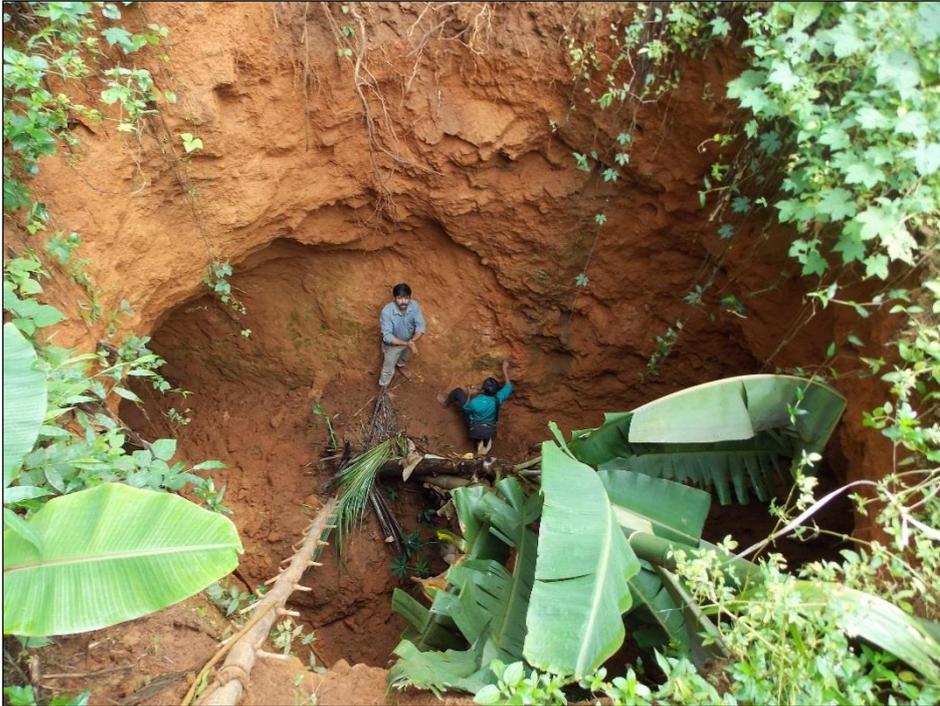
Fig 1.4 Land subsidence occurred due to piping

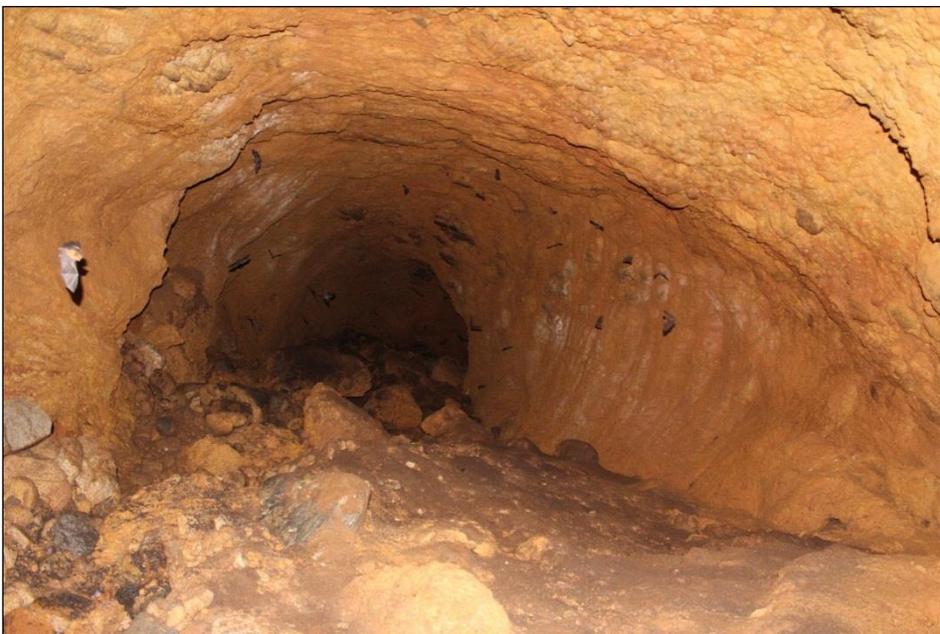
Fig 1.5 Soil pipe formed at Kottathalachi Mala

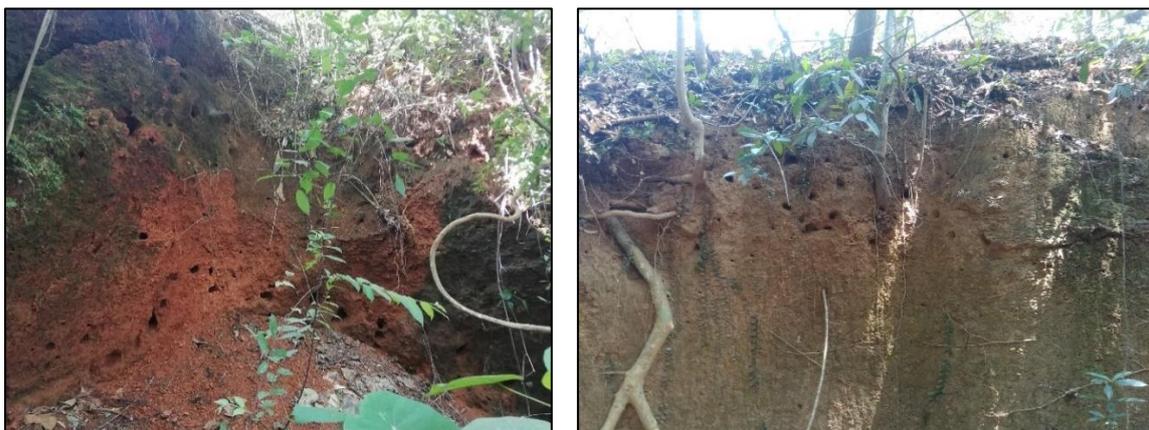
Juvenile pipes: are micro pipes. These pipes are indicators of soil piping activity in an area. Usually juvenile pipes are seen in the road and railway cuttings especially laterite cuttings. Presence of juvenile pipes could be used as one criterion of identifying a region as prone to piping. Many toppling occurring in the laterite road/rail cuttings are caused by water saturation by the juvenile pipes. Micro pipes or juvenile pipe {figure} are the initial stage of piping. The diameter of pipe is ranges from few mm to 5cm. Clayey and lateritic soils are favourable for the formation of juvenile pipes.

Figure 2.1 Micro (Juvenile) pipe.

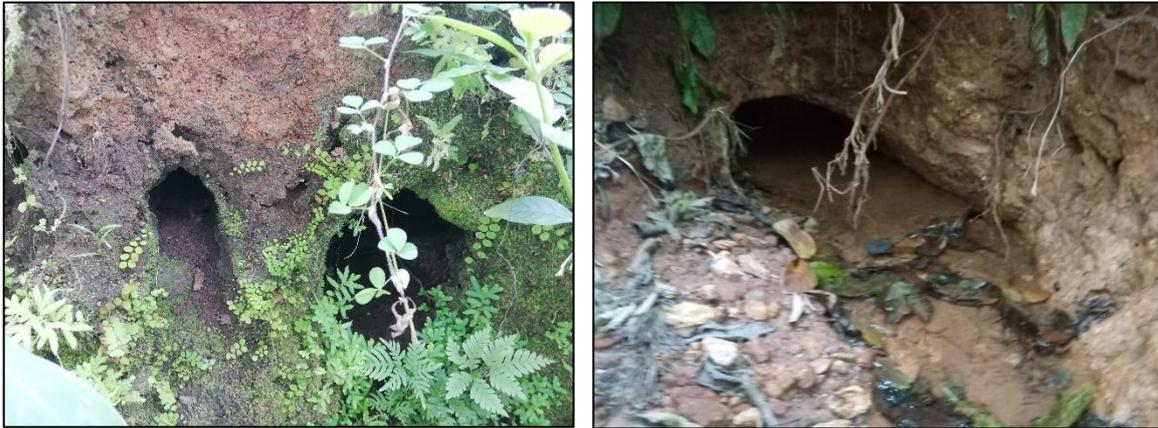
cuttings promote toppling in the lateritic area after being saturated during monsoon rains. The small pipes in an area also indicates that the soil is prone to soil piping. The diameter of small pipes ranges from >5cm to 30cm, it may combine together or individually developed as the formation of small pipe. This type of pipe is seen nearby Banasurasagar dam in figure b, is indicative of the dispersive soils occur in that area.

Figure 2.2 Small (Younger) pipe

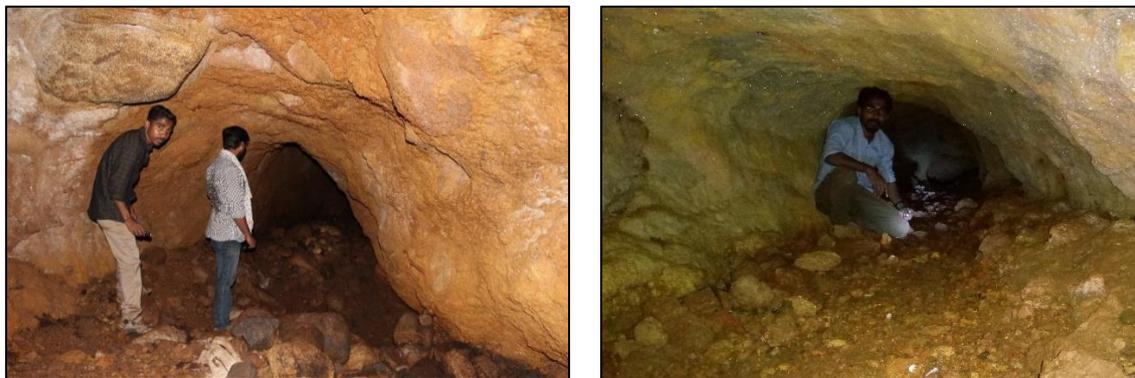
Typical pipes: are mature pipes. Mature pipe (Figure 2.3) is the third stage of development of pipe. The diameter of pipe ranges from 30cm to 5m. It may have an outlet; it acts as an underground drainage. This is the common pipes seen in the Western Ghats. The land subsidence is often caused by the growth of these pipes. This often branches in to smaller pipes giving an appearance of dendritic pattern. The size of the tunnel reduces towards the outlet attaining an overall shape of a funnel. The outlet of these pipes is often located in the lower side slopes or the valley. Here the water comes out as a fountain rather than a spring. These types of pipes are common in the affected localities. In Kerala Kottathalachimala (Kannur), Iritty, Tattékanni (Idukki) are typical examples.

Figure 2.3 (Typical pipes (mature pipe))

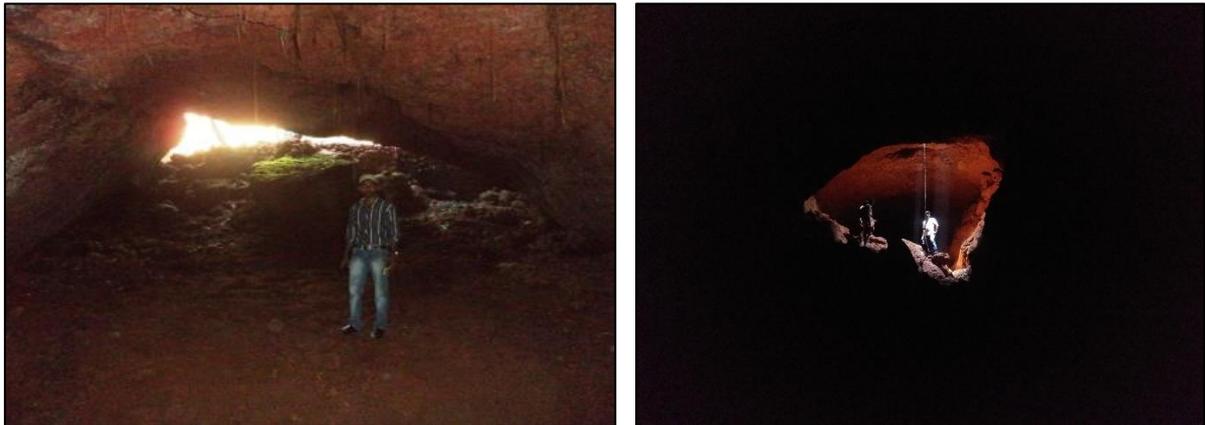
Oversized pipes: are huge pipes. It is the final stage of pipe after development of a typical pipe. The diameter of huge pipe (Figure 2.4) is >5m. It will also have an outlet. It acts as an underground drainage; it has no definite shape. These pipes often associate with their lower versions such as typical / mature pipes. These pipes are almost stable, the water erosion is very less and the walls of pipes are so hard Huge pipes are located in the Kasaragod (Kuttikol / Nelliyaadukkam) and Kannur (Umrampoyil) districts where hard duricrust is developed in deep lateritic terrains. Usually oversized pipes occur where the thickness of the lithomarge clay is high.

Figure 2.4 Over sized pipes (huge pipes)

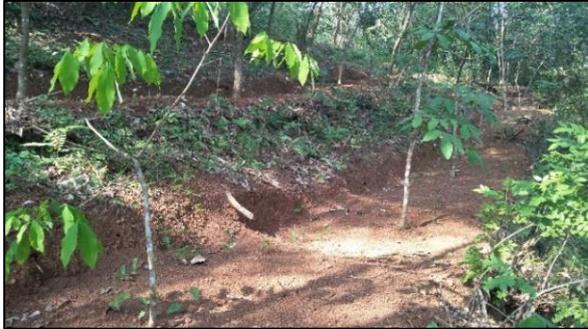
Figure 4.7: Upslope area is mostly occupied by rubber plantations.

plantations whereas the downslope is mixed tree crops. The rubber plantation and other introduced agricultural changes were observed, those are blocking the natural drainage systems. the intense rainfall accumulated in the top soil layers leading to the collapse of lands (Fig.4.7 & 4.8).

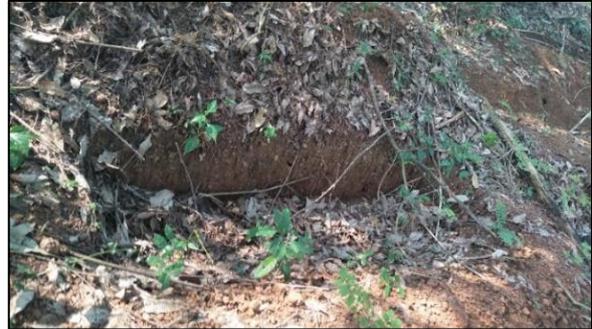
Figure. 4.8: Trenches (Mazha kuzhi) made for rainwater harvesting in the rubber plantations, which facilitate percolation of water leading to the collapse of lands.

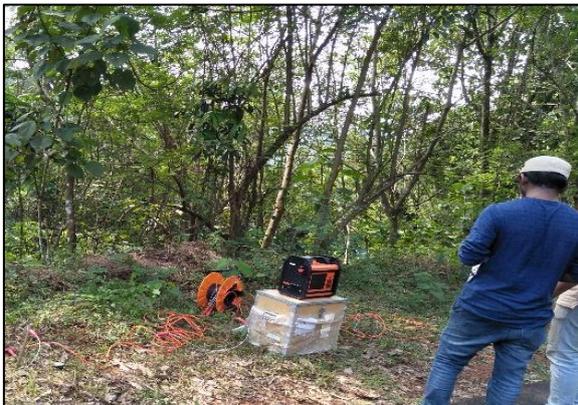
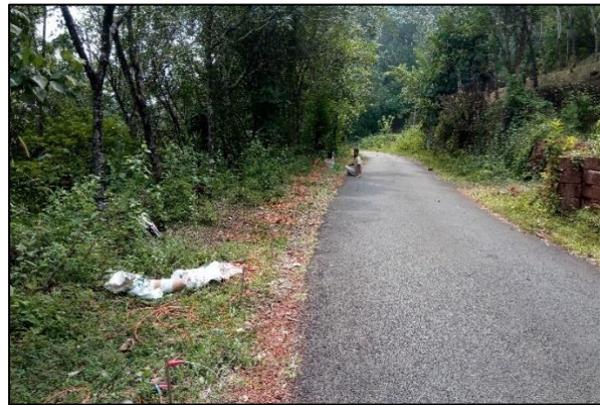
Figure 4.12: Electrical resistivity survey laid across the tunnel

Field investigations were carried out at piping affected localities of Kasaragod district, during the period of 30/10/2018 to 02/11/2018. Electrical resistivity survey is carried out to understand the scenario of soil piping on the basis of subsurface electrical signatures at Kinanoor village, Kasaragod, Kerala. For this purpose, resistivity data is acquired along a 96 m long E-W traverse using two arrays. Further, the collected data is inverted to get the subsurface electrical image upto 18 m depth. The inverted models provide the detailed subsurface structures and clearly bring out the hollow beneath the surface caused due to the soil piping.

Electrical resistivity surveys were conducted to locate the tunnel configuration beneath the Kilikalam-Varanjoor road (Latitude: 12.32° Longitude: 75.22° Elevation: 30 m Topography: Undulating)

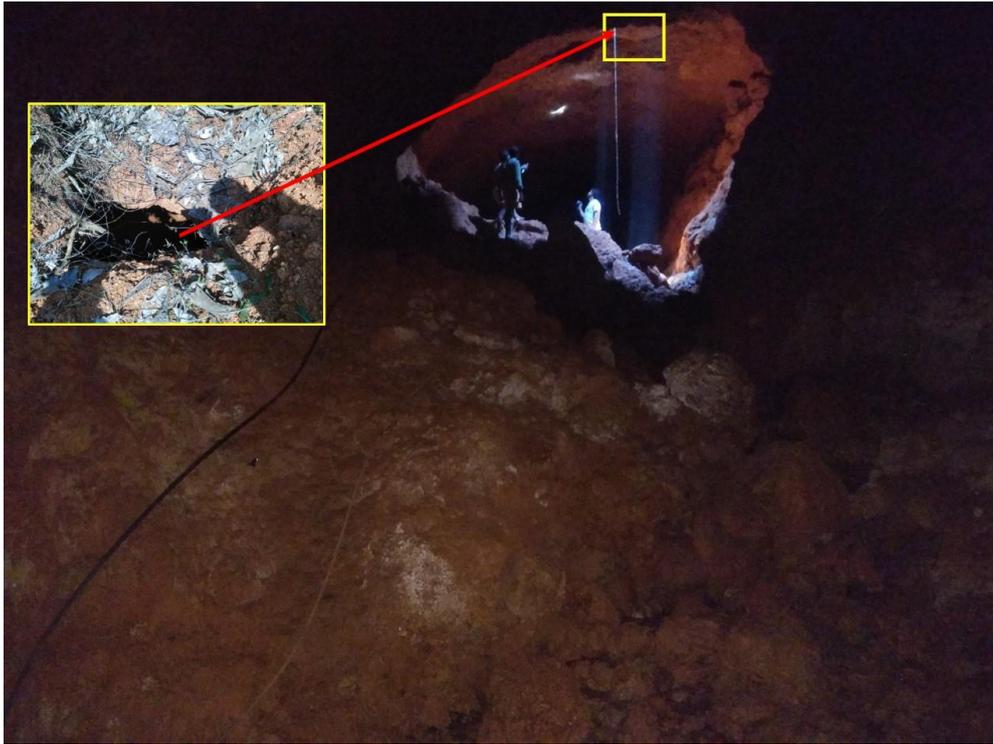
Figure 4.18: Cavity formed below road at Kizhakanodi

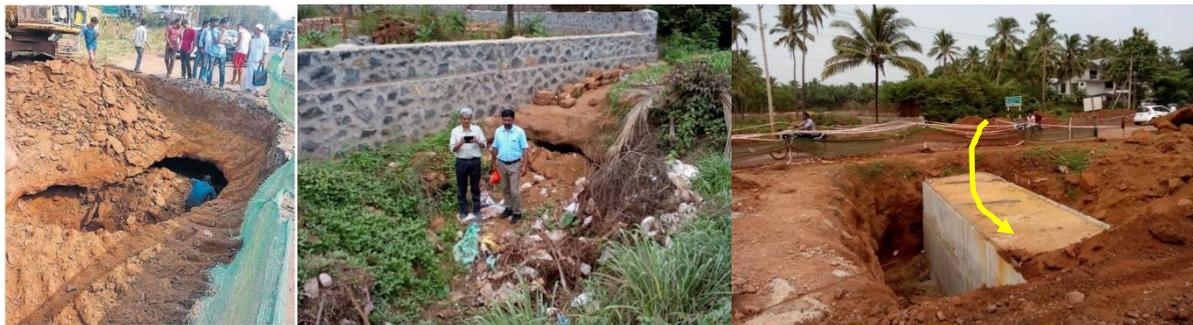
Figure 4.28: Soil piping incidence occurred in State Highway Pallikkara, Kasaragod District

A section of the road had collapsed near (Pallikara N12°23'15.8", E75°02'39.2") in 'Kanhangad-Kasaragod' State Highway. A big cavity exposed a long tunnel extending across the road at a depth is extending beneath the road. The anxiety is that pipe has recognized in a lowland area but in a lateritic terrain. The identified pipe comes under 'typical pipes category' in Kasaragod district. Since then the PWD has reclaimed the road and completely covered the cavity and passage. The measure adopted now is unsustainable and likely to collapse during course of time, geophysical survey here is recommended for designing a suitable structure here.

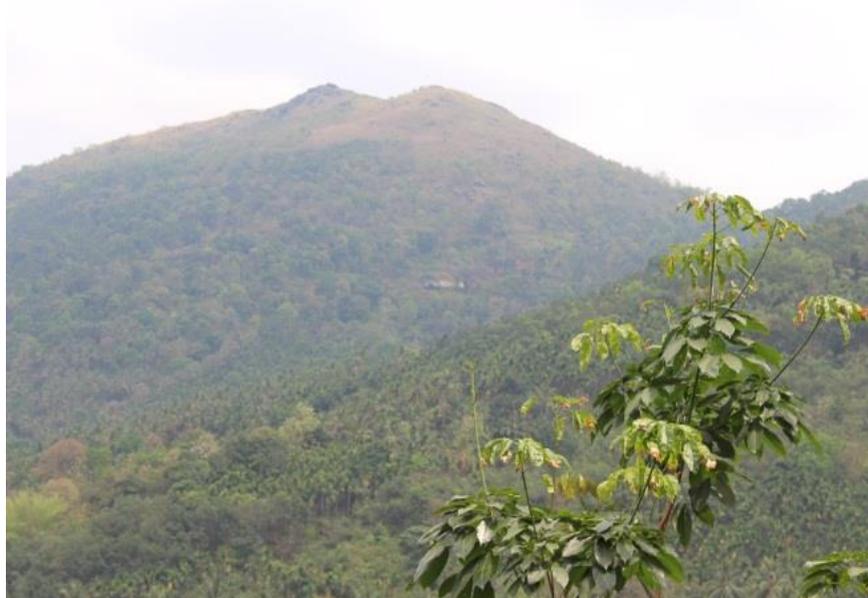
Fig.4.36: A distinct view of Kottathalachimala

The affected area located in the highland region with elevation reaching up to 830 m. The characteristic of Kottathalachimala is its anomalous slope compared to other hills, nearby area. Upper slope is about high slope (+31°). where is the lower slopes are about +24°. Kottathalachimala is characterised by radial drainage indicating its shape? Many lower order streams originated from this hill. The hill is surrounded by Pulingom River, Thirumenichal and Ponpuzha Ar.

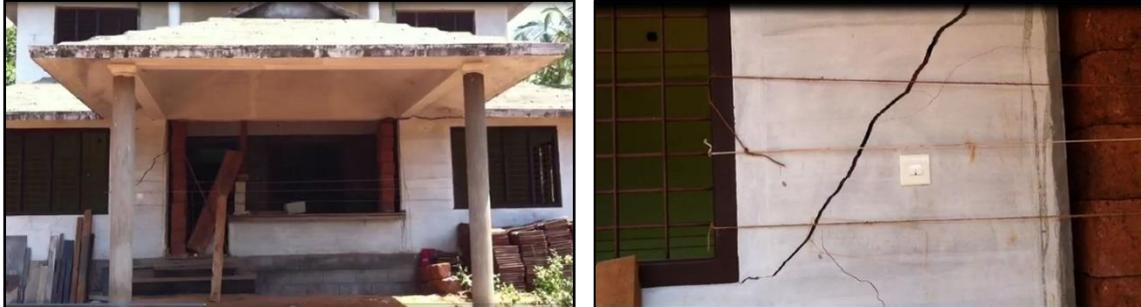
noticed on all the walls and basement. Plaster is peeled off exposing the bricks in many places. There is no definite pattern in the cracks. The floor tiles have been dislodged with formation of cavities below on account of ground subsidence. The basement appears to have subsided by few cms.

Figure 4.47: Showing the damaged house of Zainudin Paruthikunnen

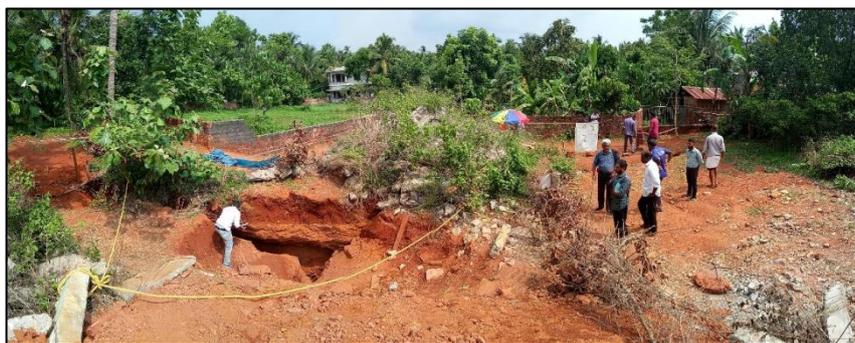
Ground cracks are more prominent on the northern and eastern part of the building. The open well with water on the northern side of the house has developed a crack all around the circular opening at about 5 m depth with an inclination to the south. There is a visible displacement seen along the cracked surface. The crack is seen in the laterite profile below the hard-vermicular layer.” At the time of this visit the house of Sri Zainudin was completely in a broken-down condition. Ground cracks have become huge. The land had subsided about 30 cm causing huge ground fissures of about 17 meters. The subsidence has taken place in an oval shape with elongation in the EW direction. The fissures have propagated to the basement of the old house there by completely destabilizing it.

Figure 4.48: Subsidence occurred at Perumanna Klari

Here the loss is total. Repair of this house or resettlement here is ruled out due to progressive subsidence of the ground.

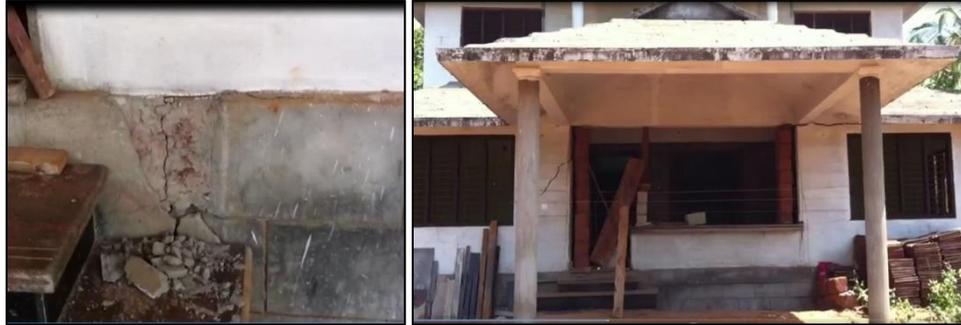
Figure 4.49: Zainuddin's house in 2013 (file photo)

Now only basement and remnants of the building are seen. Due to the ground subsidence the house and the plot cannot be put into any use and should be abandoned. The widened ground cracks are posing danger and it be barricade to prevent people from entering into the compound.

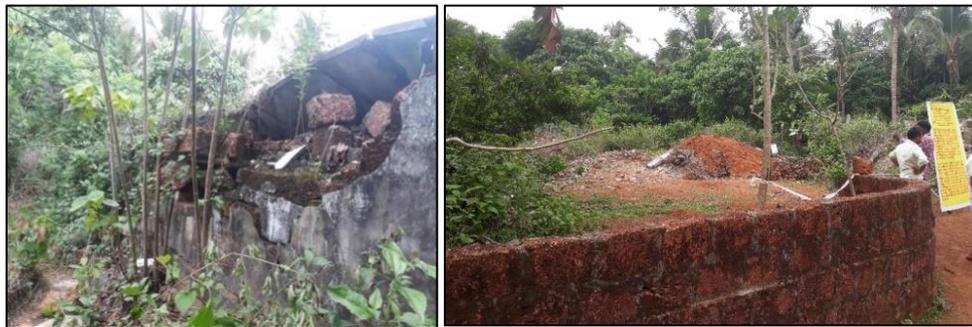
Figure 4.50: Totally damaged house of Mr. Zainuddin (2018)

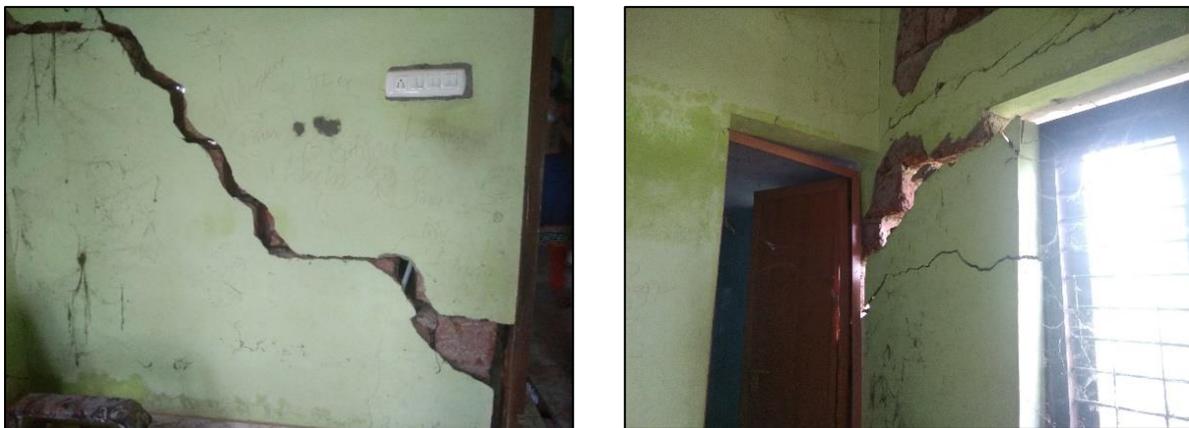
The RCC terraced house owned by Sri. Abdul Rahim, Pottachola, has been severely damaged with ground cracks extending into the basement on the South and east side. The SE corner has suffered substantial damage and developed sub-horizontal cracks below the lintel level. The floor of the house and walls are cracked in many places.

Figure 4.51: Cracks on the wall of affected house

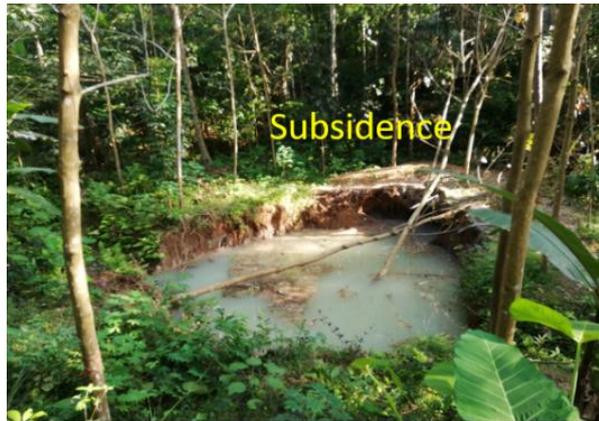
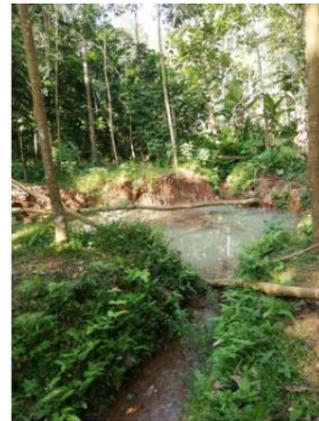
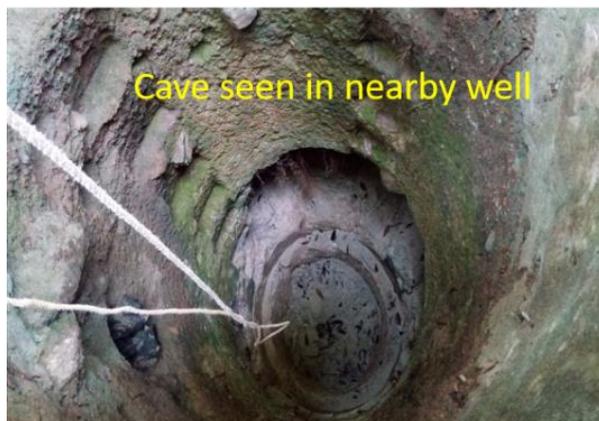
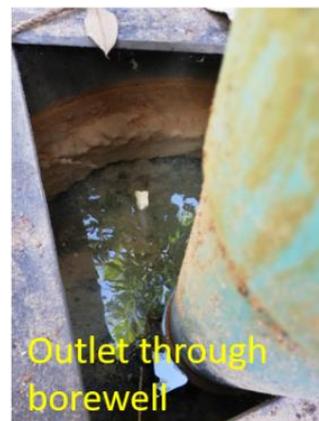
Figure 4.99: Soil pipe in Vattappara

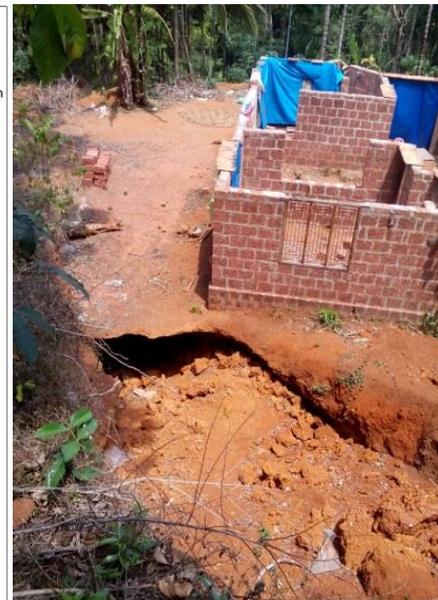
Figure 5.2: Damaged foundation in the study Area (Sankar 2015)
