# CLOSURE REPORT ON COASTAL HAZARD MONITORING

*Revenue & Kerala State Disaster Management Department*

**National Centre for Earth Science Studies**

**December 2020**

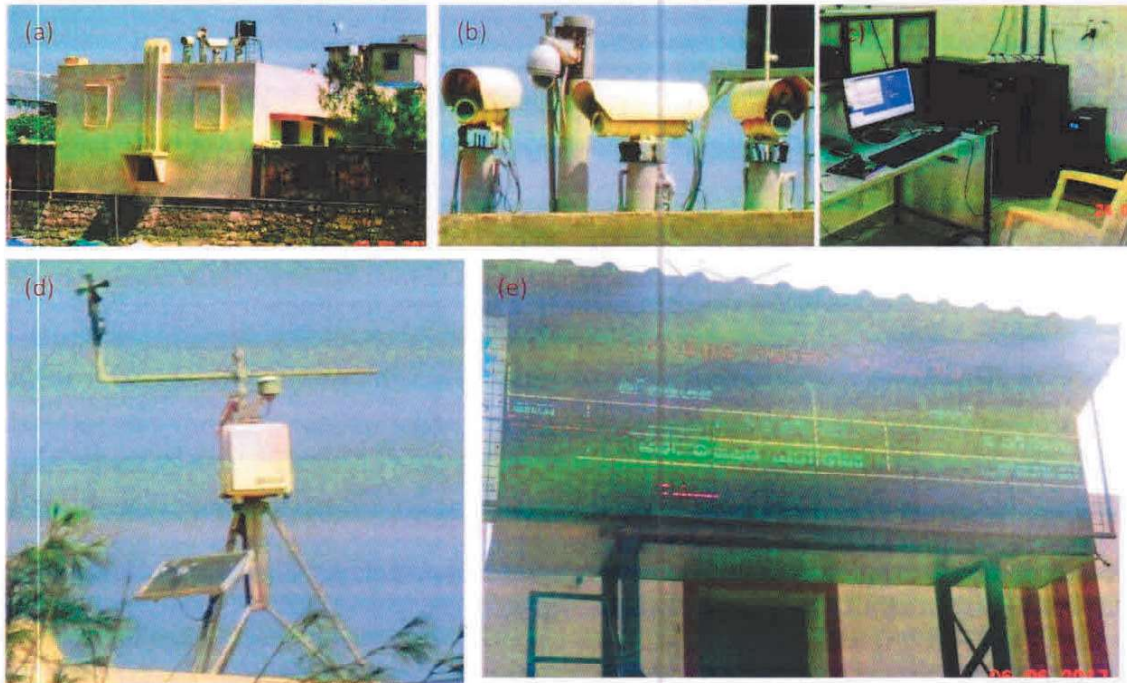
Figure2: (a) CRF Lab at Valiathura (b) Camera station (c) Storage and transfer setup (d) AWS and (e) EDB

The first camera station, which is a Video based Beach Monitoring System (VBMS) comprising of four cameras was installed on the terrace of the Coastal Research Facility Lab (CRFL) of NCESS (Figure 2 (a)) at Valiathura. The main purpose of installing the VBMS is to continuously monitor the small pocket beach flanking either side of the 220m long Valiathura pier thereby collecting primary data related to surfzone dynamics of the Valiathura coast, which forms part of the Thiruvananthapuram coast which is considered as a typical high energy coast. The VBMS was mounted on a frame at a height of 10.3 meters above the Mean Sea Level such that it covers a coastal stretch of 200 meter in the alongshore direction and about 500 meter in the cross-shore direction. It consists of four cameras, out of which three are static Weather-Proof IR Bullet cameras, with a resolution of 2 MP (1080x1920), and the fourth one is a PTZ camera with 2MP resolution, facility for 360° continuous rotation and a zoom lens(20x Zoom). The three static cameras were fixed in such a way that they were able to capture the target area of interest, i.e. one camera is directed to the region immediate south of the pier and the remaining two are aligned to capture the region towards the north of the pier with proper overlap so that the combined view gives proper coverage of the target area. Provision was also made for data storage with a server at the CRF Lab (Valiathura) and also at NCESS campus through direct data transfer by establishing VPN connectivity with the support of BSNL. Along with the Camera Station (Figure 2(b)), an Automatic Weather Station (AWS) (Figure 2 (d)) to monitor the local weather conditions and an Electronic Display Board (EDB) (Figure 2 (e)) to provide timely information on the Sea State condition to the local user community were also installed at Valiathura during September 2016. After the initial trial tests, the VBMS started full-fledged operation in October 2016 and the sea state data as well as the

local coastal weather data were made available to the coastal community through the EDB mounted on the eastern side wall of the CRF Lab.

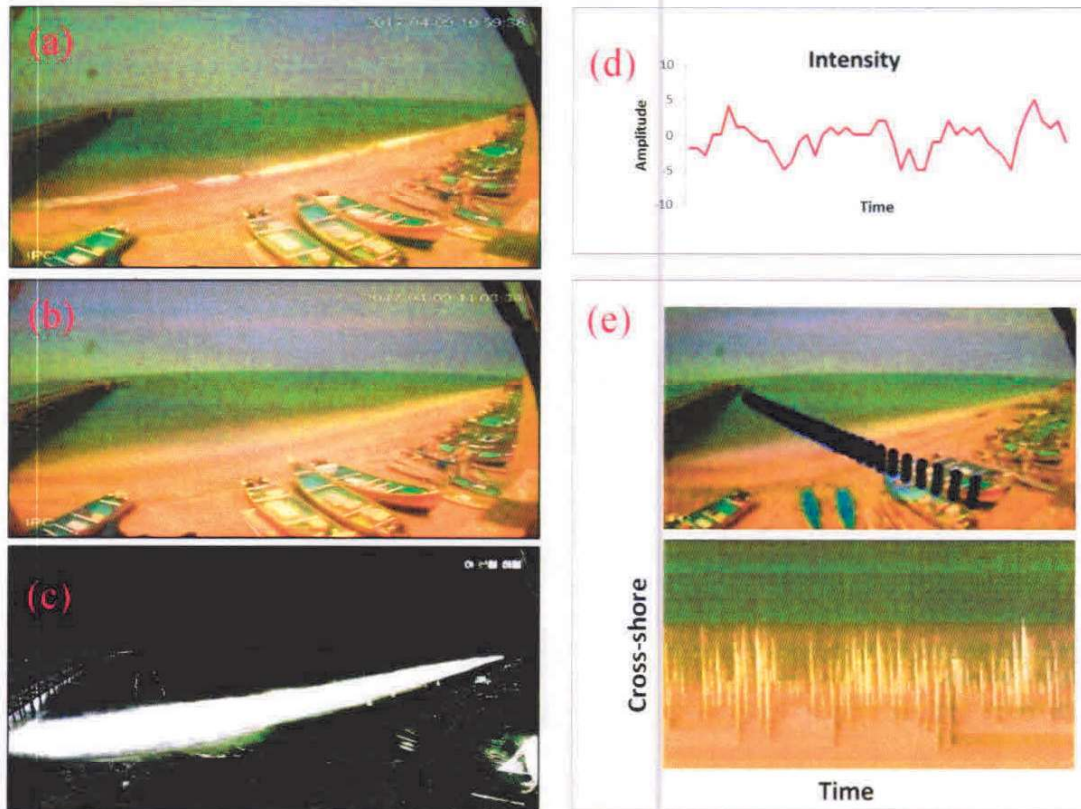
Figure3: Data products derived from the video images - (a) Snapshot (b) Timex (c) Variance (d) Single pixel timestack and (e) Cross-shore array

The VBMS became operational in October 2016. The four cameras were used to record a video of one hour duration on daily basis so as to provide site specific information to understand the short-term changes in beach morphology under varying coastal processes which is dictated mainly by the offshore wave conditions and nearshore hydrodynamics which in turn are dependent on the coastal wave, wind and tidal conditions. The recorded video, which is essentially a time series collection of images, were processed further to extract useful statistical image products like snapshot (Figure3 (a)), timex (Figure3(b)), and variance (Figure3(c)), images. Further detailed analysis of these image products provides vital information regarding daily variations in beach width, surfzone and wave runup. Also attempts were made to extract information on temporal changes in wave characteristics from the recorded video, by generating time series products of a single pixel (Figure3(d)), and cross shore array (Figure3(e)). Camera calibration and rectification of image products which form part of the image processing techniques were carried out using algorithms that were developed in-house at NCESS.

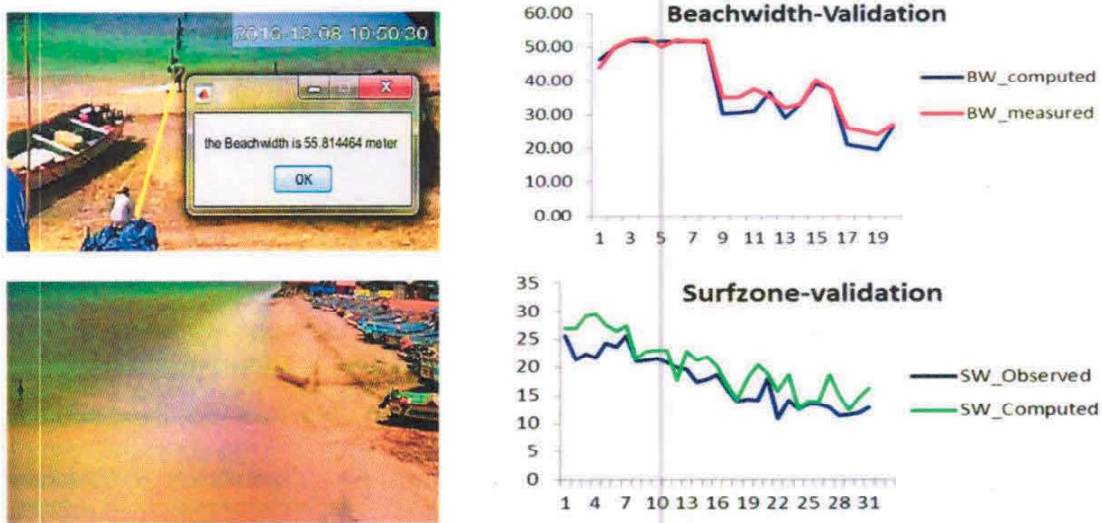
Figure 4: Beach width and surfzone width calculated from video images

Beach width measurements give first-hand information on the stability of the beach. In this project, a MATLAB based tool was developed for obtaining the beach width from recorded video images of the beach. A fixed reference point on the beach (figure 4) is used as the reference point for the estimation of the beach width, which is calculated as the perpendicular distance from the reference point to the waterline. Using the MATLAB tool, the beach widths on either side of the pier were calculated daily from the recorded video images. The computed daily beach widths have been successfully validated by comparing with the measured values as shown in Figure 4 and they give a reasonably good comparison (correlation of 0.93).

carried out. As part of this study, timex images are used to compute the surfzone widths and the results are validated by comparing with the visual observations as well as physical measurements (made using the scale markings to facilitate easy measurements) (Figure 4).

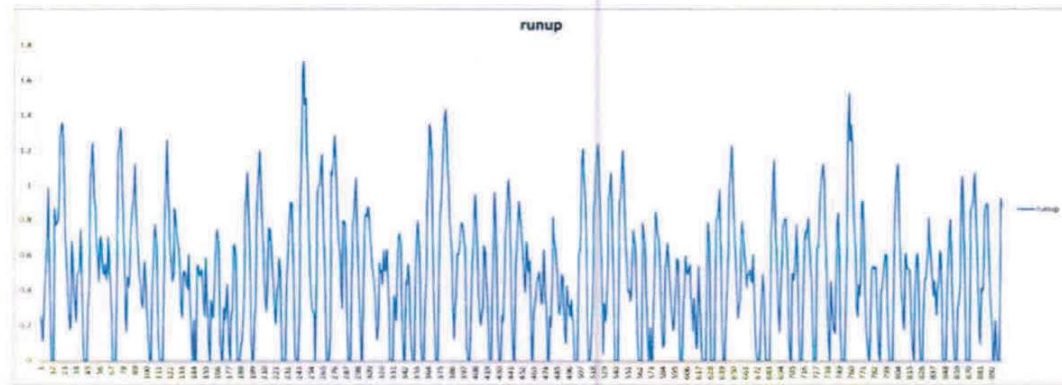
Figure 5: Time series of wave runup

As mentioned before the runup is computed from the swash width, which in turn is derived from the recorded video data and the field measured beach slope. A total of 900 individual run up events were obtained from the 15-minute video recording covering the northern stretch of the Valiathura beach. The computed wave runup during the recording period is presented in Figure 5. The measured wave runup varied between 0 and 1.8 m during this period. Reasonably good correlation is observed between the video derived results and the field measurements.

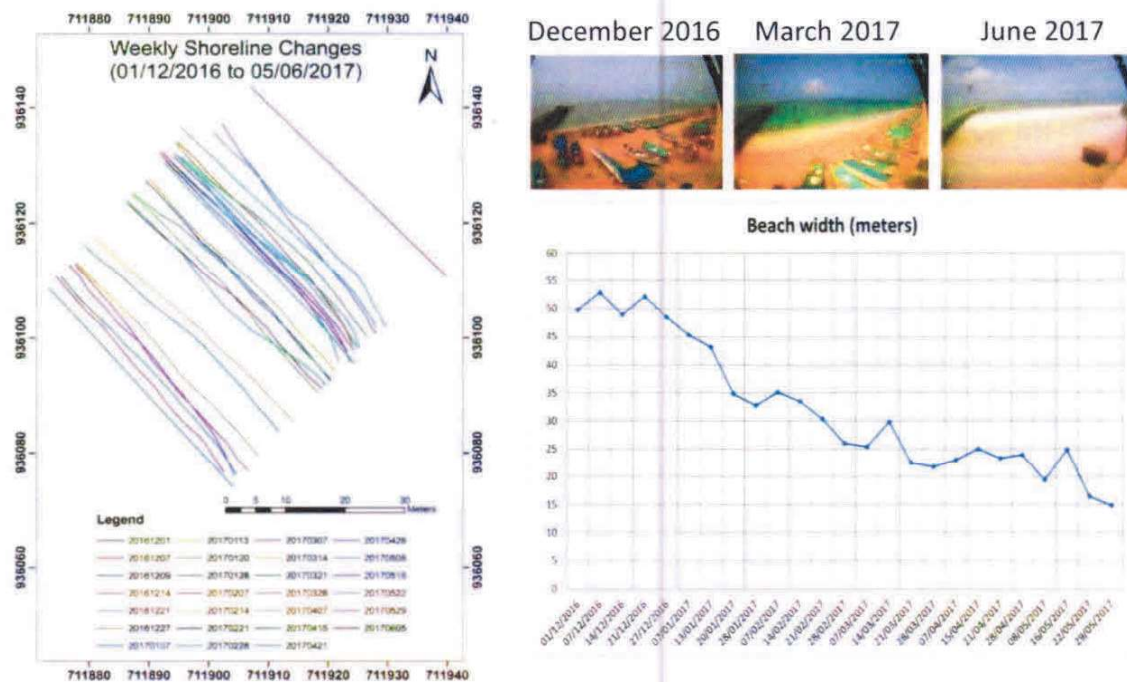
Figure 6: Computed short-term shoreline changes at Valiathura

Daily shorelines were extracted from rectified plan view images and further analyses were carried out using ArcGIS tools to study the short-term shoreline changes. According to the results of the study (Figure:6), about 50m reduction in beach width was observed during the period from December 2016 to June 2017.

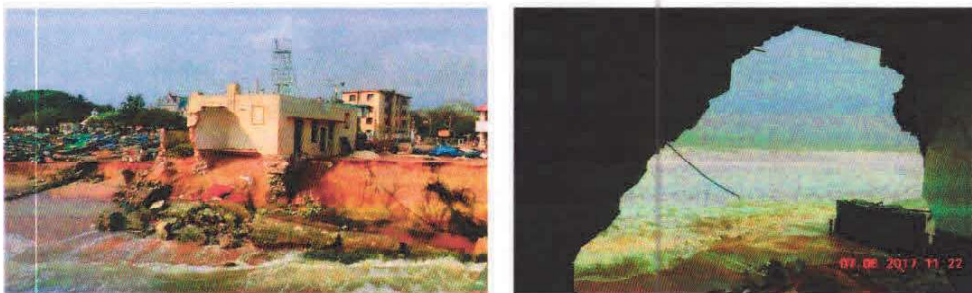
Figure 7: View of the partially collapsed building of the NCESS Coastal Lab. Facility at Valiyathura (June 2017)

The unusually high wave activity and subsequent erosion during the month of May 2017 and also early June, led to the partial collapse of the Coastal Research Lab. building at Valiathura (the sea facing room collapsed with sea water gushing into the building) on 7<sup>th</sup> June morning. Following this, NCESS was forced to suspend all the field activities at Valiathura (Figure 7). Even though NCESS attempted to reinstall the system and resumed the field data collection once again during March 2018 (Figure 8), it did not last long as the building was further damaged due to high wave activity later in the same month (Figure 9) and also during the subsequent monsoon season of 2018. The building which was in a dilapidated condition since September 2018 eventually collapsed in April 2019 (Figures 10 & 11) forcing NCESS to permanently stop all the field data collection activities related to this project.

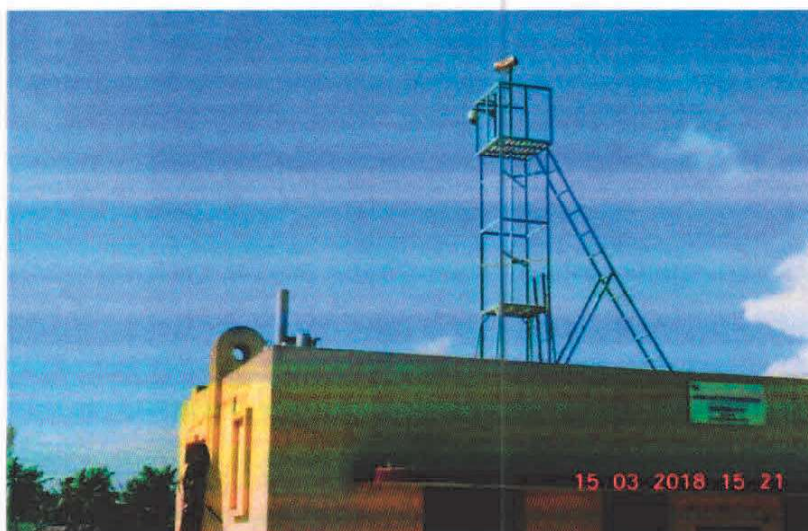
Figure 8: Attempt to reinstall the camera system by shifting the mounting frame to the middle portion of the terrace area

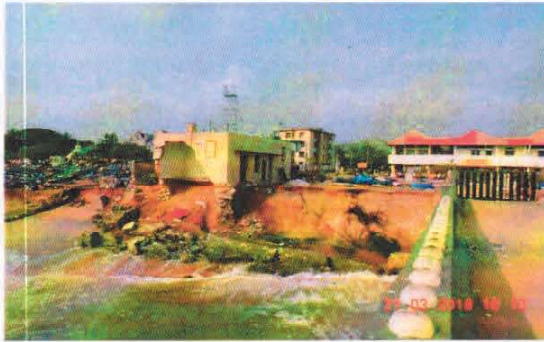
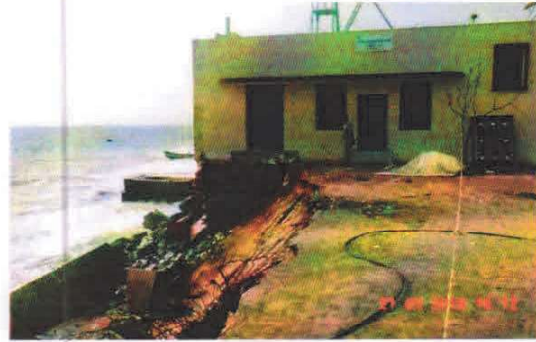
Figure 9: Increased coastal erosion at Valiathura in March 2018 due to high wave activity

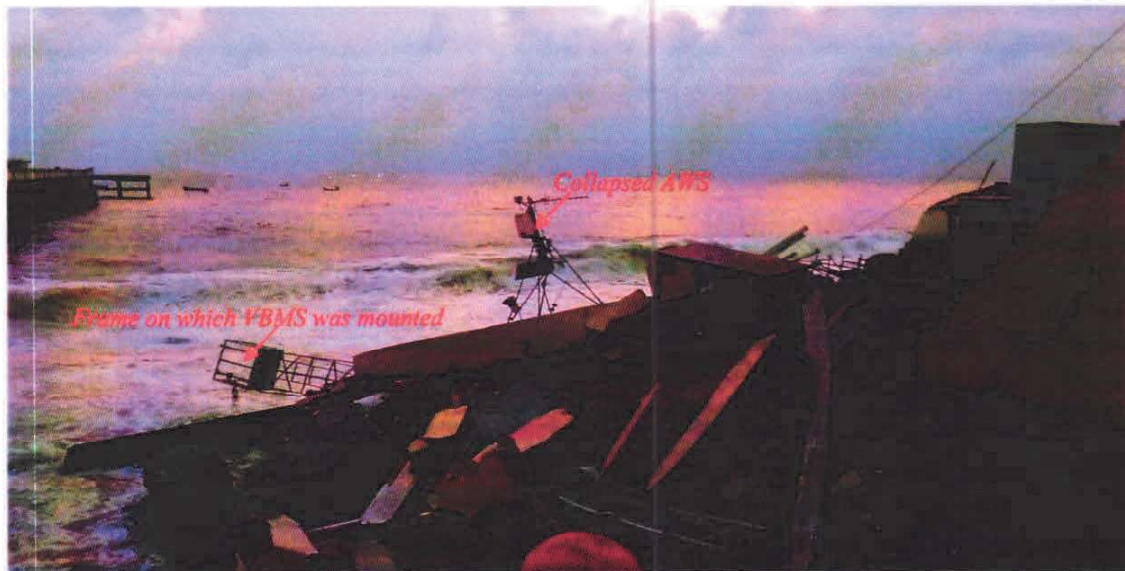
Figure 10: Photograph showing the ruins of the NCESS CRF building at Valiathura after it was razed to ground due to erosion on 24<sup>th</sup> April 2019

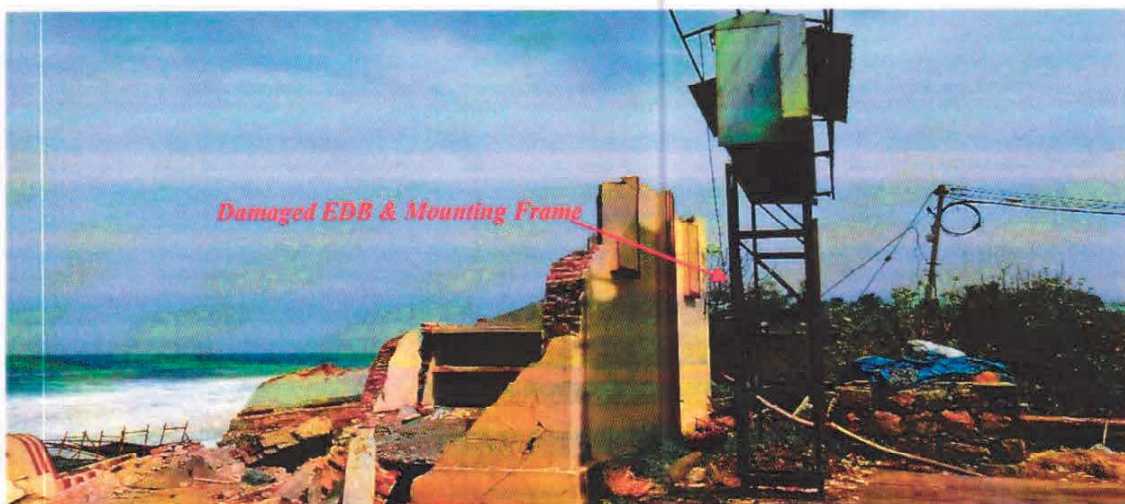
Figure 11: Photograph showing the damaged frame of the EDB after the building collapsed on 24<sup>th</sup> April 2019
