**Report on Piping Phenomenon in front of the house of Mr. V.K
Balan, S/O Kottan (L), Nellyadukkam, Kollampara,
Neeleswaram, Kasargode**

Ref: Government Ltr. No. 68141/K2/2014/DMD dated 16-06-2016

Investigation Series 2016
22-08-2016

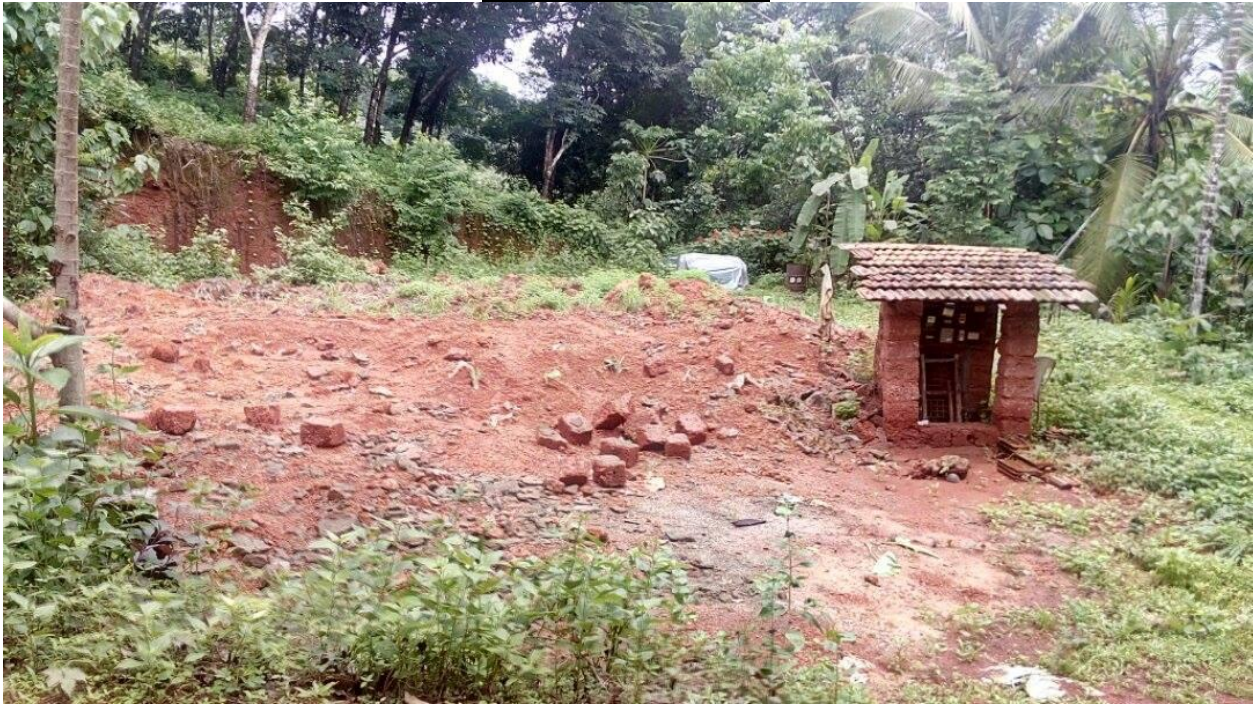
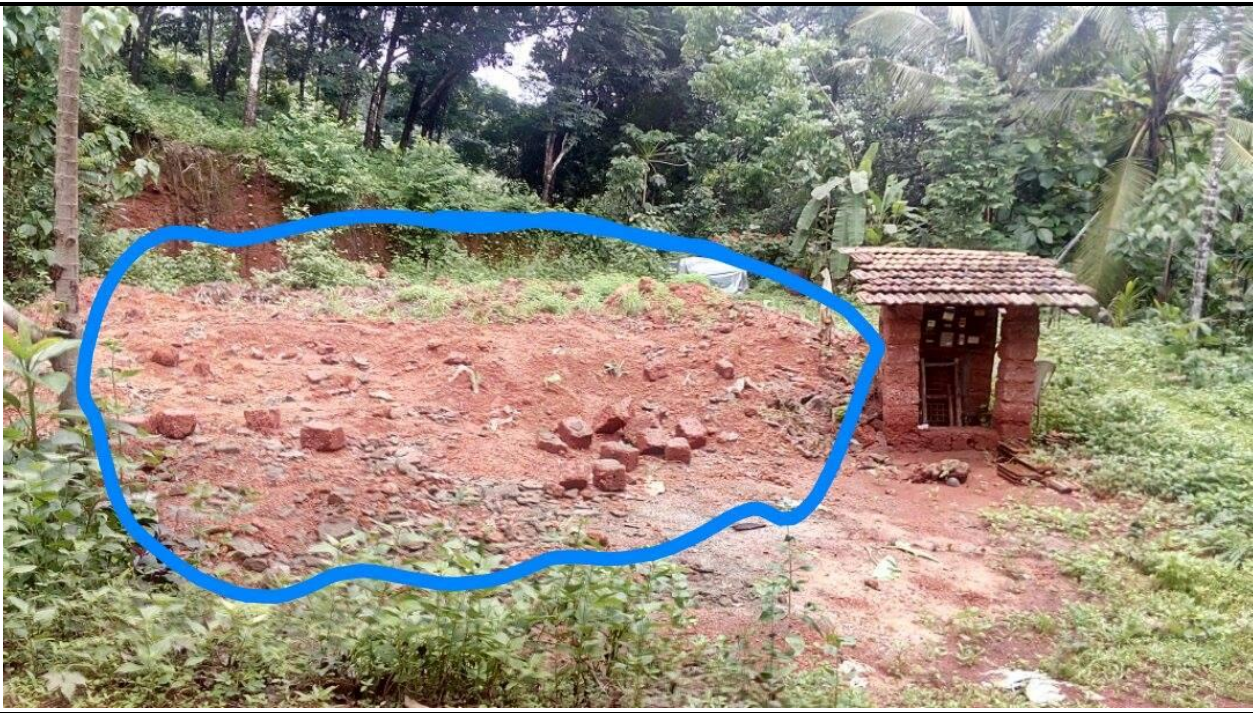
Underground caves are seen, formed at 3 locations causing serious threat to the area highlighting the presence of soil pipes. The underground caves are bedded with a thin layer of granite. The caves which had formed underground are about 5 to 6 meter wide in the same direction and are interconnected.

Underground Caves

Based on the site visit and the facts ascertained, it is concluded that the land is not stable structurally and geologically. Thus the land is not safe and suitable for further building or construction purpose. Illustrations and photographs of site inspection are included herewith.

1. Government may consider allotting Mr. V.K Balan, S/O Kottan (L), Nellyadukkam, Kollampara, Neeleswaram, Kasargode the maximum relief assistance payable under SDRF & CMDRF (₹2,00,000/-) for house damage due to landslip (landslide). Subsequently, the matter may be placed before the State Executive Committee of KSDMA for ratification in accordance with GO (Rt) No. 2167/2016/DMD dated 19-03-2016.
