Rapid visual screening of the precarious boulder at Parakovil, Thirumala, Thiruvananthapuram
Ref: Ltr. No. 6087/K1/2013/DMD dated 08-11-2013

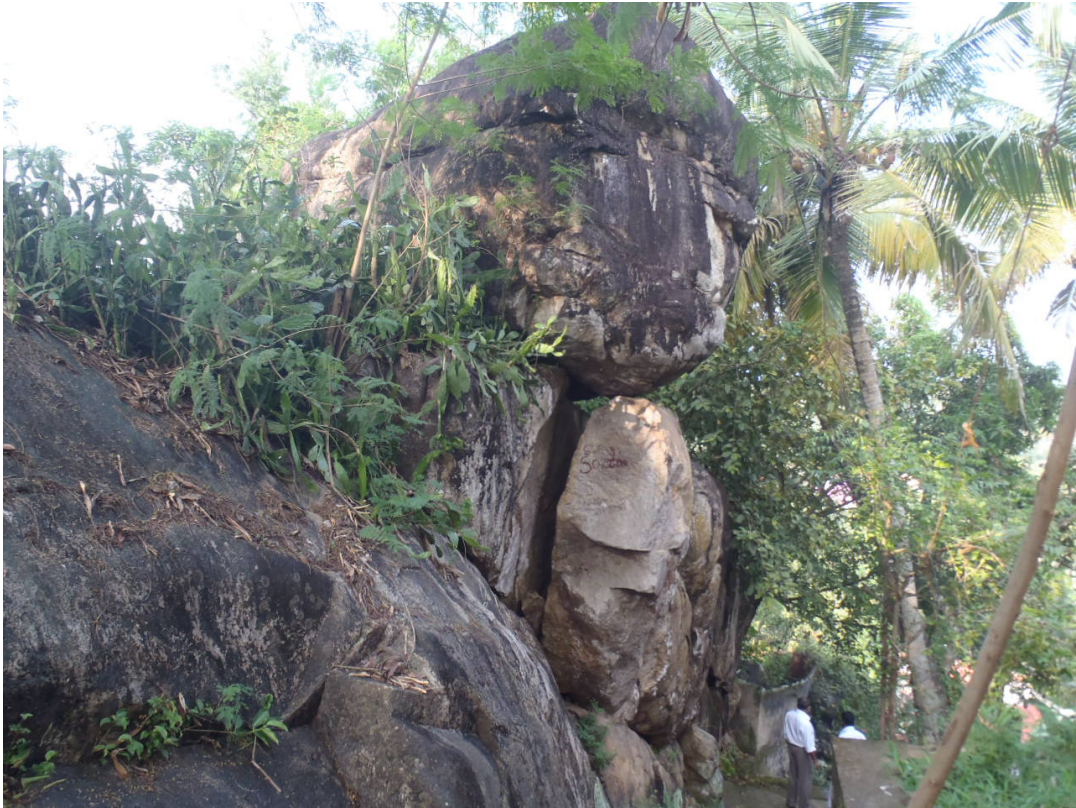
The said rock is an inselberg, with multiple fractures, running multidirectional in orientation. On the top of the hillock, boulders of huge dimension which attached to each other were observed. The natives of the area described that the gap between the supporting rocks and over sitting rocks were enlarged and shown slight change in position of the boulders present. While inspecting it is noted that, all the hanging rocks and supporting rocks shows an inclination towards the sloping side and considered to be dangerous in nature. It is advised that proper management of these overhanging, fractured, inclined rocks should be needed to avoid any dangerous situations. The close examination of the fracture pattern present in the area, particularly in the rock, suggests safe removal of the material by an expert group. The area is highly populated and any down movement of these huge boulders cause severe damages to life and property.

The precariously posed boulder

1. The precarious boulders on 'Parakovil' have to be removed. Note that it is not just one boulder that would be dislodged if a rockfall is triggered. The Parakovil area has numerous such rocks and many of them are prone to be dislodged. All these rocks may be removed at one go as the cost involved would also be lesser in doing so and the Government may benefit from auctioning the removed rocks.

2. We concur to the view of the District Collector that the removal of these rock boulders can only be done by the Engineers of Indian Army or professional private agencies who have the skills and facilities for controlled blasting or chemical breaking of such rocks

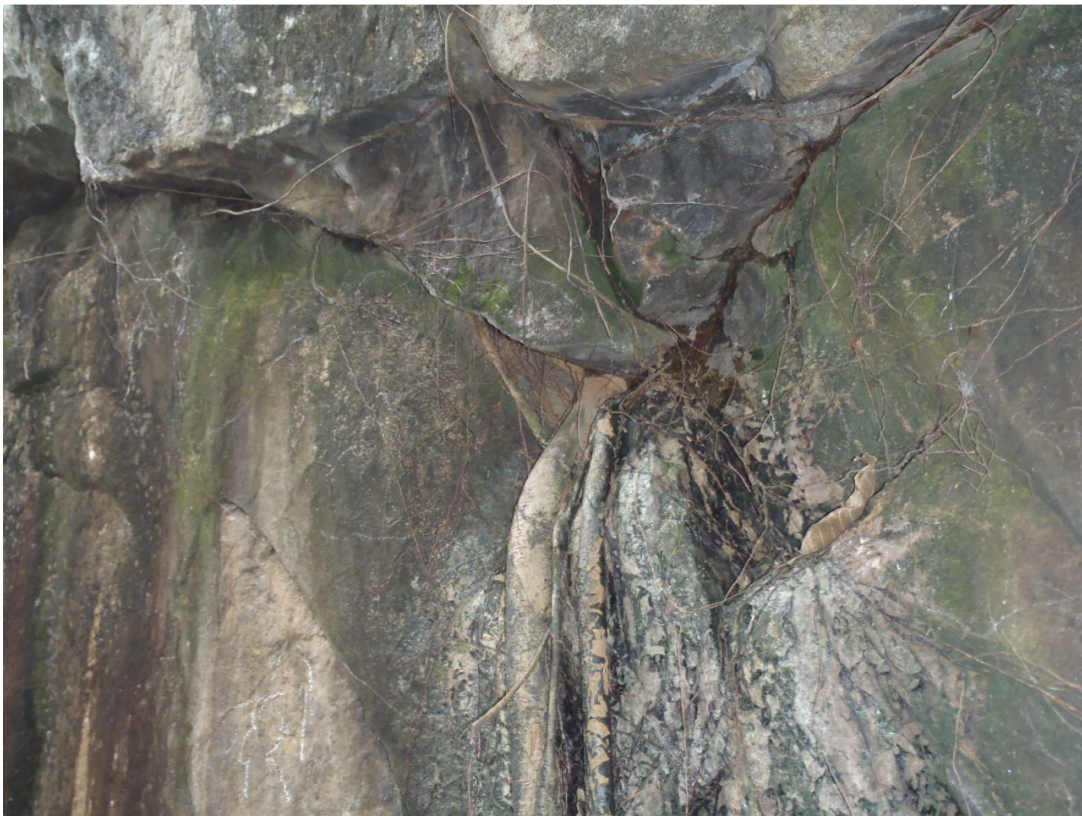
The highly fractured joints probably with no anchor
