FIRE MOCK DRILL

REPORT

Main Block, Government Secretariat | 8th March 2018

Kerala State Disaster Management Authority General Administration Department & Kerala Fire and Rescue Services

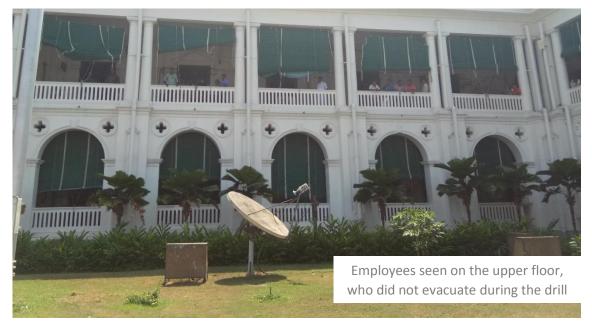
- 5% of employees did not cooperate with the drill. Many were found to be inside the building while their colleagues were evacuating. Refer the following photograph.
