**AUGMENTING GROUNDWATER RECHARGE THROUGH
RENOVATION OF PONDS - A MODEL STUDY IN
VADAKARAPATHI PANCHAYAT, PALAKKAD DISTRICT**

**Sponsored by State Disaster Management Authority,
Govt. of Kerala**

**ESSO- National Centre for Earth Science Studies
Ministry of Earth Sciences, Govt. of India
Akkulam, Thiruvananthapuram- 695011
January 2019**

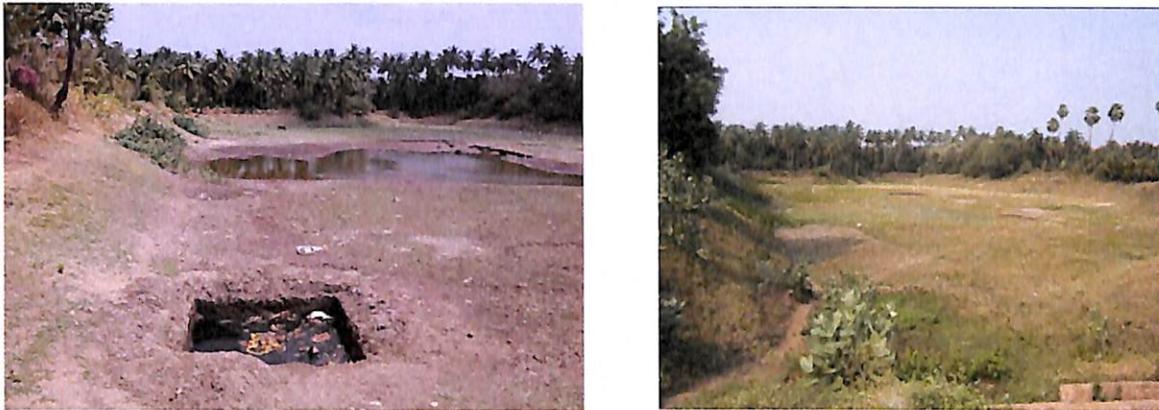
Figure 9: Photographs of the pond in two seasons. The photograph on the left is taken in February, 2015 when the pond had little water in the deeper part of the floor. On the right is the photograph taken during December, 2016 when the pond bed is exposed with some grass cover.

The photographs given in figure 9 indicate the site condition of Mariamman pond when it was nearly dry in March 2015 and December 2016. The year 2014 was a normal rainfall year with the pond reaching to its full capacity. In spite of the normal rain it is seen that the pond had dried up in March 2015. The monsoon of 2015 and 2016 was poor that made the pond dry in the month of December itself. It is clear that even though the pond collects water to its full level during rainy season, bulk of it seeps out and is rendered dry.

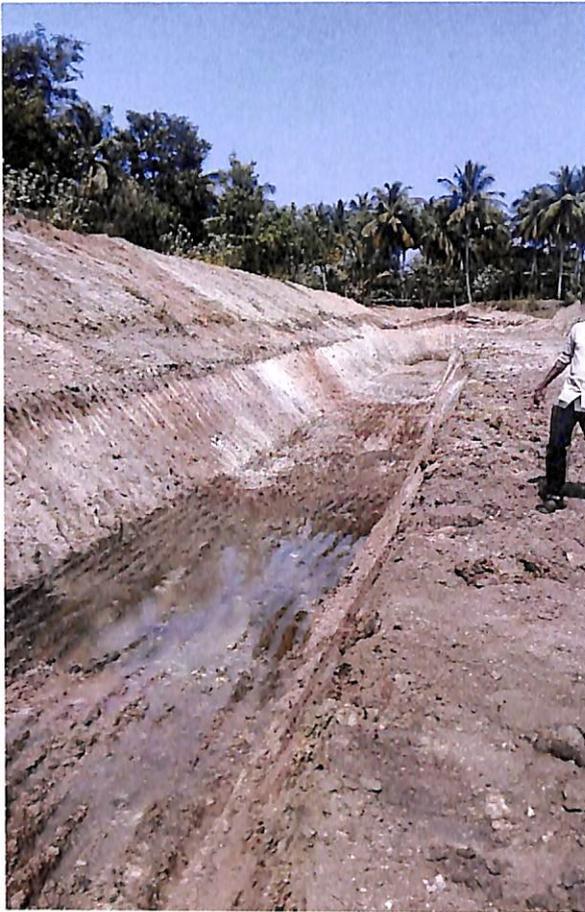
Figure: 15

Photograph showing the initial excavation for the trench. Far end is the northern end while the closer edge is the southern part. To start with, the bund is trimmed to free it from all vegetation including the roots. A smooth surface is made carefully with the existing slope. The base of the bund is cut with steep angle such that the sides are maintained without slope failure. At a depth of about 4 m from the pond floor water table is met. The excavated material is mostly overburden that is the product of complete weathering.

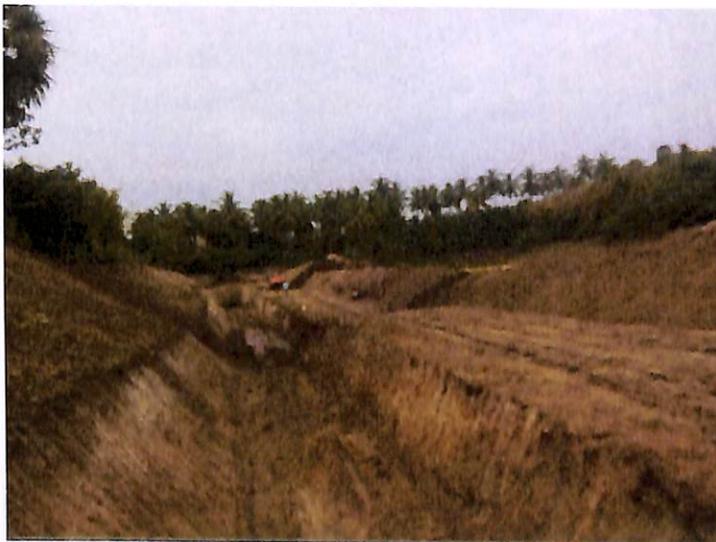
Figure: 16

Another view of the trench excavation in progress prior to the intersection with water table.

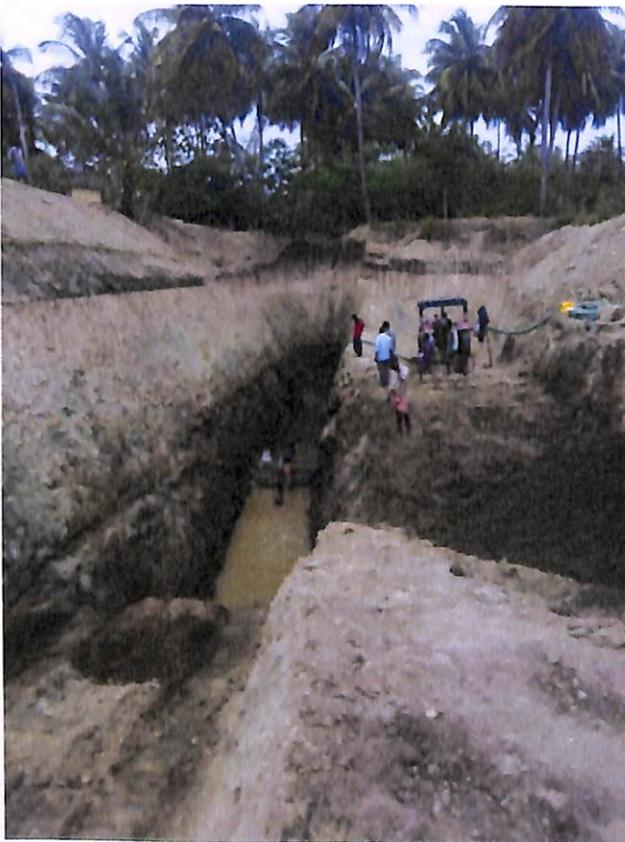
Figure: 17b. Further progress of excavation in the northern part. The depth of excavation has reached about 7 m from the original floor level of the pond. The dark layer in the bottom part of the trench shows weathered rock. Water is being pumped out of the trench using a tractor mounted heavy duty pump.

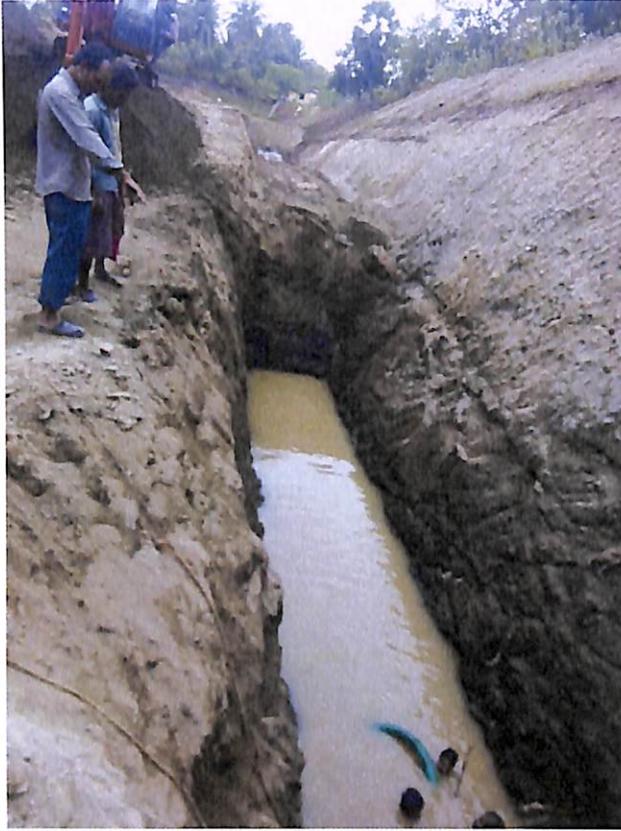
Figure: 18
View of the trench looking south from the northern edge. Partly weathered rock is exposed in the trench. Fractures are visible. The presence of a hard rock barrier in the centre of the trench has limited the progress of excavation. Workers are in action to ensure that continuous dewatering is carried out and the water level does not rise.

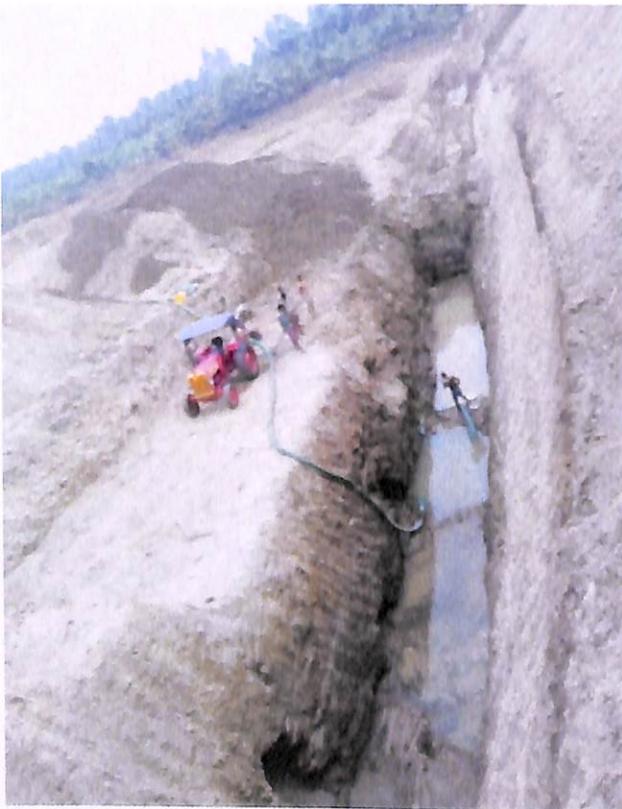
Figure: 19
Photograph showing a long view of the trench excavation that is in progress. Note the slumping of the cutting on the valley floor (lower bottom) due to heavy seepage of water. Water is being bailed out on a continuous basis. The hard rock in the centre is adding to the undulations in the trench.

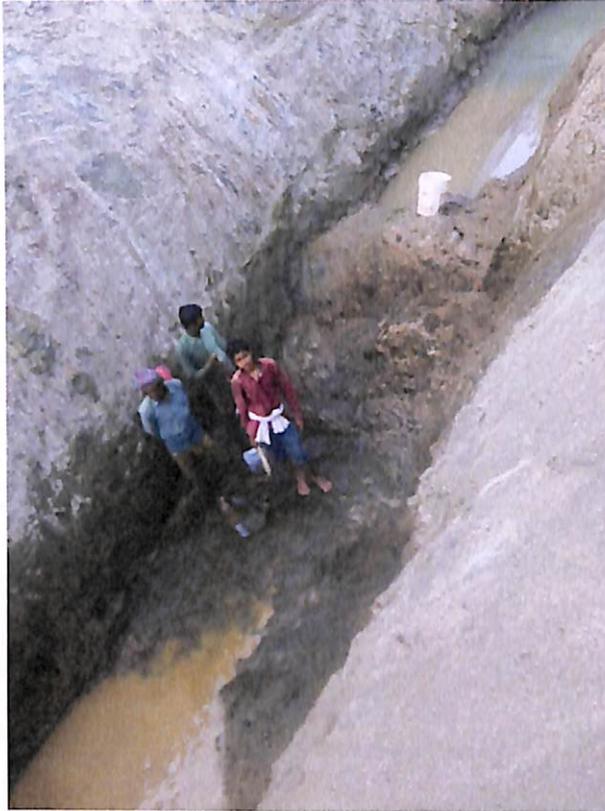
Figure: 20

The trench being manually cleaned such that all debris and mud are removed. The fresh rock- migmatite- is exposed in the trench.

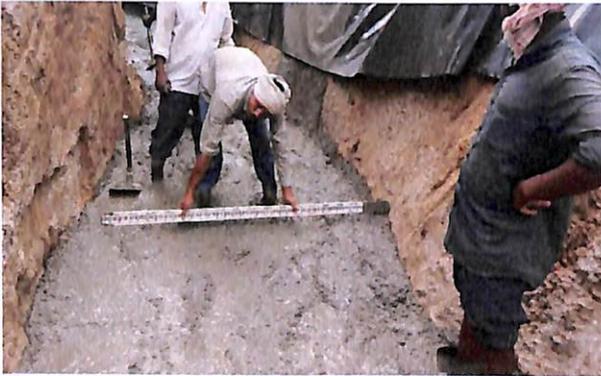
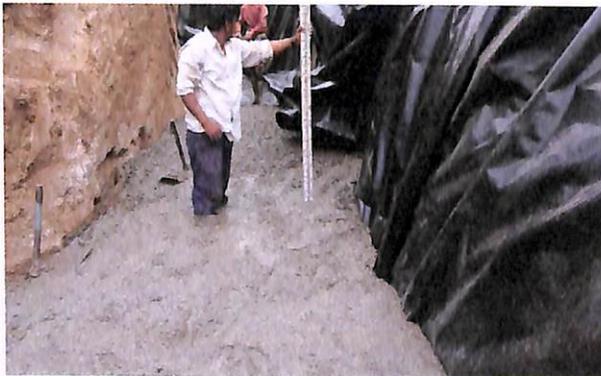
Figure: 21 a & b

- a) The irregular surface of trench is being levelled with plain cement concrete (PCC) to give a smooth surface before anchoring the LDPE sheet. The thickness of the PCC layer can vary from place to place but the average thickness provided is 20 cm.
- b) The LDPE sheet is anchored into the PCC by providing another 20 cm thick covering. This layer acts as an impervious barrier at the bottom. The width and thickness of the PCC layer is indicated with the graduated levelling staff.

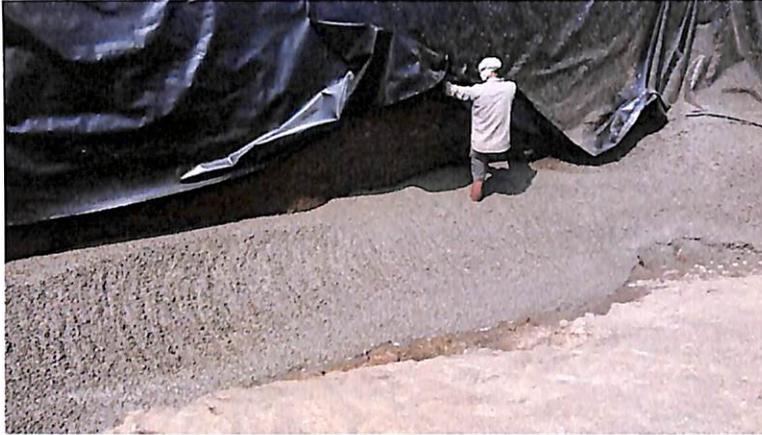
Figure: 22

The LDPE sheet is being lowered into the trench before its anchoring into the PCC layer.

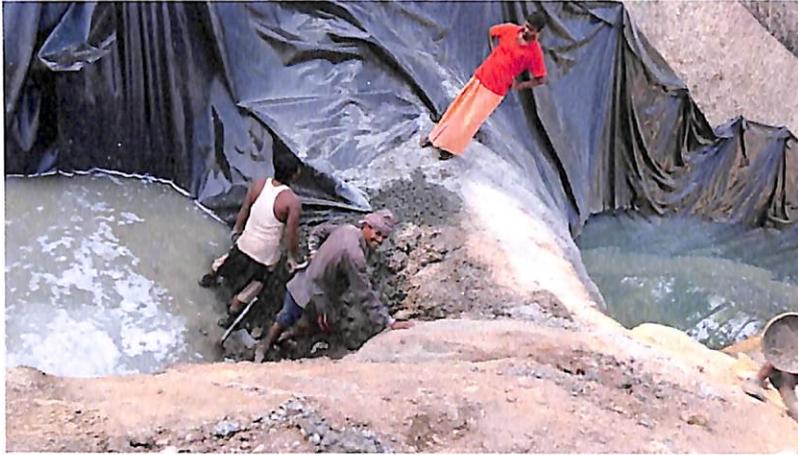
Figure: 24
Embedding the LDPE sheet in the sector where the rock is exposed as a barrier in the trench.

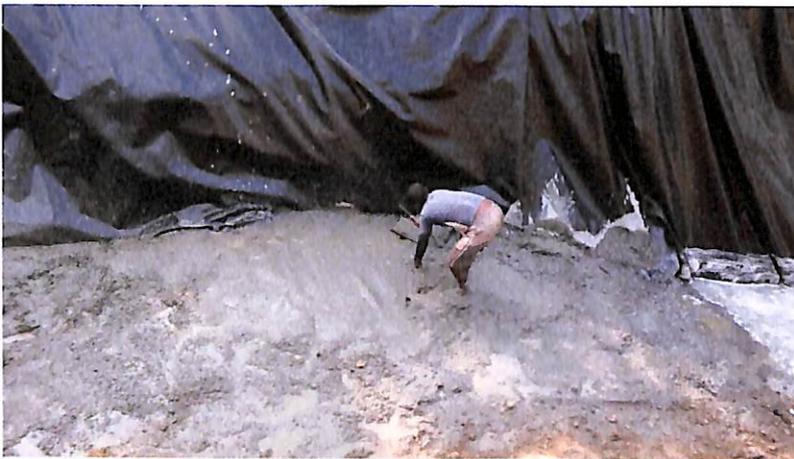
Figure: 25
Completing the work of laying LDPE sheet in the trench with a PCC layer over it.

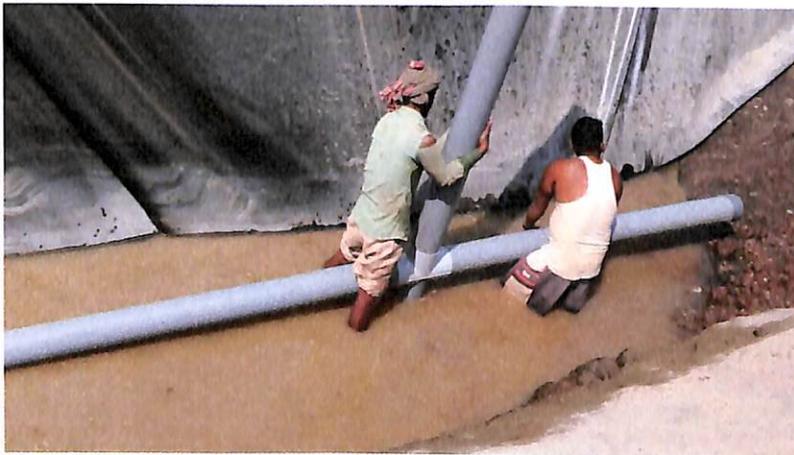
Figure: 26
In order to measure the water level in the pond above the trench bottom, a piezometer has to be installed. For this purpose perforated PVC pipe is inserted. The photograph shows inserting a 110 mm dia interconnected PVC pipes to act as a piezometer for recording the water

level. The bottom horizontal pipe is perforated all through to permit entry of groundwater into it. End cap is provided to prevent entry of mud into the pipe. The water level in the vertical pipe is recorded.

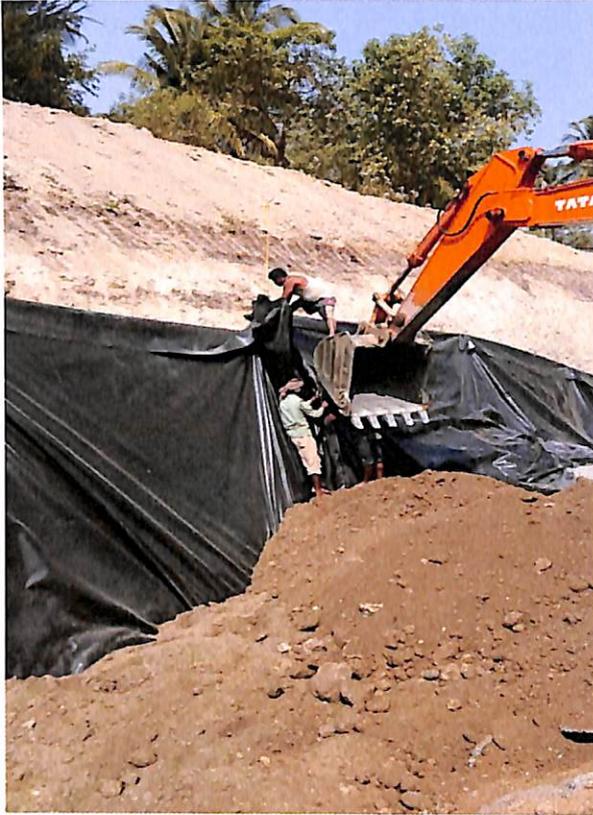
Figure: 27

The entire trench length up to the road level is covered with LDPE sheet. This acts as the impervious layer arresting any seepage through the bund. It also strengthens and adds stability to the bund. After laying the sheet, the trench is filled with loose excavated earth. Care is taken to ensure angular fractions of large dimensions like boulders are not coming in direct contact with the sheet. Dropping them from a height can damage the sheet. So the process of refilling is done slowly and with care.

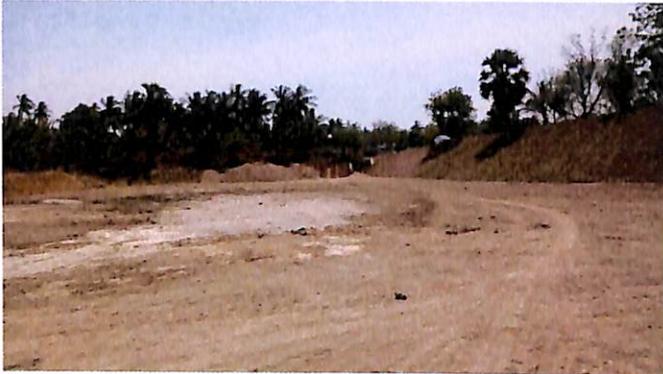
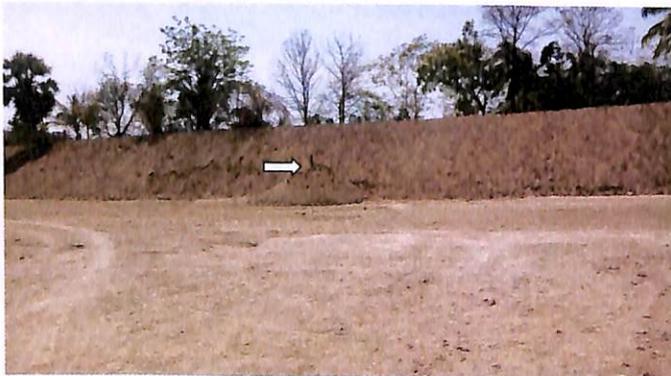
Figure: 28 a and b

a) The trench is filled up and the LDPE sheet covered with excavated earth. The slope of the bund is maintained at about 1 in 2 to prevent slumping. Additionally the freshly covered face of the bund will be provided with a grass cover.

b) Another view of the completed bund without grass cover. Note the small mound in the foreground with a PVC pipe in the centre. This is to record the ground water level in the pond. Total height of the pipe is 7.6 m.

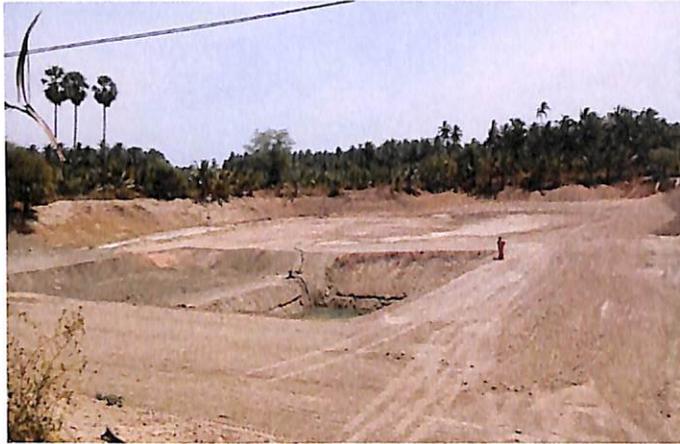
Figure: 29 a and b

b) Further, the new excavation was extended on one side having a dimension of 15 m x 10 m x 4 m. In this pond, water was seen at a depth of 2 m at the time of excavation. This became a source of water for the local population during the summer of 2017. This additionally excavated structure enhances the percolation rate into the surrounding aquifer ensuring the recharge component.

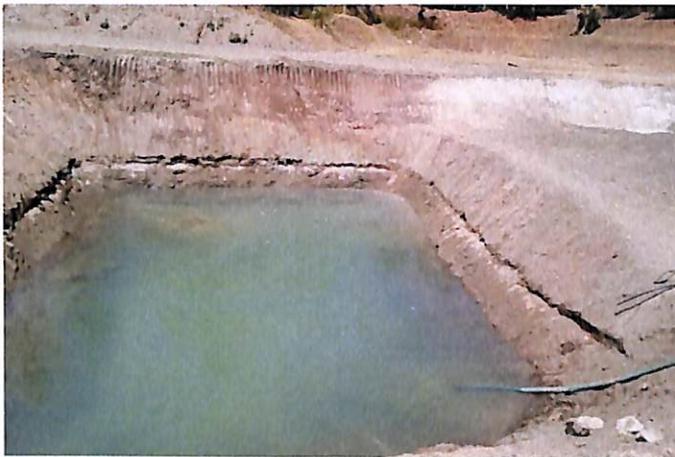
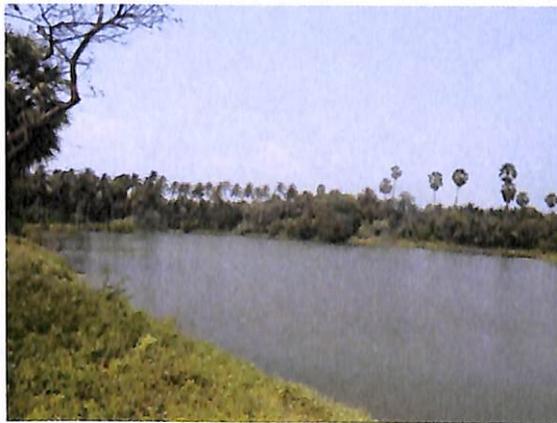
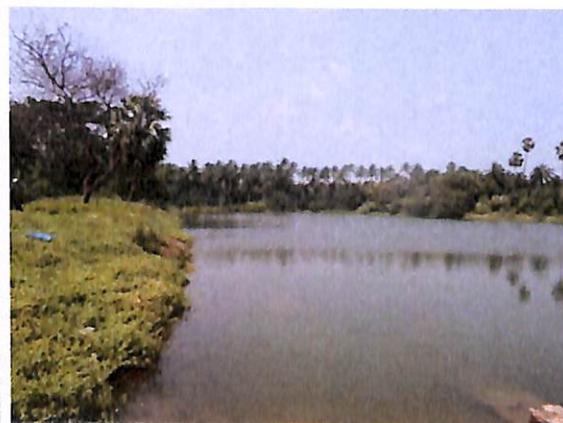
Figure 30 a & b

View of the Pond with water up to the overflow level marked by the masonry step visible in water over which a flat stone is placed for washing clothes. The elevated grass covered part is the bund in which LDPE sheet has been embedded.

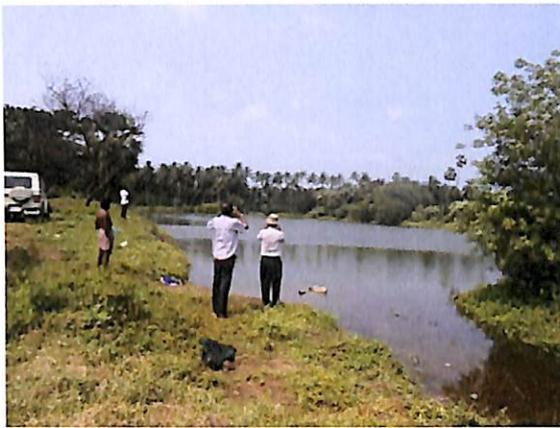
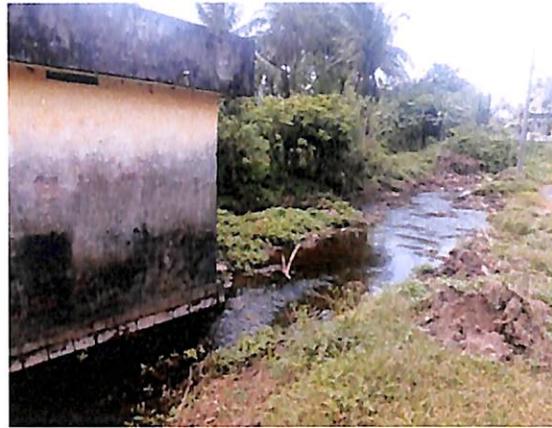
Figure 31 a & b

View of the pond with the bund and overflow section. Over flow water is channelized by the side of the pump house and led to the southern part to be released into the valley. The over flow which was initiated on 23.07.2018 after heavy rains continued till the first week of November 2018.

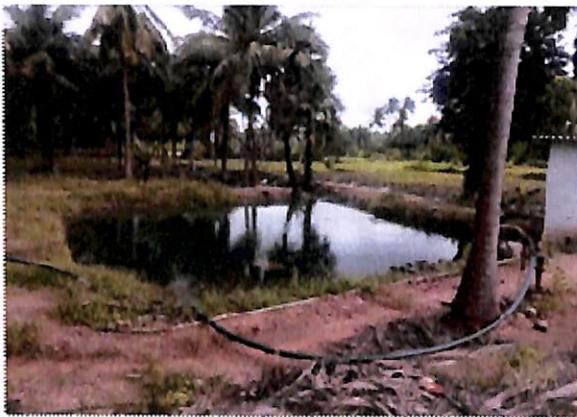
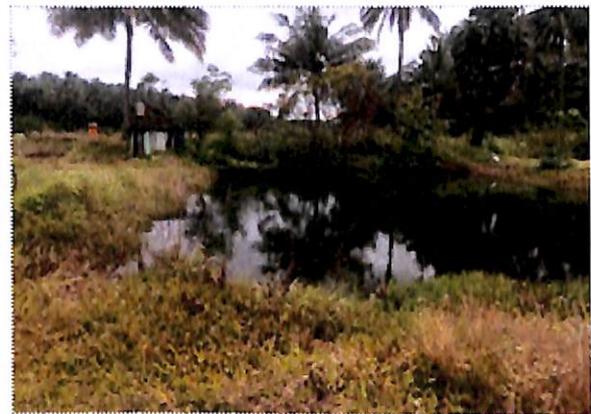
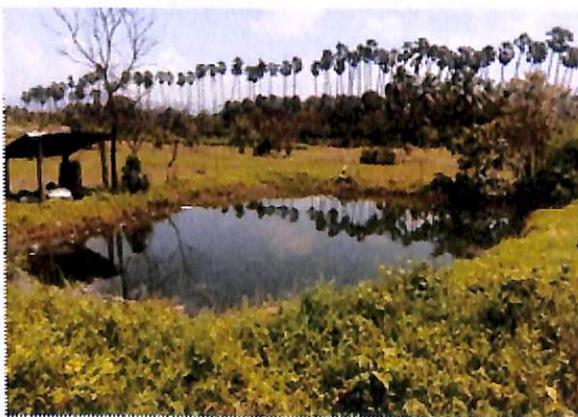
Figure 32 a, b & c

Photographs of selected open irrigation wells where water level has come nearly up to the surface. Well -a is 13m, well-b is 15.7 m and well-c is 9m

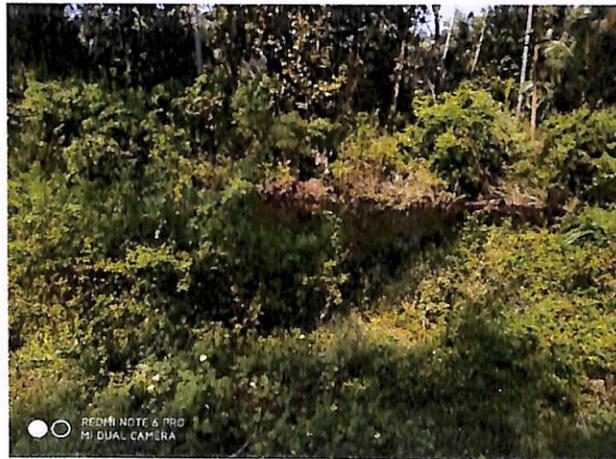
Well No: 02

Location: Lat 10⁰ 48' 01.24" N; Long 76⁰ 53' 30.69" E
 Landform: valley well bottom exposes hard rock
 Elevation: 214 m amsl
 Ownership: Private- Ramesan
 Total depth. 9.2 m bgl

Date	Depth to Water table	Date	Depth to Water table
8.12.2016	6.8	16.03.2018	7.1
02.03.2017	6.6	07.06.2018	6.5
25.08.2017	6.5	07.07.2018	2.8
27.09.2017	6.0	30.08.2018	0.1
06.11.2017	6.3	27.12.2018	0.9

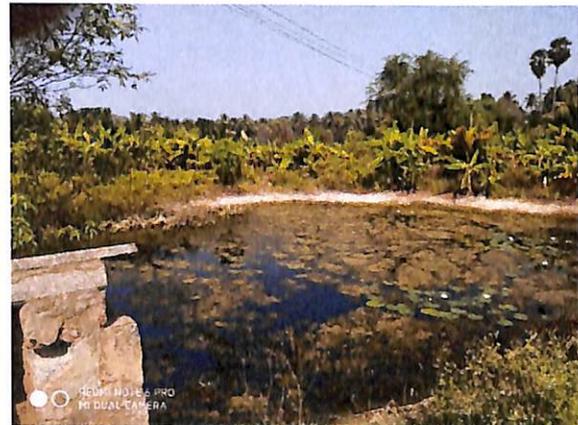
Well No 3

Location: Lat 10⁰ 47' 55.25" N; Long 76⁰ 53' 36.68" E
 Elevation: 219 m amsl
 Landform: Lower terrace
 Ownership: Private- Ramesan
 Total depth: 9.5 m bgl

Date	Depth to Water table	Date	Depth to Water table
8.12.2016	8.1	16.03.2018	9.0
02.03.2017	8.0	07.06.2018	8.1
25.08.2017	7.1 (well being filled from a bore well)	07.07.2018	6.2
27.09.2017	7.0	30.08.2018	0.2
06.11.2017	8.2	27.12.2018	3.4

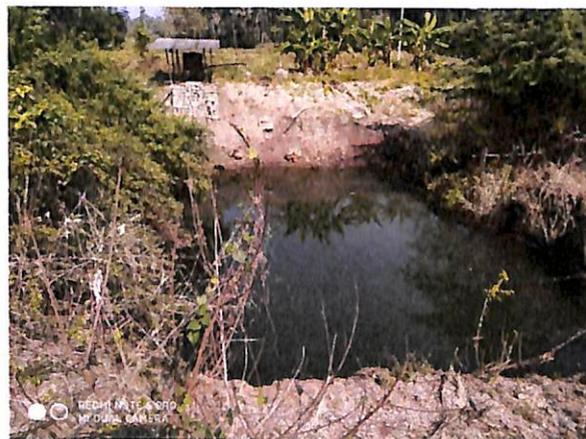
Well No 4

Location: Lat 10⁰ 48' 04.94" N; Long 76⁰ 53' 25.06" E
 Elevation: 211 m amsl
 Landform: valley side
 Ownership: Private- Divakaran
 Total depth: 6.0 m bgl

Date	Depth to Water table	Date	Depth to Water table
8.12.2016	4.4	16.03.2018	5.9 (deepened)
02.03.2017	5.5	07.06.2018	4.6
25.08.2017	5.6	06.07.2018	2.0
27.09.2017	4.4	30.08.2018	0.1
06.11.2017	4.2	27.12.2018	0.5

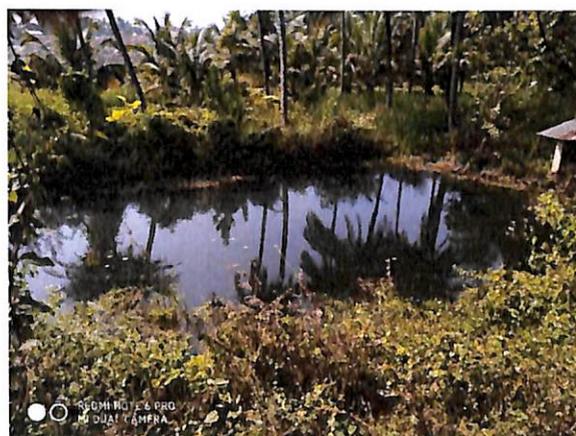
Well No 5

Location: Lat 10⁰ 48' 07.56" N; Long 76⁰ 53' 11.56" E
 Elevation: 209 m amsl
 Landform: Lower terrace-valley
 Ownership: Private- Swamiappan
 Total depth: 10.6 m bgl

Date	Depth to Water table	Date	Depth to Water table
8.12.2016	8.7	16.03.2018	10.2
02.03.2017	9.2	07.06.2018	8.8
25.08.2017	9.6	06.07.2018	7.6
27.09.2017	8.3	30.08.2018	0.2
06.11.2017	9.3	27.12.2018	0.7

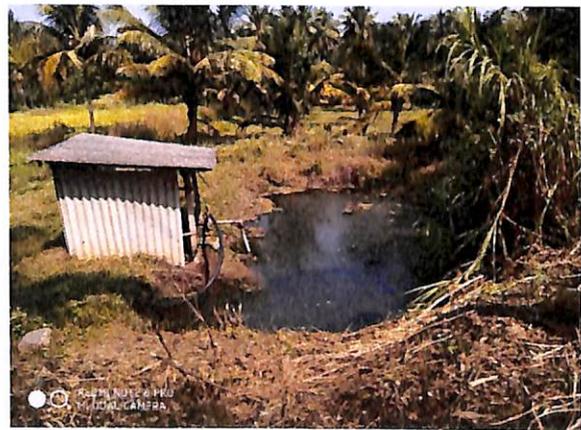
Well No 6

Location: Lat 10⁰ 48' 05.32" N; Long 76⁰ 53' 05.26" E
 Elevation: 207 m amsl
 Landform: terrace edge - valley
 Ownership: Private-Kuppuswamy
 Total depth: 11.2 m bgl

Date	Depth to Water table	Date	Depth to Water table
02.03.2017	7.9	07.06.2018	8.2
25.08.2017	8.2	06.07.2018	5.1
27.09.2017	7.8	30.08.2018	0.1
06.11.2017	8.4	27.12.2018	1.0
16.03.2018	dry

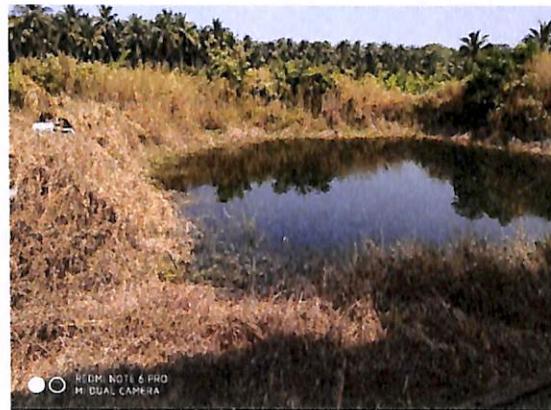
Well No 7

Location: Lat 10⁰ 48' 03.01" N; Long 76⁰ 52' 58.93" E
 Elevation: 204 m amsl
 Landform: valley
 Ownership: Private-Premanand
 Total depth: 16.4 m

Date	Depth to Water table	Date	Depth to Water table
02.03.2017	14.5	07.06.2018	15.1
25.08.2017	15.1	06.07.2018	10.4
27.09.2017	14.6	30.08.2018	0.2
06.11.2017	15.3	27.12.2018	0.7
16.03.2018	15.9

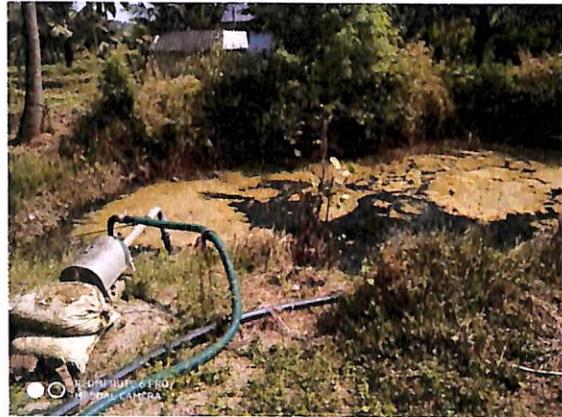
Well No 8

Location: Lat 10⁰ 48' 19.13" N; Long 76⁰ 53' 32.40" E
 Elevation: 218 m
 Landform: Flat terrace
 Ownership: Private-Thomas
 Total depth: 5.6 m.

Date	Depth to Water table	Date	Depth to Water table
02.03.2017	dry	07.06.2018	dry
25.08.2017	dry	30.08.2018	0.6
27.09.2017	dry	27.12.2018	1.3
06.11.2017	dry		
16.03.2018	dry

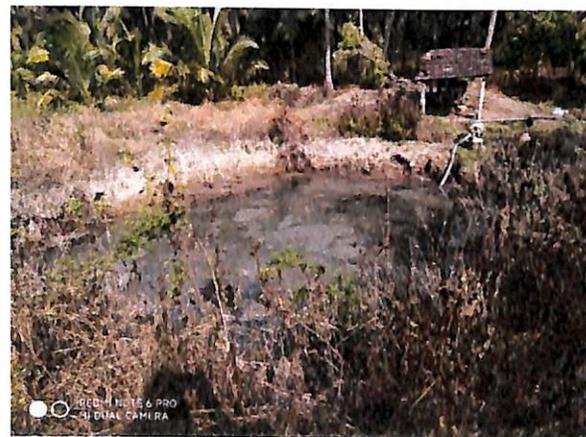
Well No 9

Location: Lat 10⁰ 48' 23.44" N; Long 76⁰ 53' 38.81" E
 Elevation: 223 m amsl
 Landform: Flat terrace
 Ownership: Private-Thomas
 Total depth: 12.3 m

Date	Depth to Water table	Date	Depth to Water table
02.03.2017	dry	07.06.2018	dry
25.08.2017	dry	30.08.2018	1.5
27.09.2017	dry	27.12.2018	3.0
06.11.2017	dry		
16.03.2018	dry

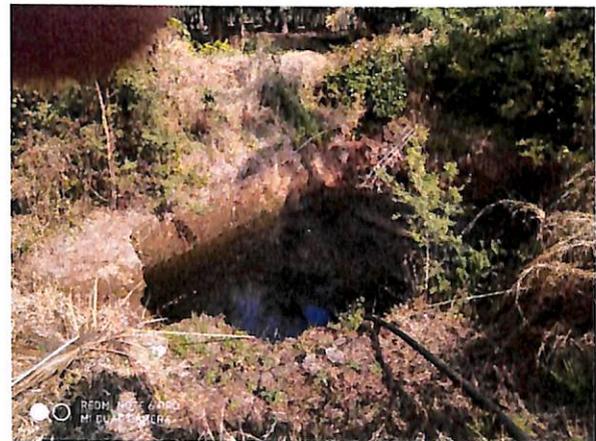
Well No 10

Location: Lat 10⁰ 47'50.65" N; Long 76⁰ 53' 39.32" E
 Elevation: 221 m amsl
 Landform: Valley edge
 Ownership: Private-Krishnaraj
 Total depth: 10.2 - Well deepened to 16.5 m in May, 2017

Date	Depth to Water table	Date	Depth to Water table
02.03.2017	9.1	07.06.2018	16.0
25.08.2017	16.1	06.07.2018	12.9
27.09.2017	14.8	30.08.2018	0.5
06.11.2017	15.0	27.12.2018	1.6
16.03.2018	15.8

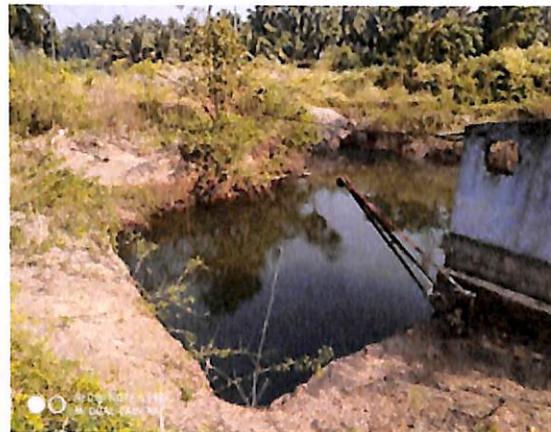
Well No 11

Location: Lat 10⁰ 47' 44.18" N; Long 76⁰ 53' 48.95" E
 Elevation: 226 m
 Landform: flat land
 Ownership: Private- Karuppuswamy Koundar
 Total depth: 12.5 m- well deepened to 15.7 m in March 18

Date	Depth to Water table	Date	Depth to Water table
02.03.2017	11.1	07.06.2018	dry
25.08.2017	11.8	19.06.2018	15.5
27.09.2017	11.5	07.07.2018	12.2
06.11.2017	11.7	30.08.2018	0.6
16.03.2018	dry	27.12.2018	1.2

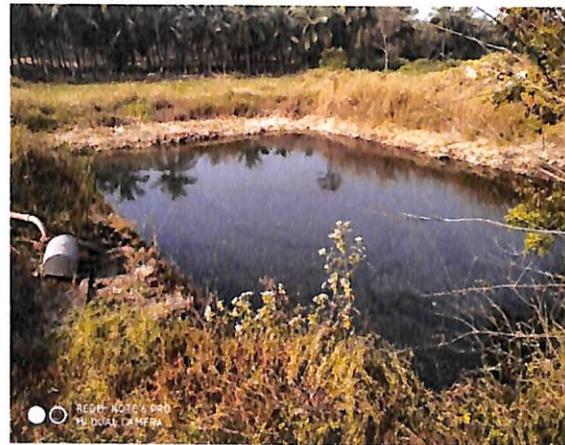
Well No 12

Location: Lat 10⁰ 47' 39.49" N; Long 76⁰ 53' 50.51" E
 Elevation: 228m
 Landform: valley edge south side
 Ownership: Kumaraswamy Koundar
 Total depth: 13 m bgl

Date	Depth to Water table	Date	Depth to Water table
02.03.2017	12.1	07.06.2018	12.8
25.08.2017	12.7	07.07.2018	11.8
27.09.2017	12.4	30.08.2018	0.5
06.11.2017	12.2	27.12.2018	1.4
16.03.2018	12.5

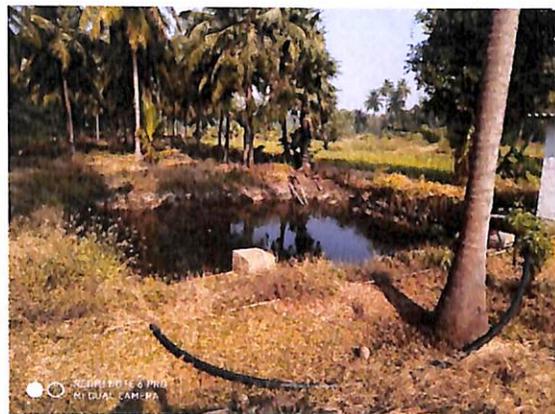
Well No 13

Location: Lat 10⁰ 48' 04.96" N; Long 76⁰ 53' 28.87" E
 Elevation: 211 m
 Landform: Valley –pond floor
 Ownership: Public-Mariamman kovil Pond
 Total depth: 6 m from pond floor

Date	Depth to Water table	Date	Depth to Water table
02.03.2017	4 m (below pond floor level)	07.06.2018	3.6 m
25.08.2017	4.4 m	19.06.2018	1.2 m
27.09.2017	3.0 m	07.07.2018	0.9 m
06.11.2017	3.7 m	12.07.2018	+0.75 m
16.03.2018	5.1 m	30.08.2018	+3.4 m
		27.12.2018	+2.7 m

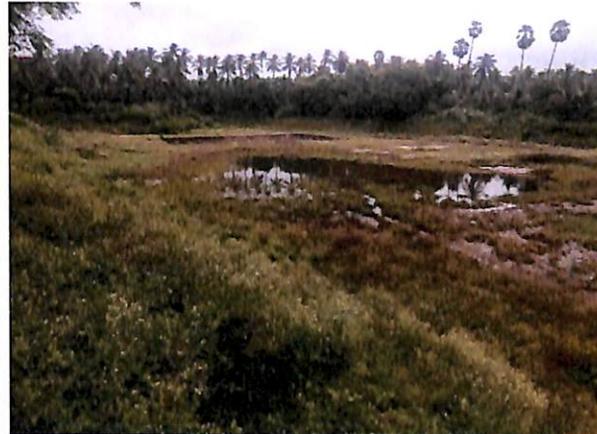
Top-View of the floor of the pond in June 2018
 Bottom- A view of the deepened part of the pond when constructed in 2017.

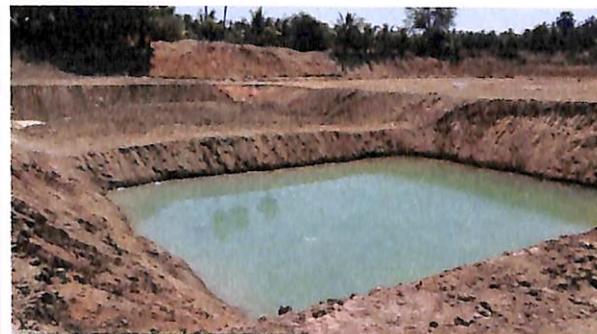
Pond overflowed on 23.07.2018. The over flow continued from the pond and peaked on 16.08.2018 when the water level above the over flow point (cemented steps) was 1.5 m. Over flow from the pond continued till the middle of November, 2018. On 30.08.2018, the water level stood at 0.4 m above the overflow point while it was 0.3 m on 14.10.2018.

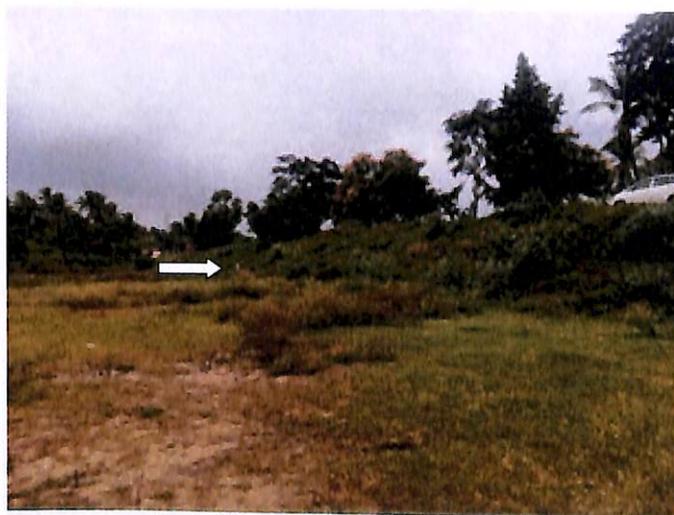
Arrow points to the head of the pipe piezometer from where measurements are taken
