## SITREP - 3, 1300 Hrs on 25/05/2025

# Sinking of MSC ELSA III (IMO no – 9123221, Flag Liberia) 13 nm South West of Kochi

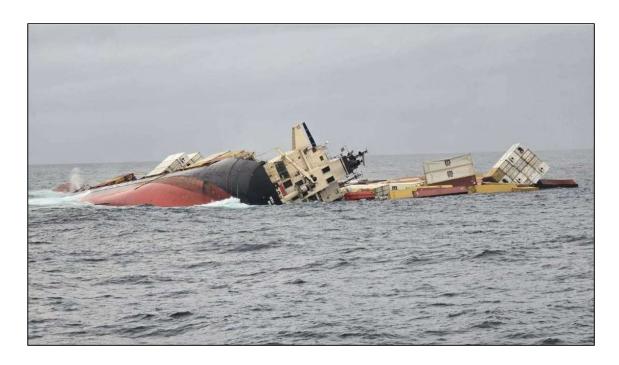
On 24 May 2025 at approximately 1300 hrs IST, the container vessel MSC ELSA 3, operated by MSC Ship Management Ltd., developed a severe starboard list while enroute from Vizhinjam to Cochin, about 30 nautical miles southwest of Kochi Port. By 1515 hrs IST, the list had increased to 30 degrees and stabilized, with no further progression observed.

Figure 1: MSC ELSA 3 on 25th May 2025 AM hours

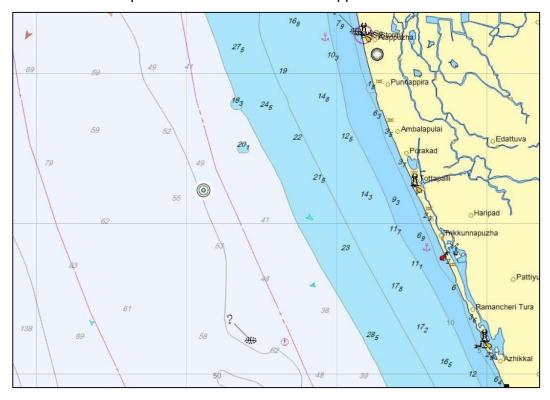
Figure 2: MSC ELSA position at 0700 hrs on 25th May 2025

The vessel sank approximately 13 nautical miles off the coast of Kerala at 0750 hours on 25<sup>th</sup> May 2025 in position **09 Deg 18.75N 076 Deg 08.16E**. As a result of the incident, all deck containers have been reported adrift in the surrounding waters. Among these are 13 containers classified under IMDG (International Maritime Dangerous Goods) Class 4.3, which are known to contain Calcium Carbide — a hazardous substance that reacts violently with water, releasing flammable gases. The uncontrolled drift of these containers presents a serious risk to maritime safety, posing immediate navigational hazards to passing vessels in the busy sea lanes off the Kerala coast. Prompt tracking, marking, and retrieval of these containers is critical to prevent collisions, environmental contamination, and potential threats to human life and property at sea.

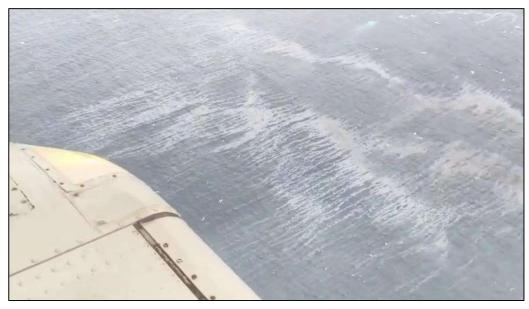
At approximately 0750 hours, the vessel sank about 13 nautical miles off the Kerala coast. Of the 24 crew members on board (comprising 1 Russian, 2 Ukrainians, 1 Georgian, and 20 Filipinos), 21 were safely evacuated from the liferaft on 24<sup>th</sup> May 2025. The remaining three crew members were subsequently rescued by the Indian Coast Guard on 25<sup>th</sup> morning hours. The Coast Guard has been conducting continuous surveillance of the area, and preliminary observations indicate signs of an oil spill in the vicinity of the incident.

Figure 3: Aerial view of Oil Spill (source : Indian Coast Guard)

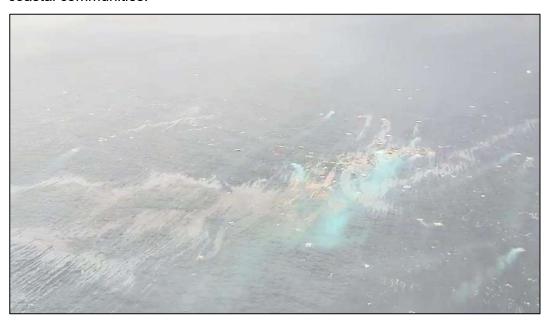
The adrift containers not only pose a navigational hazard but also represent a significant environmental threat, particularly given the nature of the cargo involved. The vessel was carrying approximately 367 tonnes of Heavy Fuel Oil (HFO) and 84.4 tonnes of Diesel Oil at the time of the incident. With the wreck located in close proximity to the Kerala coastline (approximately 13 nautical miles), there is a heightened risk of an oil spill. Such a spill could have serious

Figure 4:Aerial view of Oil Spill (source : Indian Coast Guard)

ecological consequences, including damage to marine biodiversity, coastal ecosystems, and local fisheries. Immediate containment and recovery measures are essential to mitigate the potential impact on the environment and nearby coastal communities.
