**ASSESSMENT OF IMPACT OF FLOOD/ LANDSLIDE
ON BIODIVERSITY WITH SPECIAL EMPHASIS ON
RIPARIAN VEGETATION IN
PAMBAYAR, PERIYAR, CHALAKUDYAR
AND BHARATHAPUZHA**

CENTRE FOR ENVIRONMENT AND DEVELOPMENT

JUNE 2019

**VOLUME-I
(MAIN REPORT)**

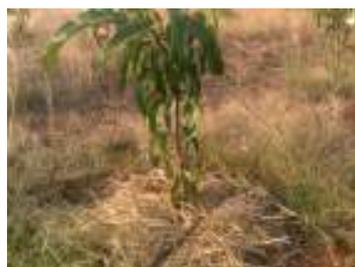
Mulching

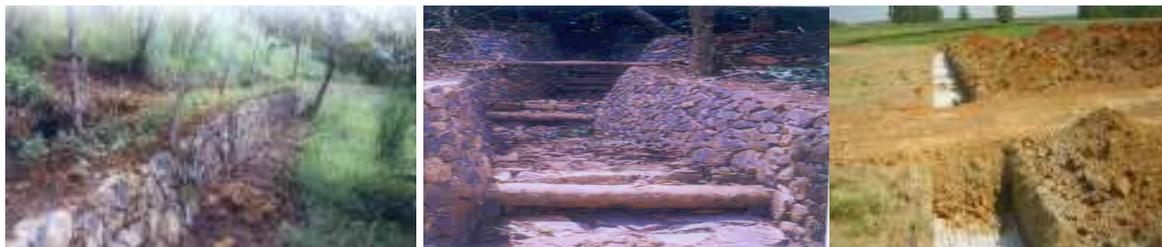
***Edakayyalas*****Gully Plugging with Local material****Contour Trenching**

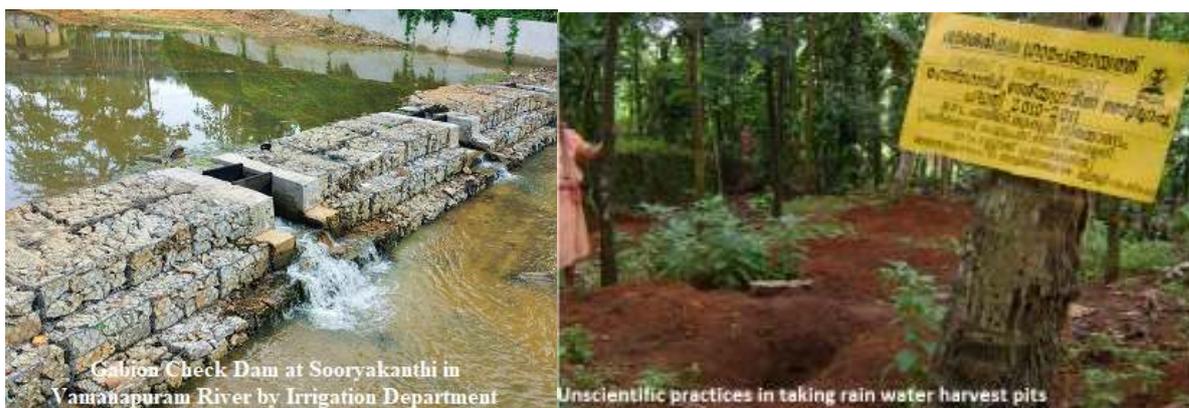
- Contour trenching checking the velocity of runoff in the ridge area of any watershed. A contour trench is a trench dug along a contour line. Digging a trench along such a line increases the chances of containing run off for a longer period of time within the trench. It is also true that if trenches were not followed a contour, it will increase the possibility of soil erosion because there would be a rise in the velocity of runoff following an increase in the slope of the land.
- Ecofriendly check dams with Gabion technology shall be constructed in the Main River and major tributaries, based on detailed study.

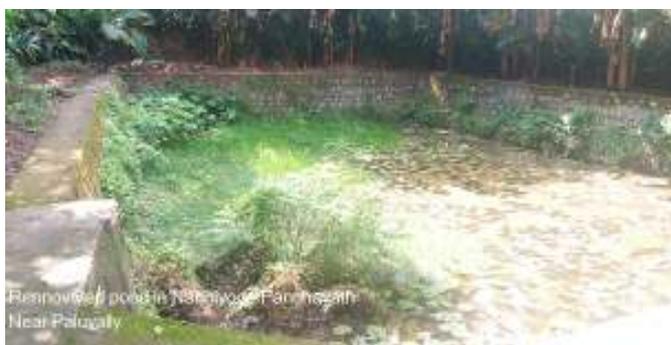
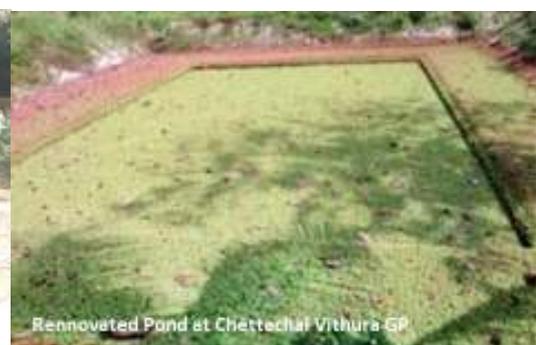
Pond rejuvenation and constructing new ponds is another activity which has to be promoted for sustainable water management through ground water recharging. A survey conducted by the fisheries department in 2000 and published 2002 (Pan fish book) has basic data on the ponds of Kerala. However, it is found that most of the ponds are now used for dumping waste.

The irrigation department has rejuvenated many ponds but due to unscientific practices like constructing concrete walls, the situation is worse in these ponds.

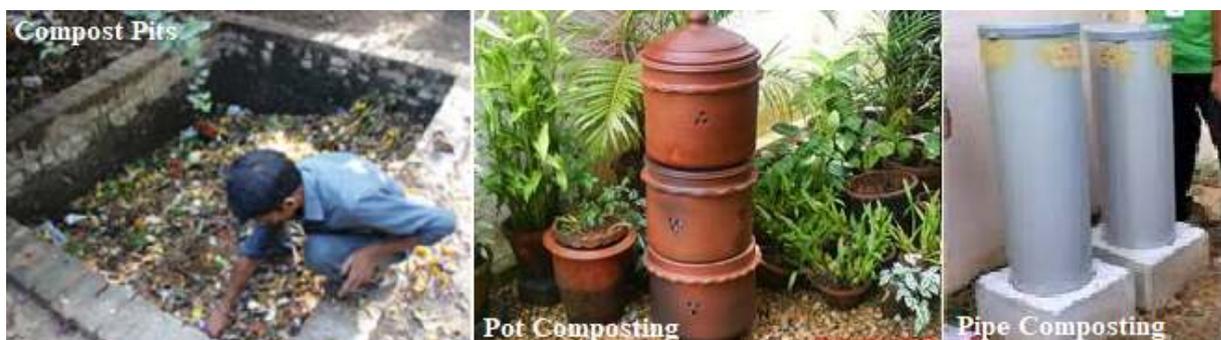
cases the expenditure can be reduced to such an extent that it can be shared by the community. As for market wastes and waste from other sources money for meeting capital expenditure has to be raised in advance as the cost involved will be high. Municipal Solid Waste (Handling and Management) Rules, 2000 provide a framework encompassing collection, transportation, treatment and disposal of municipal solid waste. These Rules are complemented by the existing Bio-medical Waste Rules of 1998 and Hazardous Waste Rules of 1989 respectively, whereby disposal of these wastes along with usual urban municipal waste is prohibited. Recently a more comprehensive legislation incorporating changed deadlines is issued by the Ministry, SWM Rules 2016. The Solid Waste Management (SWM) Rules, 2016 was published by the Ministry of Environment, Forests and Climate Change in supersession of the Municipal Solid Waste (Management and Handling) Rules, 2000. These rules are applicable to every local body and stipulate that all municipal authorities to scientifically manage the solid waste generated in their respective jurisdictions. Various biodiversity friendly are technologies like compost pits, pot compost, Pipe Composting, vermi composting etc. are now widely used in various parts of our state for processing of the biodegradable waste treatment.

Community based initiatives like Biomethanation, Aerobins (Thumburmuzhy model), Biobins (CREDAI Model) etc. are also are practiced very efficiently in the State in various places.

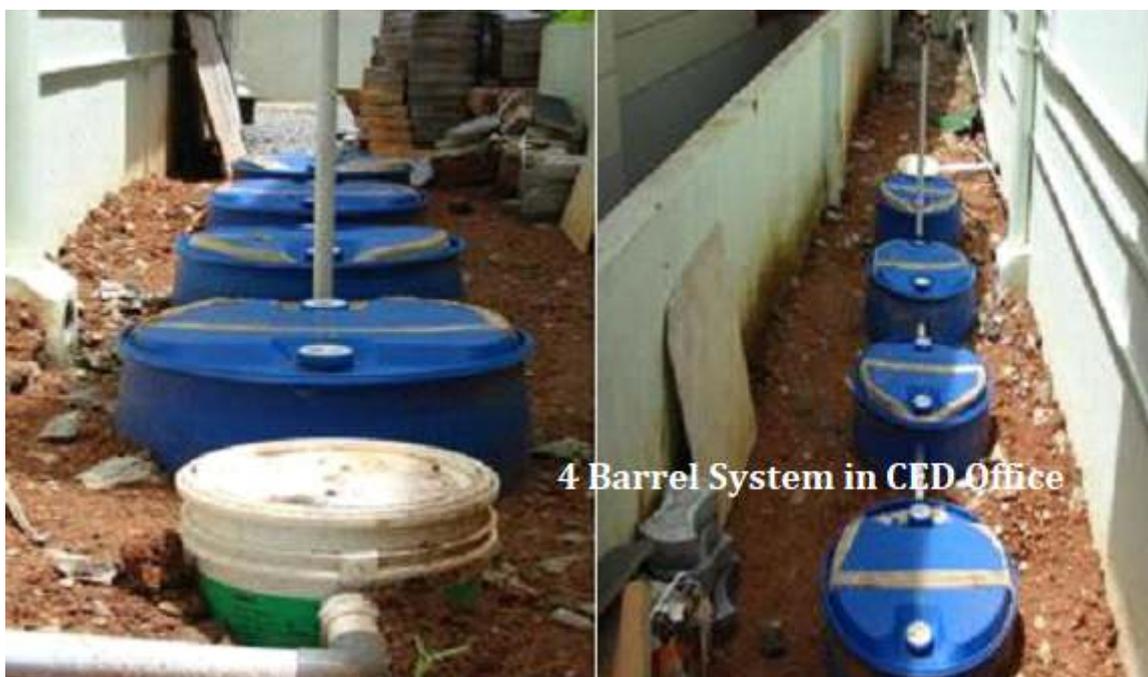
Grey water is a potential substitute for freshwater for a variety of uses, both domestic and industrial. Once the wasted grey water is captured and reused, the demand for potable water can be substantially reduced. Also the effort and money spent on wastewater management could be considerably reduced. Hence, Wastewater management strategy should essentially focus on grey water reuse in view of its latent capability to reduce the volume of wastewater to be treated with expensive treatment methods. There are many technologies available for treating the waste water which include Soakage Pits, The 4-Barrel System, The Confined Trench (CT) system, Septic Tank, Waste Stabilization Ponds, Constructed Wetland Treatment System etc.

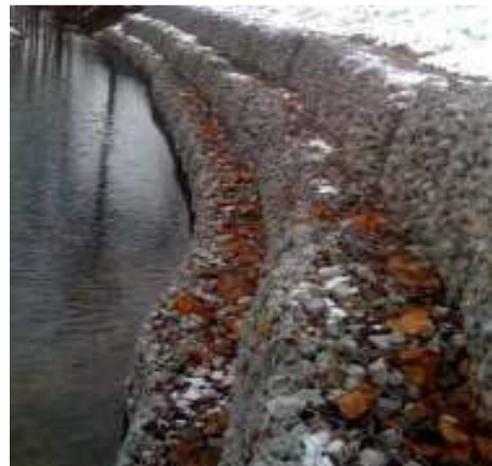
Gabion Baskets

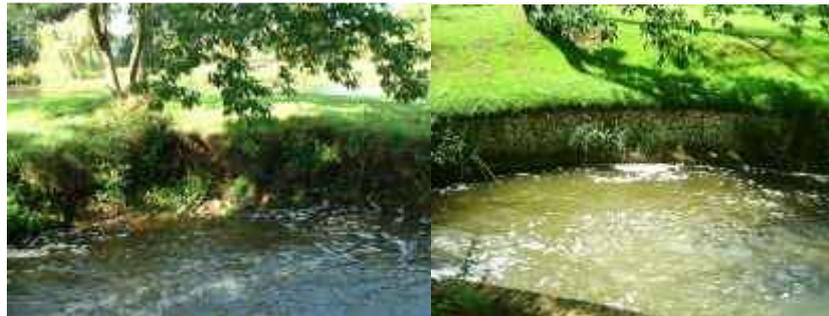
Gabion Protection of River: Before and after Protection
