FIELD BASED ASSESSMENT OF THE EFFECTS OF RECENT EARTHQUAKE IN KOLLAM DISTRICT OF KERALA

Hazard, Vulnerability and Risk Assessment (HVRA) Cell
Department of Revenue and Disaster Management, Govt. of Kerala

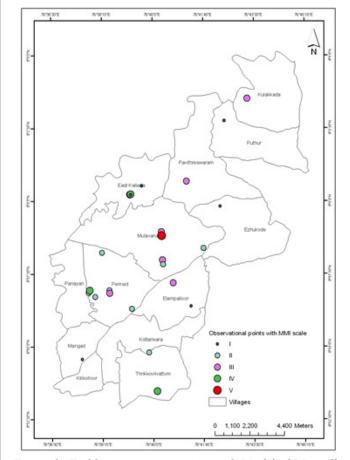
Figure 2: Field investigation points with Modified Mercalli Intensity Scale

(MMI). The MMI measures the intensity of an earthquake's effects in a given locality. The values on MMI scale ranges from I to XII were I – represents "not felt" and XII represents "total damage" (Appendix II). Coordinates of every observation were converted into point feature, with corresponding MMI scale as its attribute (Fig. 2). These values were interpolated with the Inverse Distance Weighted (IDW) method to produce an isoseimal surface map (Fig. 3). The surface map thus created shows, isoseismic areas in the

earthquake affected areas based on direct field observations. From the isoseismal map, it may be seen that the intensity of earthquake was the highest in Mulavana and Trikkovilvattom areas (Fig. 3). The spatial distribution of earthquake intensity map indicates the distribution pattern of earthquake related tremors, sounds and other associated features of earthquake in the affected areas. The map indicates a north-south trend of earthquake ground motion.

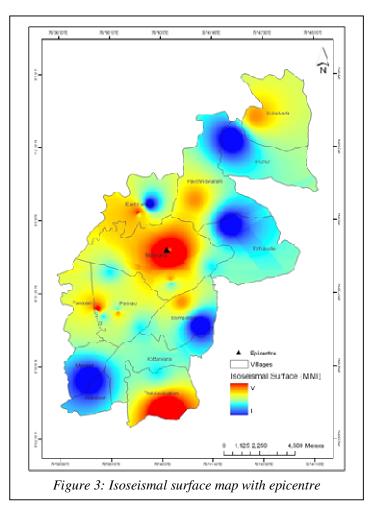
An inference of the location of epicentre of the earthquake was also made from the MMI spatial distribution of map. The epicentre derived based on felt reports is marked with the triangle symbol in Figure 3 and was found to be at 76° 40′ 16″E and 8° 58′ 59″N.

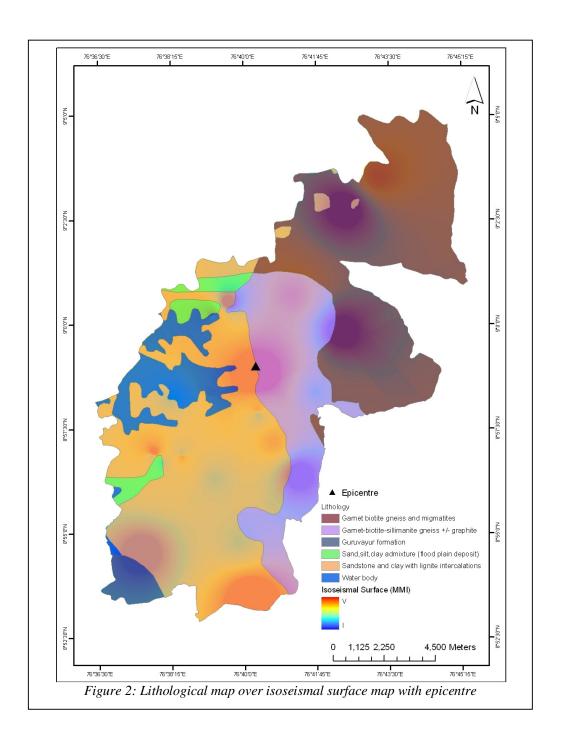
was observed that, the epicentre was located in the contact zone between sandstone/clay with lignite intercalations and granite biotite sillimanite gneiss with graphite (Fig. 4). Lithological contact zone just above the focus of earthquake enhanced earth vibration and caused damages to building and other masonry structures.
