**LAND SUBSIDENCE AND EARTH FISSURES IN WEST KALLADA
AREA OF KOLLAM DISTRICT**

**Dr. VIJITH H
Mr. PRADEEP G.S
Ms. PARVATHY S**

Hazard, Vulnerability and Risk Assessment (HVRA) Cell
Department of Revenue and Disaster Management, Govt. of Kerala
2nd Floor, Institute of Land and Disaster Management
PTP Nagar, Thiruvananthapuram 695038
Tel/Fax: 0471-2364424. Email: hvracell.gok@gmail.com
Web: disasterlesskerala.org

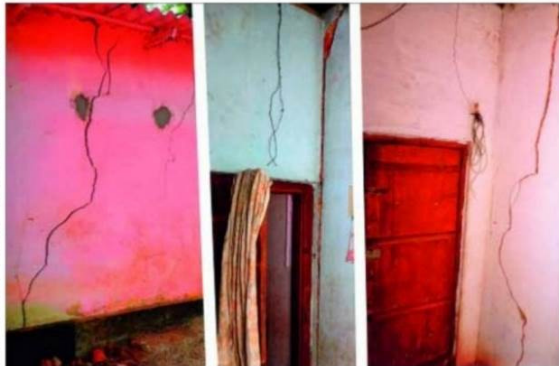
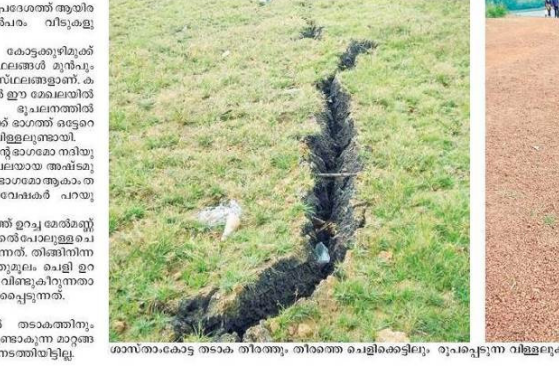
പടിഞ്ഞാറെ കല്ലടയിലുണ്ടായ ഭൂചലനത്തിൽ വീടുകളുടെ ഭിത്തി പിളർന്ന നിലയിൽ

Figure 2 & 3: Newspaper cuttings of the West Kallada events reported.
