Directorate General of Shipping

SITREP – 8, 2200 Hrs on 15/06/2025

Explosion on WAN HAI 503 (IMO no – 9294862, Flag Singapore) West of Kerala

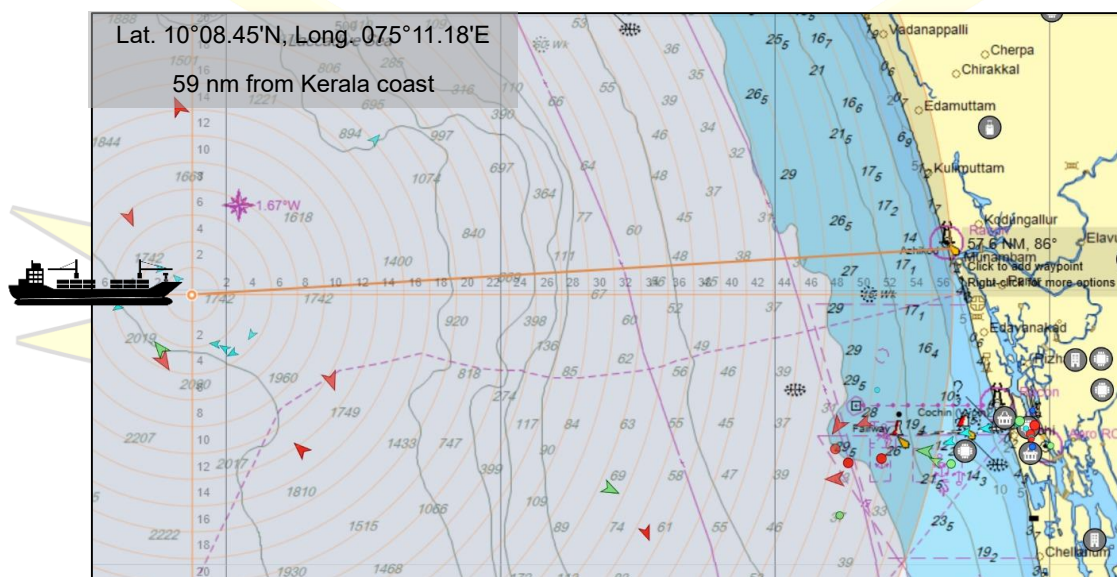
The vessel *WAN HAI 503* remains under controlled tow in the open sea, currently positioned at 10°08.45'N, 075°11.18'E, which is approximately 57 nautical miles (nm) from the Kerala coastline and 266 degrees 57 nm west of Azhikode. The vessel's movement remains minimal, with a westward course of 275° at a very slow speed of 0.3 knots, allowing salvage teams to stabilize its position. While the main structural drift towards the Indian coast has been controlled for now, the vessel continues to remain highly vulnerable due to persistent adverse sea and weather conditions that demand continuous course correction and real-time adjustments.

Figure 1: Position of WAN HAI 503 as on 15.06.2025 2100 hrs

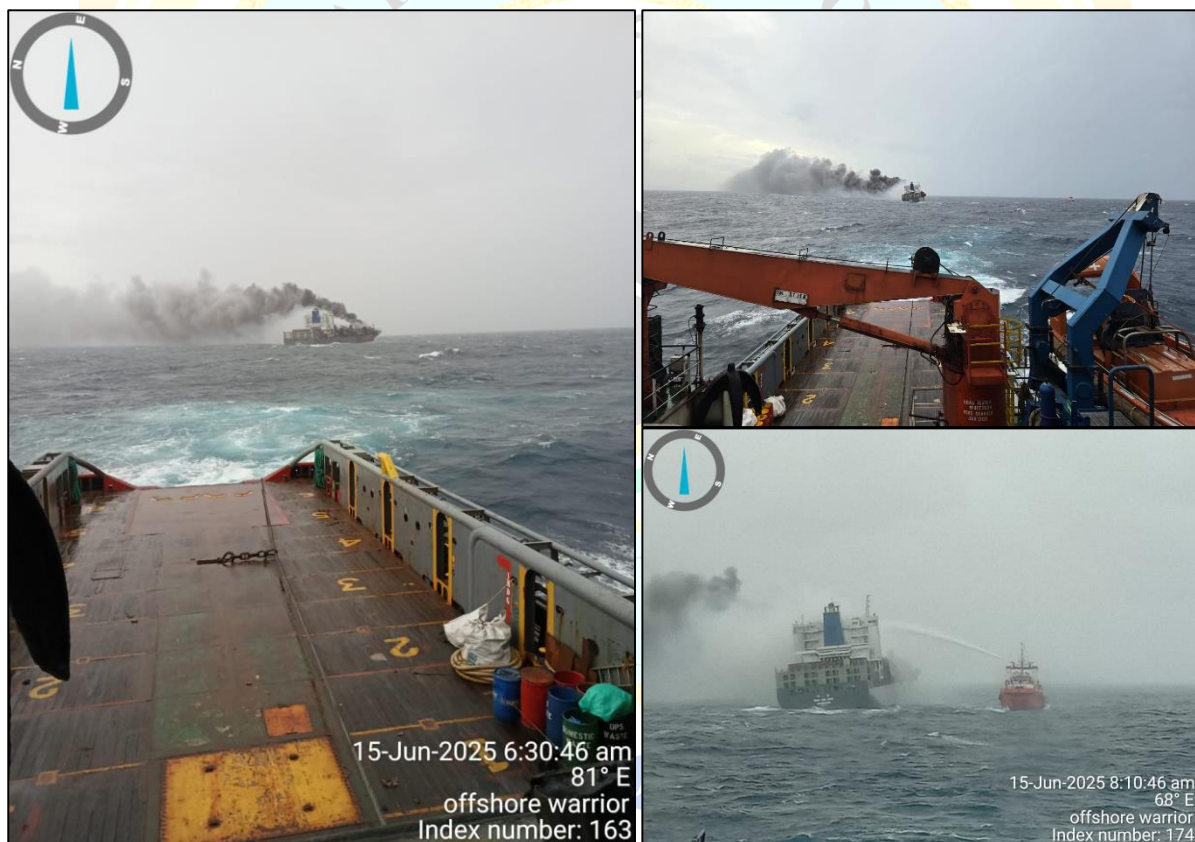
The salvage operation is being sustained by a comprehensive multi-agency deployment working continuously under the operational coordination of the Directorate General of Shipping. Tugs including *Boka Winger*, *Garnet*, *Saksham*, *Triton Liberty*, and *ETV Water Lily* are engaged in rotation to conduct continuous boundary cooling on critical bays identified earlier, including 35, 49, and 51. Each vessel is taking turns to maintain thermal balance on the vessel and prevent any reignition or structural escalation.

Figure 3: Vessel Deployment for Emergency Response
