Directorate General of Shipping

SITREP – 9, 1800 Hrs on 16/06/2025

Explosion on WAN HAI 503 (IMO no – 9294862, Flag Singapore) West of Kerala

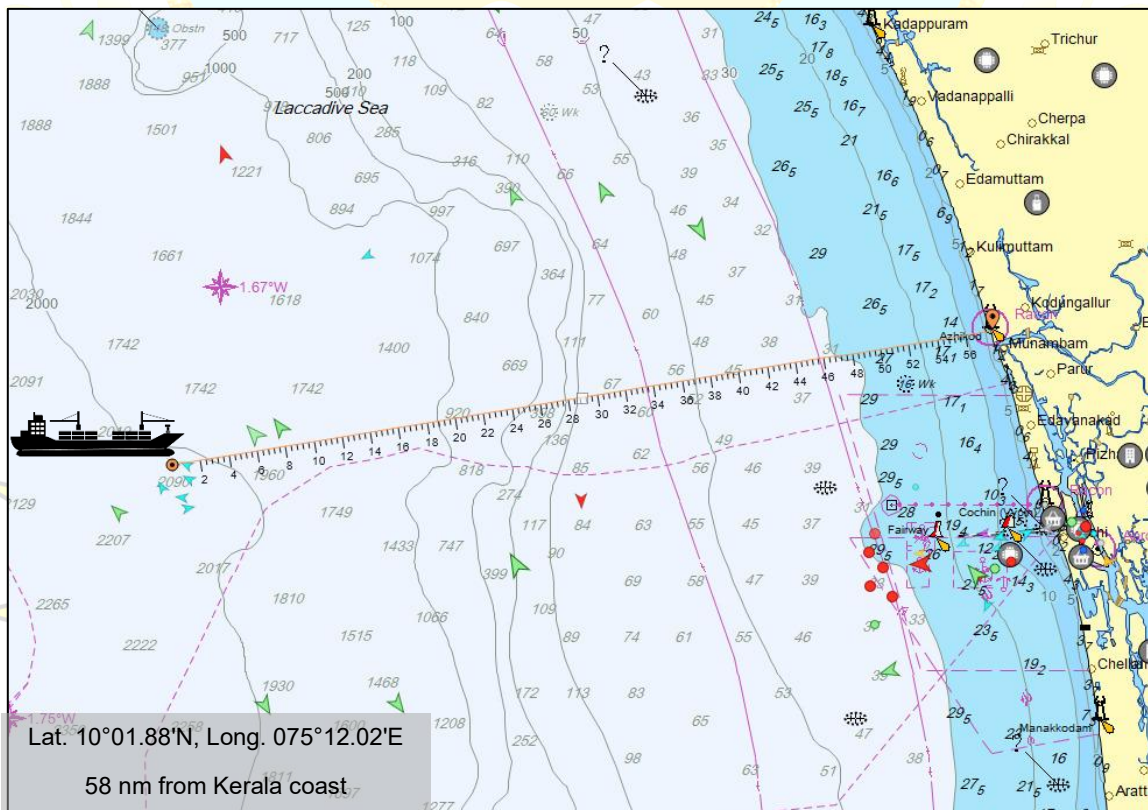
As of 1200 hrs on 16.06.2025, *WAN HAI 503* remains under controlled tow at position 10°01.88'N, 075°12.02'E, approximately 58 nautical miles west of Azhikod, holding a westerly course at a reduced speed of 0.3 to 0.6 knots.

Figure 1: Position of WAN HAI 503 as on 16.06.2025 1200 hrs
