Directorate General of Shipping

SITREP - 13, 1800 Hrs on 20/06/2025

Explosion on WAN HAI 503 (IMO no – 9294862, Flag Singapore) West of Kerala

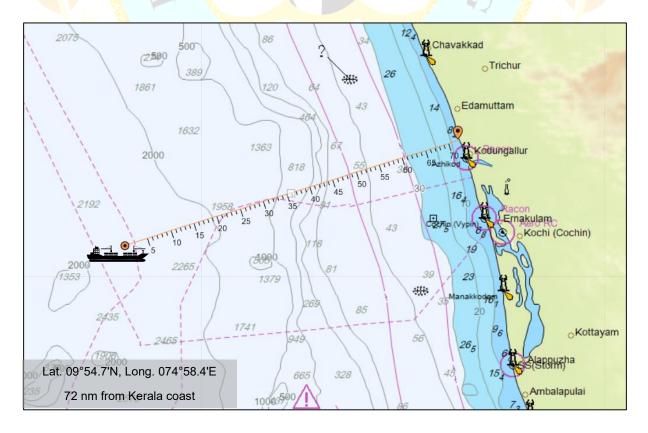
As of 0600 hrs on 20 June 2025, *MV WAN HAI 503* is located at position 09°54.7'N, 074°58.4'E, approximately 72 nautical miles from the Indian coast, maintaining a north-westward drift at a course of 320° and speed of 0.7 knots.

Figure 1: Position of WAN HAI 503 as on 20.06.2025 0600 hrs
