## **Directorate General of Shipping**

**SITREP – 14, 1800 Hrs on 21/06/2025**

### **Explosion on WAN HAI 503 (IMO no – 9294862, Flag Singapore) West of Kerala**

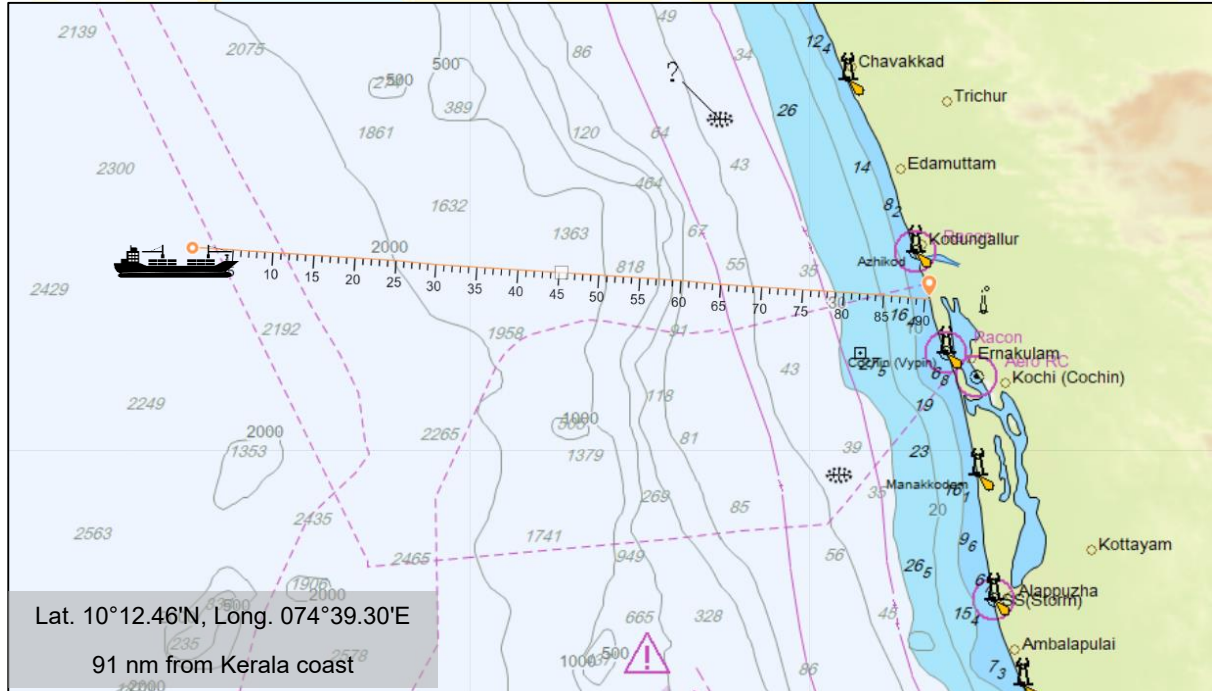
As of 1800 hrs on 21 June 2025, MV WAN HAI 503 is located at 10°12.46'N, 074°39.30'E, approximately 91 nautical miles from the Kerala coast, drifting at a speed of 0.7 knots on a 295° course.

Figure 1: Position of WAN HAI 503 as on 21.06.2025 1800 hrs
