# **Directorate General of Shipping**

#### SITREP - 31, 1800 Hrs on 14/07/2025

### Explosion on WAN HAI 503 (IMO no - 9294862, Flag Singapore) West of Kerala

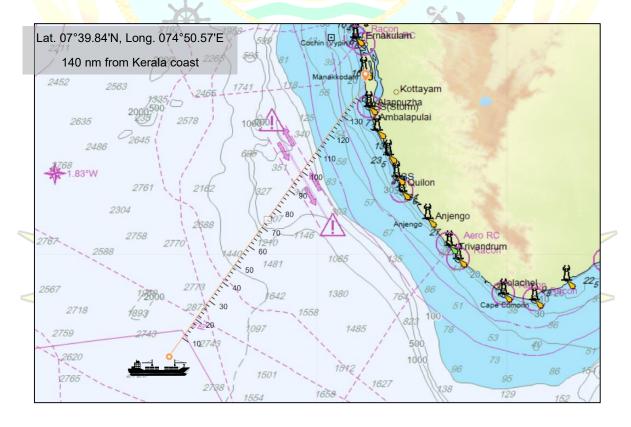
As of 1800 hours on 14 July 2025, the casualty vessel *Wan Hai 503* remained under tow by Offshore Warrior and maintained her position outside the Indian Exclusive Economic Zone (EEZ) at 07°39.84'N, 074°50.57'E, heading 290° at a speed of 1.4 knots.

Figure 1: Position of the vessel on 14.07.2025 1800 hrs
