ROCK SLOPE STABILITY: TECHNICAL STUDY REPORT

.....
Name of Client : District Collector, Disaster Management
Authority, District Collectorate, Kudappanakunnu
.....
.....

Job No. : CET/ITC&SR No. 558/22-23
.....

**REPORT ON ELECTRO-TELLURIC SURVEY AT VELLAR,
PACHALLOOR, TRIVANDRUM**

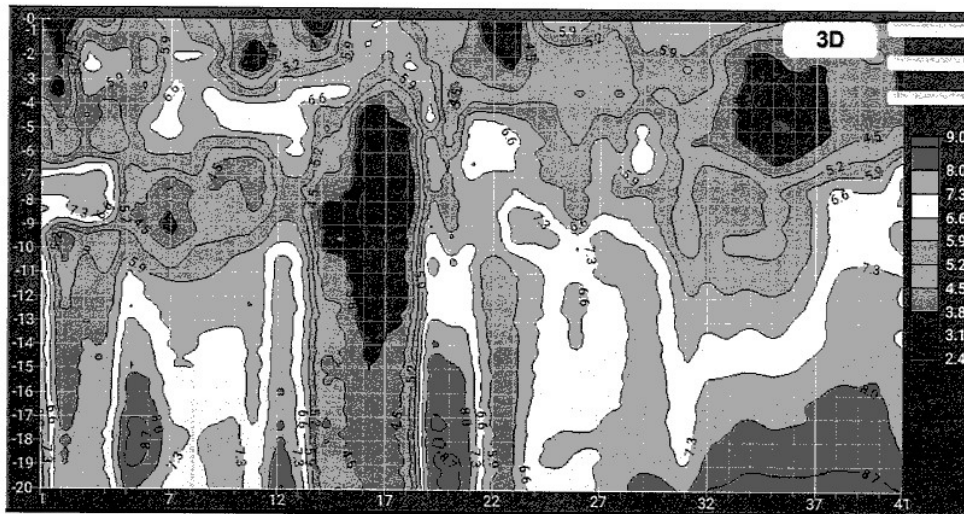
Figure 4- Transect 1

The following section presents three tellurograms obtained from this study. These visual representations of telluric currents are included to facilitate a comprehensive analysis of the subsurface geological structures, the fracture planes and the weathered horizons and its correlation with the geological understanding derived from the terrain.

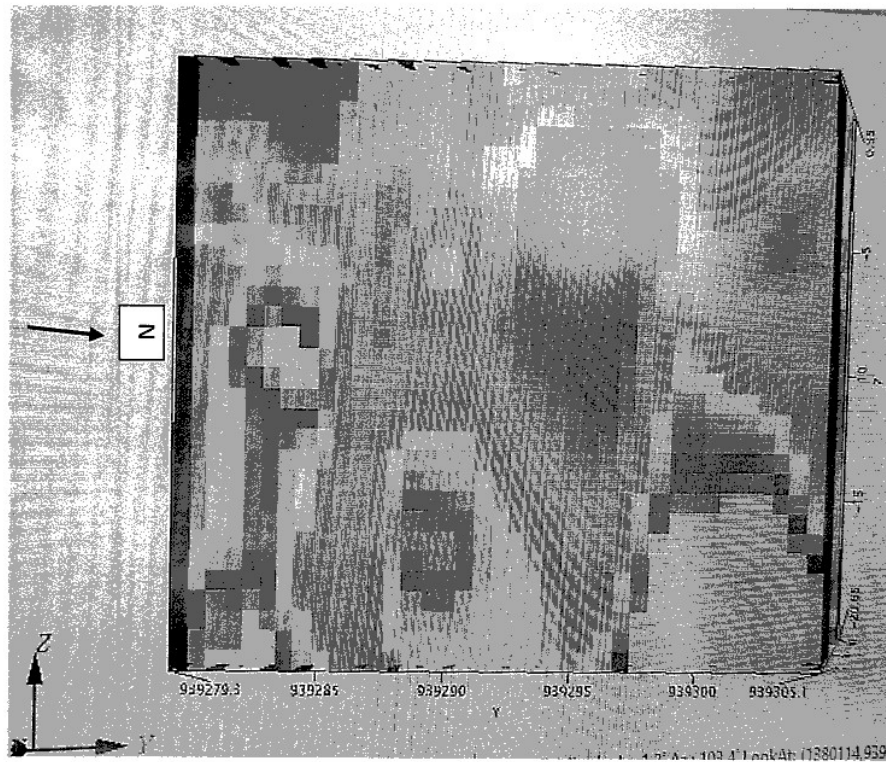
Figure 8-Profile of the section averaged to the Transect taken

The following section presents three tellurograms obtained from this study. These visual representations of telluric currents are included to facilitate a comprehensive analysis of the subsurface geological structures, the fracture planes and the weathered horizons and its correlation with the geological understanding derived from the terrain
