Directorate General of Shipping

SITREP - 15, 1800 Hrs on 22/06/2025

Explosion on WAN HAI 503 (IMO no – 9294862, Flag Singapore) West of Kerala

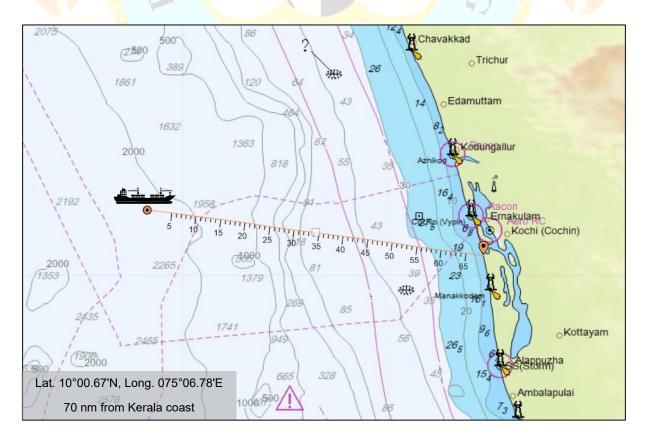
Figure 1: Position of WAN HAI 503 as on 22.06.2025 1800 hrs

As of 1800 hrs on 22 June 2025, *MV WAN HAI 503* is positioned at 10°00.67'N, 075°06.78'E, approximately 70 nautical miles off the Indian coast, drifting at a course of 225° with a speed of 1.3 knots.

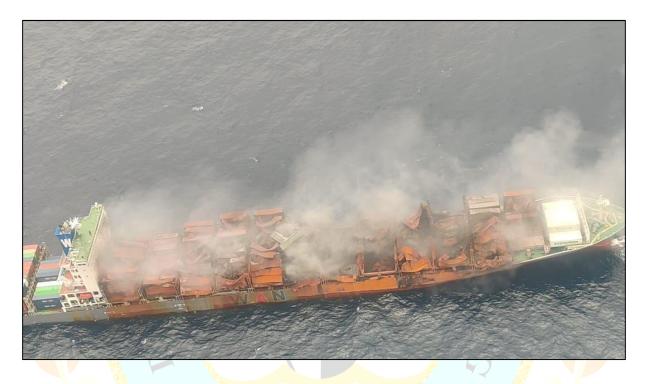
Figure 2: Visuals of vessel as on 22.06.2025, 1220 hrs

Fire activity onboard remains active but localised. Bay 14 has witnessed a reignition with visible black smoke, while light grey smoke continues to be emitted from Bays 4–9 and 37–39. Firefighting efforts are ongoing with rotation between *Boka Winger*, *Saksham*, *Saroja Blessing*, and *Water Lily* as required. Boundary cooling has resumed and thermal imaging has been deployed to monitor evolving hotspots. The engine room continues to show signs of water ingress with the aft draft having increased by approximately 30 cm. Draft readings currently stand at 11.0 m (Forward Port), 10.8 m (Forward Starboard), and 12.6 m at midship, indicating hydrostatic balance at midsection but growing concern at the aft.

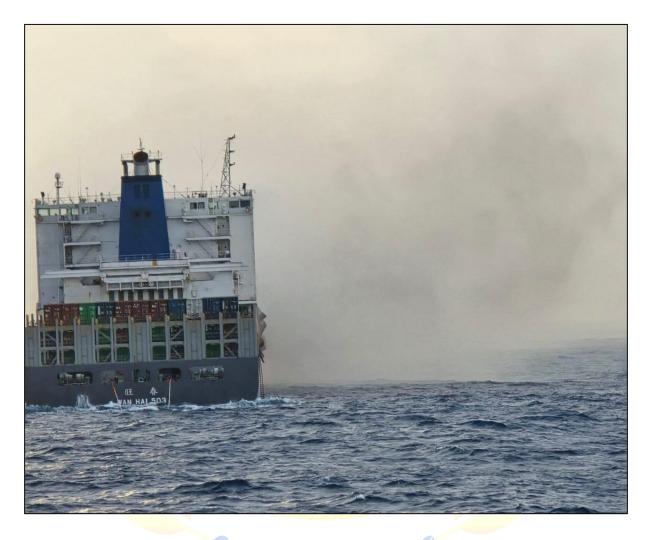
the Salvage Master and two firefighters were deployed aboard the casualty on 21 June and continue internal checks on engine room flooding, generator status, and critical systems.

A diving operation is scheduled for 23 June to locate the source of the flooding and examine any hull breach or ducting damage. T&T has also been directed to deploy submersible pumps and assess the status of the emergency generator and the main switchboard. While the emergency generator appears unaffected, its use remains pending proper testing. Additional firefighting supplies, including Pyrocool, are in transit aboard *Virgo*, currently en route to Fujairah.
