Directorate General of Shipping

SITREP – 24, 1800 Hrs on 02/07/2025

Explosion on WAN HAI 503 (IMO no – 9294862, Flag Singapore) West of Kerala

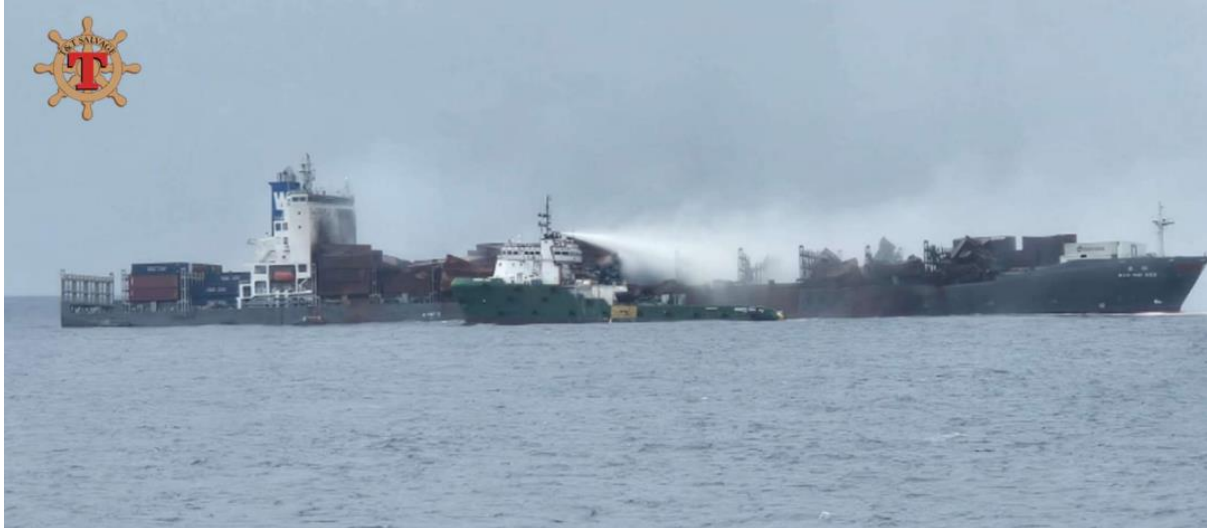
Figure 1: Condition of the vessel

The visible fire onboard has largely been contained, with only light smoke emanating forward of the accommodation block and from cargo hold no. 4. No active flames have been observed in the most recent operations.

Continuous hull and hold temperature monitoring is being carried out using thermal imaging to assess structural heat stress and potential flare-ups. Additionally, the application of approximately 9000 litres of Pyrocool firefighting agent has been completed, effectively reducing hotspot temperatures, particularly in cargo hold no. 4, where maximum recorded temperatures have now fallen to 64°C on the port side and 68°C on the starboard side.

The salvage team has activated five pumps onboard, dewatering both the engine room and the affected cargo holds. This has led to a significant reduction in engine room water levels, by approximately 3.5 metres, reducing the vessel's overall draft and providing a safer operational environment.

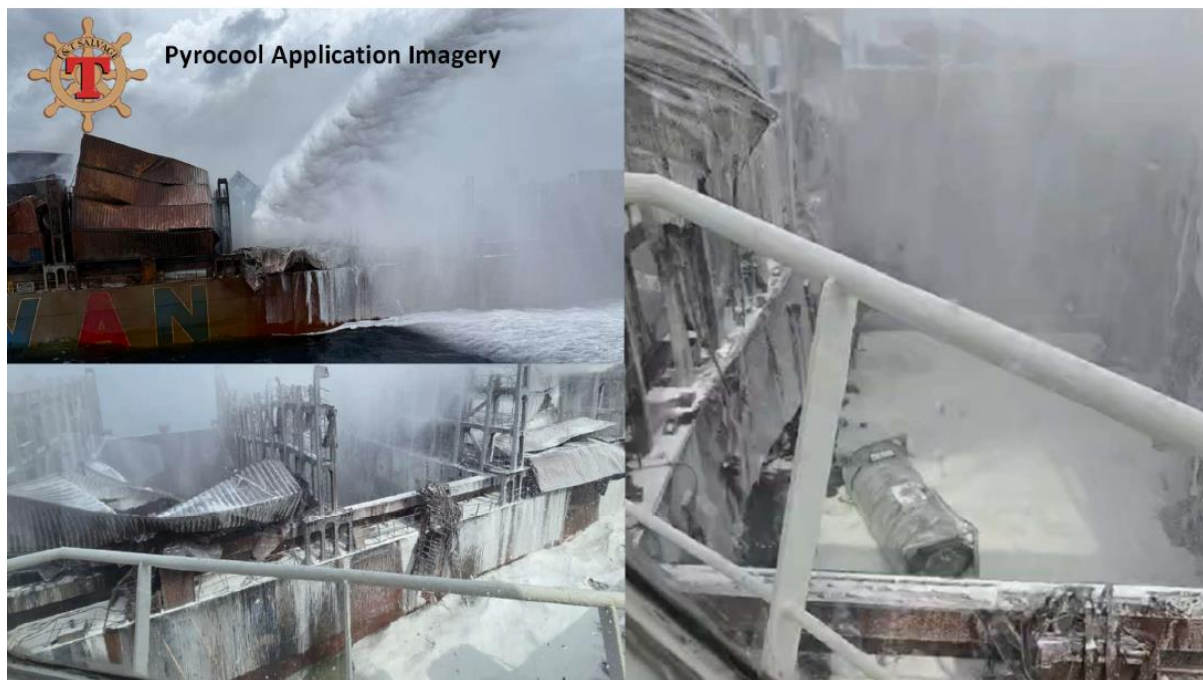
Figure 2: Pyrocool Application

Approximately 6000 litres of Pyrocool remain in reserve for any escalation, with an additional supply pre-positioned in Singapore for rapid deployment. CO₂ injection into cargo hold no. 5 has been initiated to suppress internal smouldering, with two further CO₂ discharges kept ready if required. In parallel, the salvage team has commenced ventilation of starboard side tunnels to reduce hazardous gas concentrations, allowing safer forward access and potential operations on the bow.
